L624-A.07.15	<b>To:</b> Official After Sales Network <b>Subject:</b> Seat update <b>Date:</b> 02/02/15 <b>Pages:</b> 5	 
--------------	--	---

Seat update

All Lamborghini Huracán Models MY 15 from VIN **FLA00163** to VIN **FLA01657**.

As a result of continuous product monitoring, Automobili Lamborghini Spa has decided to install a wiring reinforcement to prevent abrasion during seat movement.

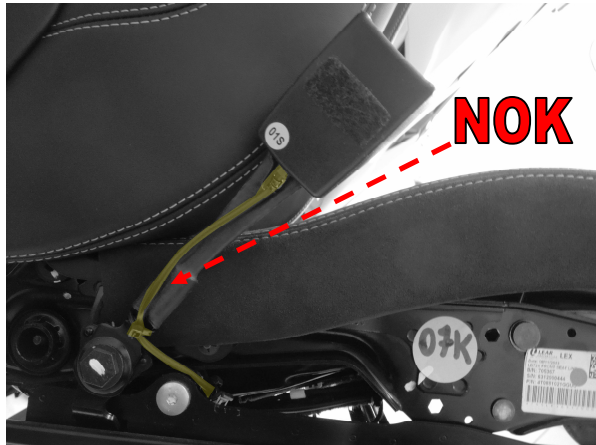
When the buckle wire is placed onto the external side of the buckle stem facing the tunnel, it must be routed again.

14. Change routing of the seat belt buckle wiring.
