L624-A.09.15	To: Official After Sales Network Subject: Instrument Cluster (Kombi) software update Date: 02/20/2015 Pages 16	 
--------------	---	---

Instrument Cluster (Kombi) software update

All Lamborghini Huracán 2015 from VIN FLA00163 to FLA02216.

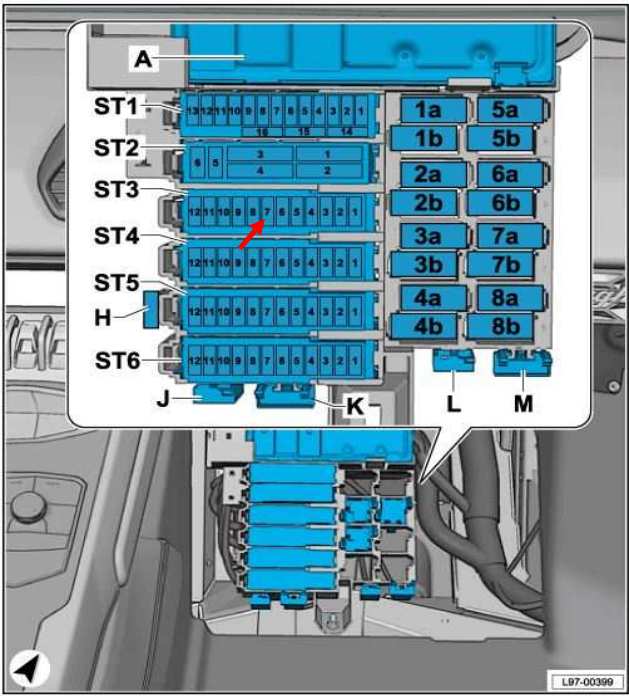
Position of the fuse on Left Handdrive cars

If the update programming has not been completed or has been for some reasons unsuccessful:

- Close the ODIS session;
- Turn the ignition OFF;
- Disconnect the locked Instrument Cluster, by removing the SC7 fuse on black fuse holder ST3 (see below images)

7	- Fuse 7 on fuse holder C -SC7-	5 A
Control unit in dash panel insert -J285-		30a

- Wait at least 10 minutes and reconnect the Instrument Cluster, by inserting the SC7 fuse before removed.
- Turn the ignition ON;
- Restart ODIS and repeat the procedure from step 11, checking that ODIS is the only application running on the diagnosis laptop.

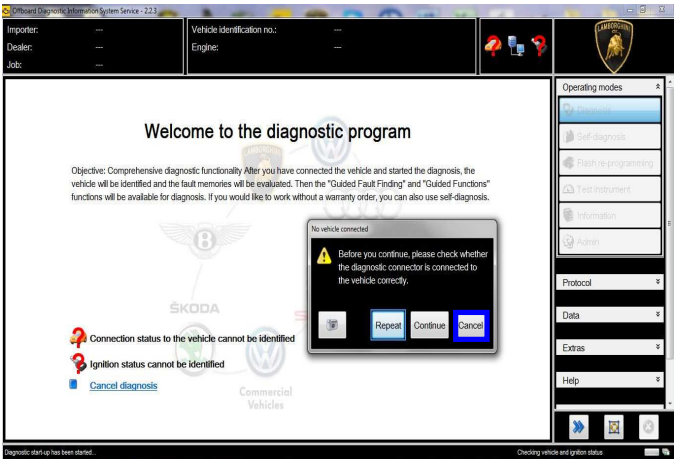
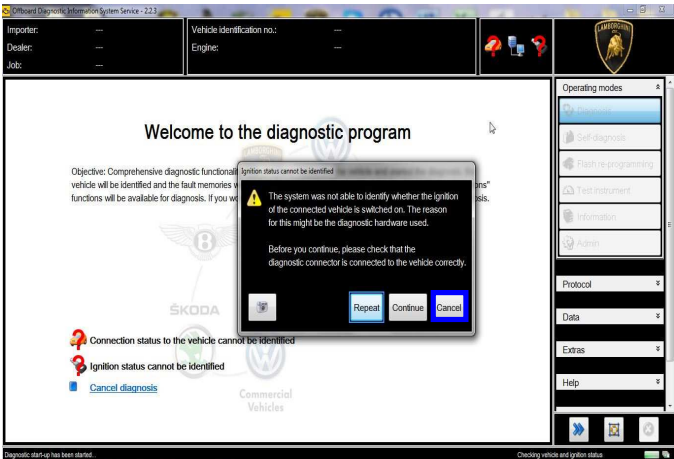
- A. If the error message regarding the VAS5054 interface and the 2 icons for status of on board connection and key on are shown as in the picture below:
- Click **“Cancel”**;
 - Repeat the VAS5054 HW interface installation following the procedure (*) **“VCI Manager v2.0”**, by entering in the menu **“Extras”** on the right side and clicking on **“Diagnostic interface”**.

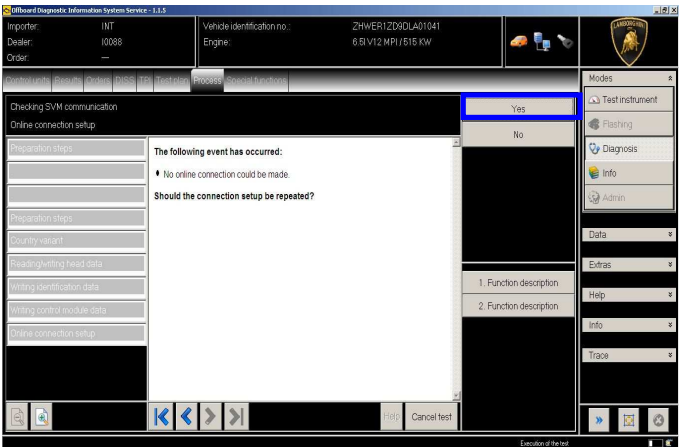
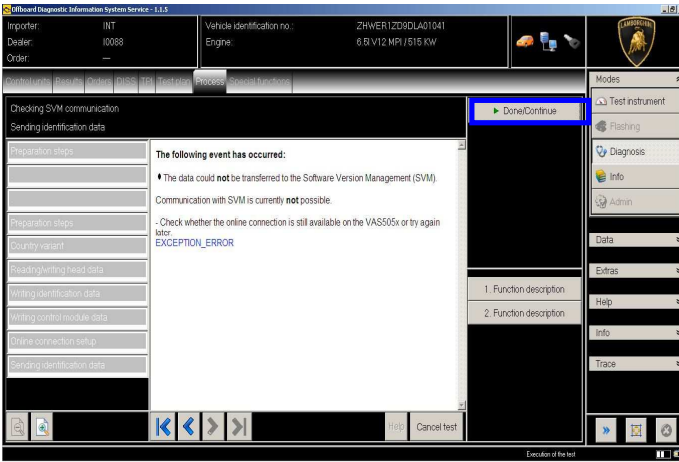
B. If one of the connection errors screens is shown as in the pictures below:

- it is not possible to establish a connection with the central server. Please check carefully that the diagnosis laptop is properly connected to the internet network and retry clicking “Yes” or “Done/Continue”.

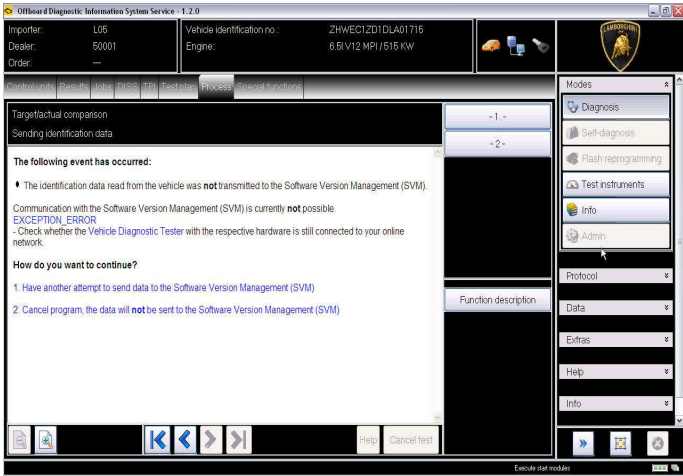
C. If the loss of connection happens during the target/actual comparison.

- It is not possible to connect to central server, check the working connection of internet and retry by clicking “1”.

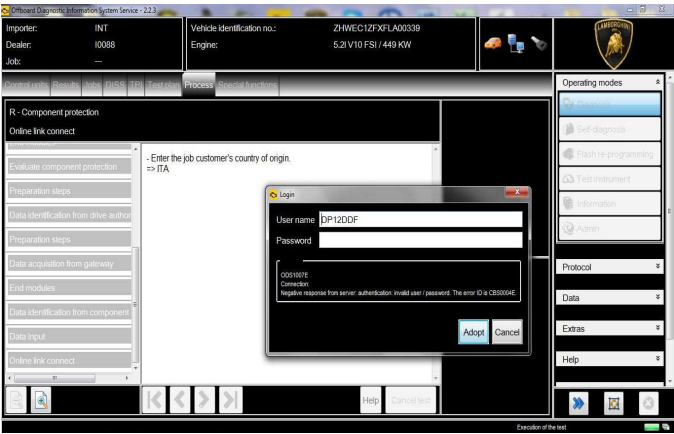
D. If the incorrect identification message is shown as in the picture below (error code: ODS1007E):

- be sure that your Geko account is valid;
- be sure that the label “Geko” is written on the token that you are using for the authentication;
- be sure the Password inserted is correct;
- click on Cancel and perform the application test (see document “ODIS_Checking_ConnectionServer_SV M_2.0” (*)).

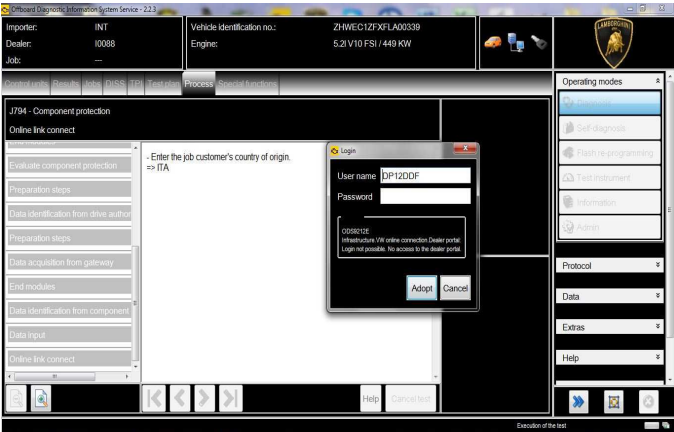
- E. If the infrastructure error message is shown as in the picture below (error code: ODS9212E):
- be sure that your Geko account is valid
 - be sure that the label “Geko” is written on the token that you are using for the authentication
 - verify in ODIS settings you have “Internet” instead of “CPN” (see document “ODIS_Initial_Setup_2.0” (*))
 - click on Cancel and perform the application test (see document “ODIS_Checking_ConnectionServer_SVM_2.0” (*))

If the same error was present during the application test, try following procedure:

- quit ODIS;
- Enter the folder C:\Program Files (x86)\Offboard_Diagnostic_Information_System_Service\automatic_sessions on your diagnosis laptop

- delete the only file present in that folder
- re-Start ODIS Service under following conditions:
 1. Network connection available;
 2. ODIS connection set on “Internet”;
- Retry the application test and the SVM with your GeKO Token.

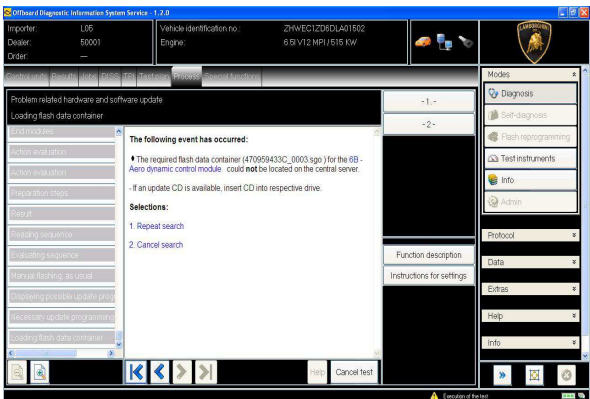
- F. In the case the flash container is not detected (see figure):

- Make sure to be recently synchronized with Mirrorserver by checking the last date of Sync under:
<http://mirrorserver/welcome>
or under
http://IP_address/welcome
if you don't have previously defined the “mirrorserver” IP address alias.
- Make sure to be correctly connected with Mirrorserver.
