L624-
A.10.15

To: Official After Sales Network
Subject: Software Update Of Headlight Alignment Adjustment Control Unit (AFS)
Date: 02/20/2015
Pages: 16

Software update of headlight alignment adjustment control unit (AFS).

All Lamborghini Huracán 2015 From VIN FLA00163 to FLA02206

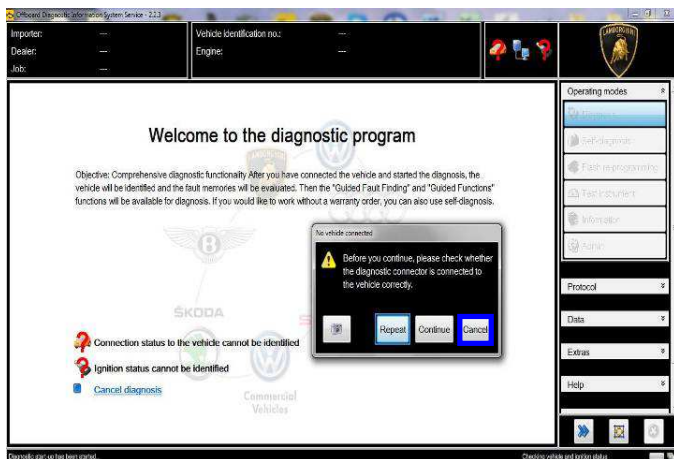
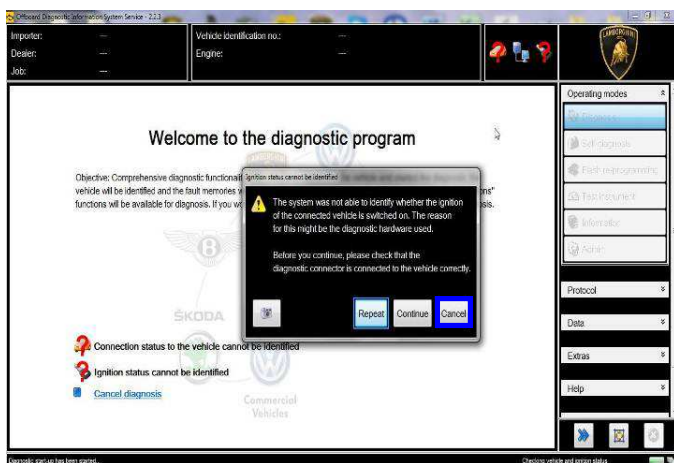
A. If the error message regarding the VAS5054 interface and the 2 icons for status of on board connection and key on are shown as in the picture below:

- Click “Cancel”;
- Repeat the VAS5054 HW interface installation following the procedure (*) “VCI Manager v2.0”, by entering in the menu “Extras” on the right side and clicking on “Diagnostic interface”.

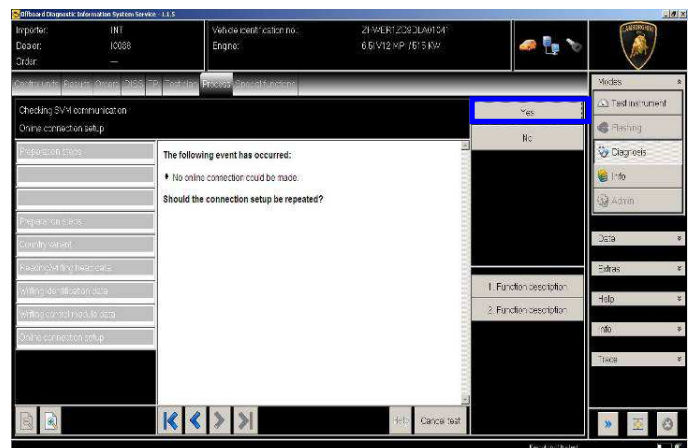
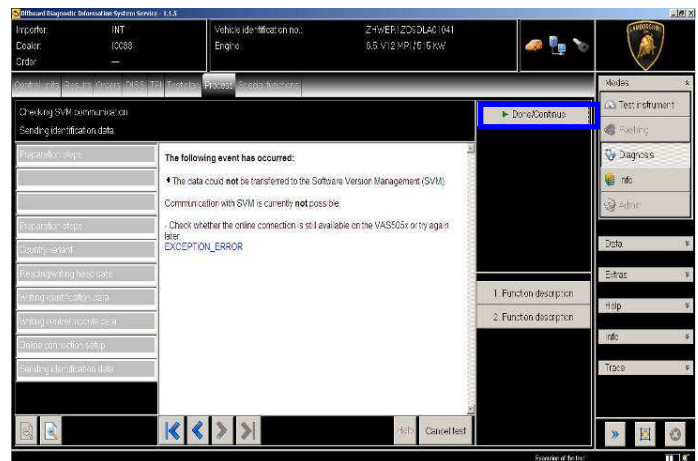
B. If one of the connection errors screens is shown as in the pictures below:

- it is not possible to establish a connection with the central server. Please check carefully that the diagnosis laptop is properly connected to the internet network and retry clicking “Yes” or “Done/Continue”.

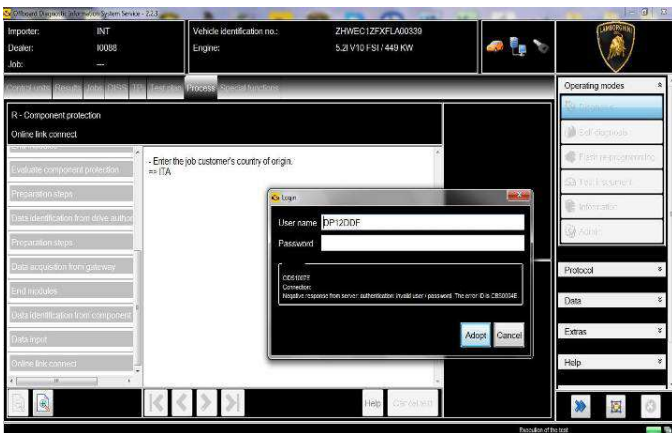
D. If the incorrect identification message is shown as in the picture below (error code: ODS1007E):

- be sure that your Geko account is valid;
- be sure that the label “Geko” is written on the token that you are using for the authentication;
- be sure the Password inserted is correct;
- click on Cancel and perform the application test (see document “ODIS_Checking_ConnectionServer_SVM_2.0” (*)).

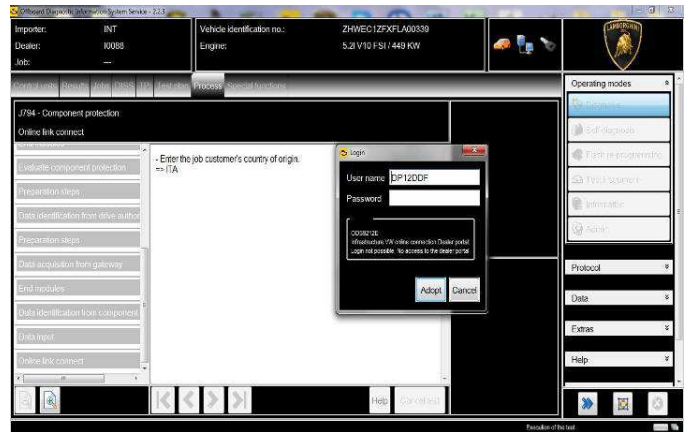
E. If the infrastructure error message is shown as in the picture below (error code: ODS9212E):

- be sure that your Geko account is valid
- be sure that the label “Geko” is written on the token that you are using for the authentication
- verify in ODIS settings you have “Internet” instead of “CPN” (see document “ODIS_Initial_Setup_2.0” (*))
- click on Cancel and perform the application test (see document “ODIS_Checking_ConnectionServer_SVM_2.0” (*))

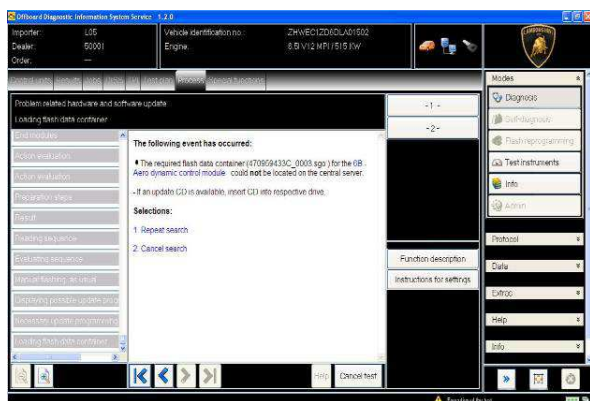
F. In the case the flash container is not detected (see figure):

- Make sure to be recently synchronized with Mirrorserver by checking the last date of Sync under:
<http://mirrorserver/welcome>
 or under
http://IP_address/welcome
 if you don't have previously defined the “mirrorserver” IP address alias.
- Make sure to be correctly connected with Mirrorserver.
