L624-A.11.15	To: Official After Sales Network Subject: Main Unit MMI coding update Date: 02/20/2015 Pages: 13

Main Unit MMI coding update

All Lamborghini Huracán MY 2015 Versions Japan, China and South Korea from VIN FLA00163 to FLA02206.

As a result of continuous product monitoring, Automobili Lamborghini Spa has enhanced the functionalities of MMI for the management of LIS2 for the Japan China and Korea markets.

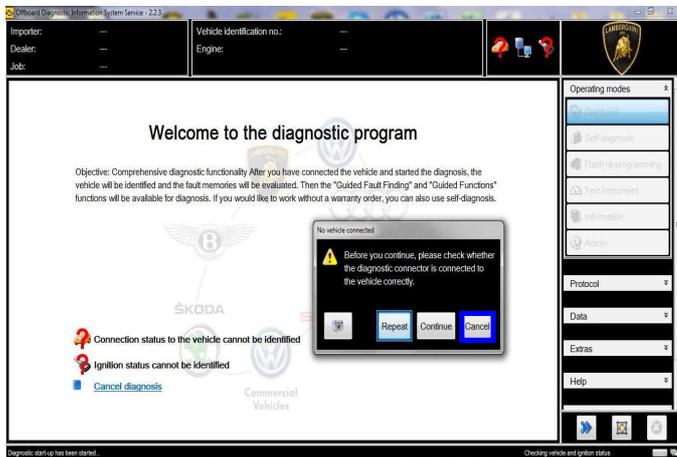
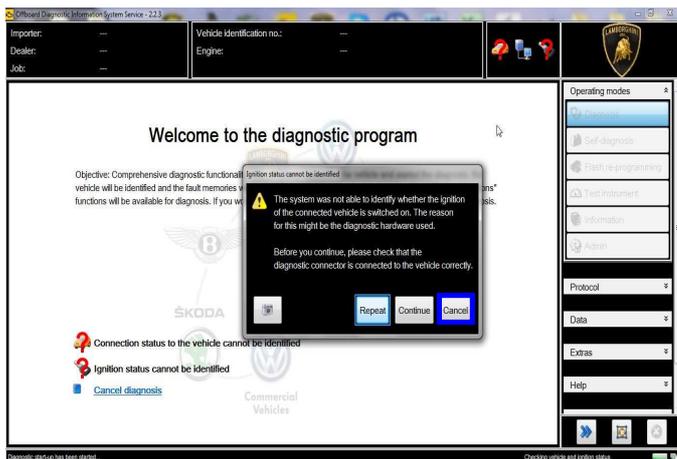
A. If the error message regarding the VAS5054 interface and the 2 icons for status of on board connection and key on are shown as in the picture below:

- Click “Cancel”;
- Repeat the VAS5054 HW interface installation following the procedure (*) “VCI Manager v2.0”, by entering in the menu “Extras” on the right side and clicking on “Diagnostic interface”.

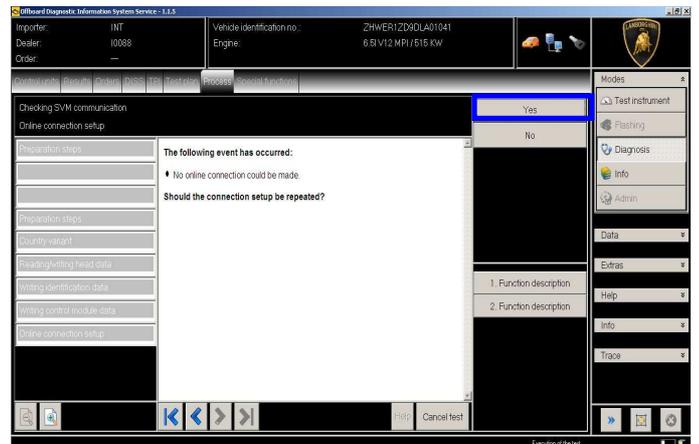
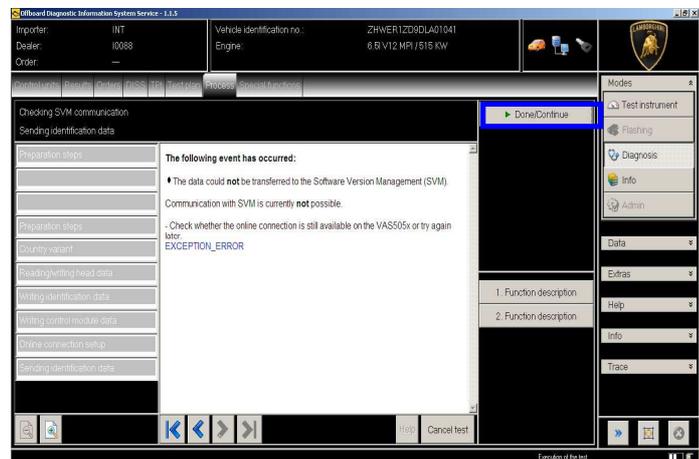
B. If one of the connection errors screens is shown as in the pictures below:

- it is not possible to establish a connection with the central server. Please check carefully that the diagnosis laptop is properly connected to the internet network and retry clicking “Yes” or “Done/Continue”.

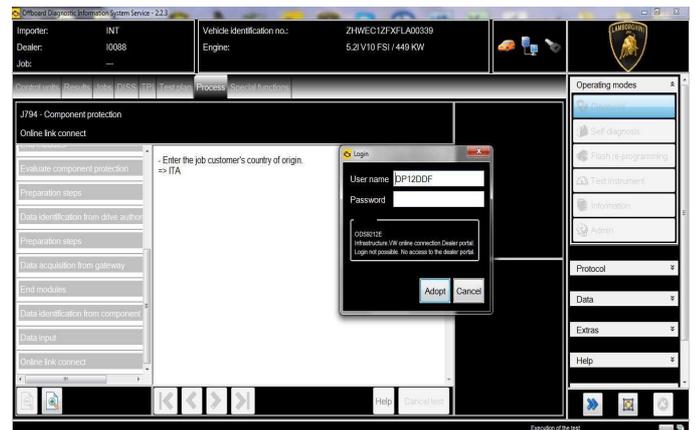
E. If the infrastructure error message is shown as in the picture below (error code: ODS9212E):

- be sure that your Geko account is valid
- be sure that the label “Geko” is written on the token that you are using for the authentication
- verify in ODIS settings you have “Internet” instead of “CPN” (see document “ODIS_Initial_Setup_2.0” (*))
- click on Cancel and perform the application test (see document “ODIS_Checking_ConnectionServer_SVM_2.0” (*))

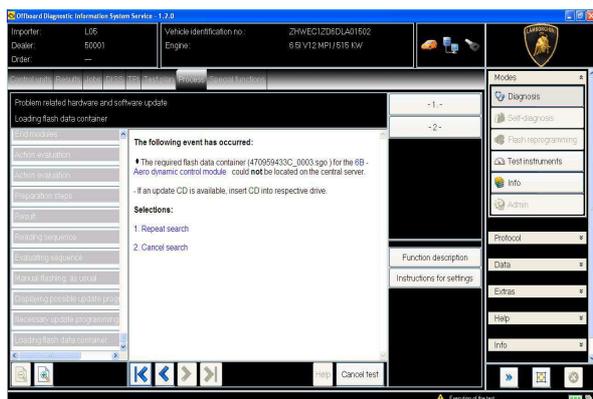
F. In the case the flash container is not detected (see figure):

- Make sure to be recently synchronized with Mirrorserver by checking the last date of Sync under:
<http://mirrorserver/welcome>
 or under
http://IP_address/welcome
 if you don't have previously defined the “mirrorserver” IP address alias.
- Make sure to be correctly connected with Mirrorserver.
