L624-A.12.15	<b>To:</b> Official Lamborghini Service Network <b>Subject:</b> Instrument Cluster Software Update <b>Date:</b> 07/24 <sup>th</sup> / 2015 <b>Pages:</b> 18	 
--------------	--	---

**Subject:**  
Instrument Cluster software update.

**Model/VIN Range**  
All MY 2015 Lamborghini Huracán vehicles from VIN FLA00163 to VIN FLA02216.

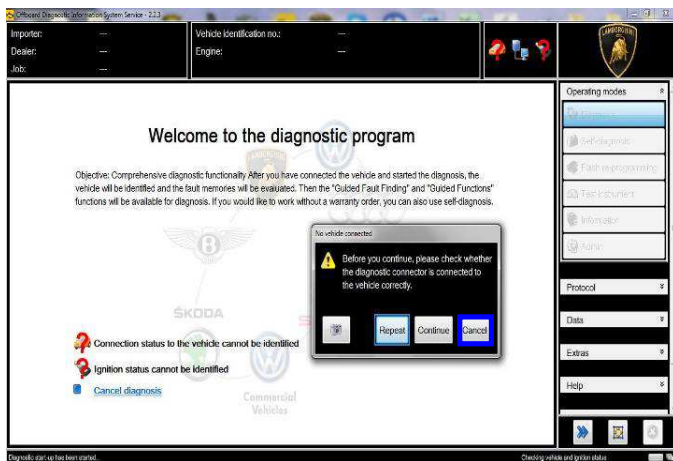
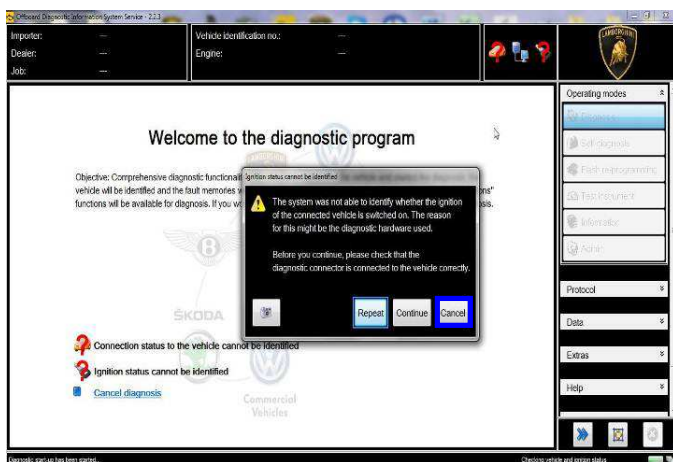
**A.** If the Hardware interface error is displayed and the 2 vehicle connection and key status icons are displayed as in the figure below:

- Click “Cancel”
- Repeat installation of the interface VAS5054 per the instructions in the document (\*) “VCI Manager rev2.0”, selecting the right-hand “Extras” menu in ODIS and clicking on the “Diagnostic interface” button.

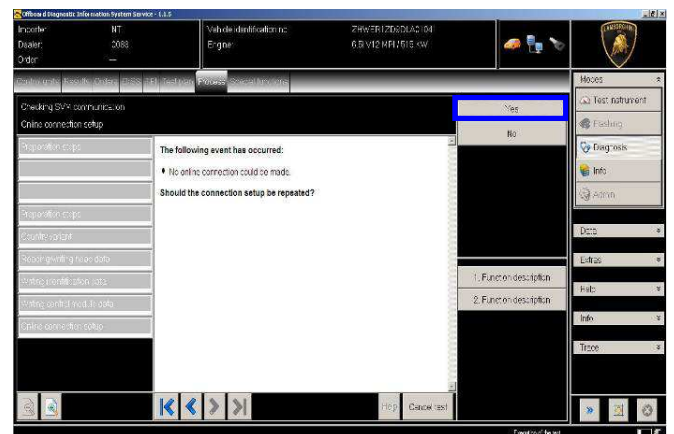
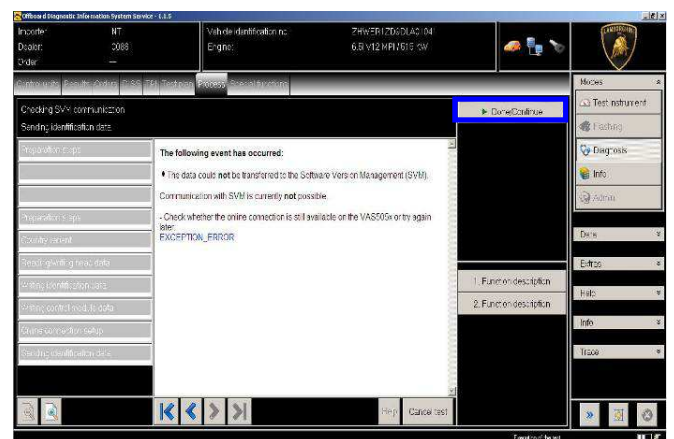
**B.** If one of the following connection errors is displayed like in the following example screenshots:

- It is not possible to connect to the central server; check that your laptop is correctly connected to the Internet and retry by clicking on “Yes” or “Done/Continue”, as appropriate.

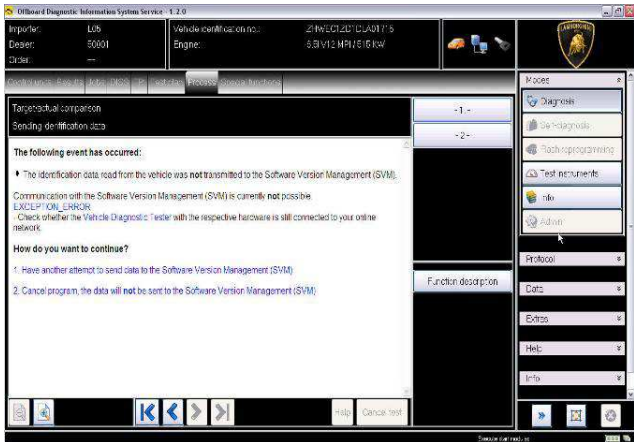
**C.** If the connection is dropped during the course of the target/actual comparison (during an SVM)

- It is not possible to connect to the central server; check that your laptop is correctly connected to the Internet and retry by clicking on “1”.

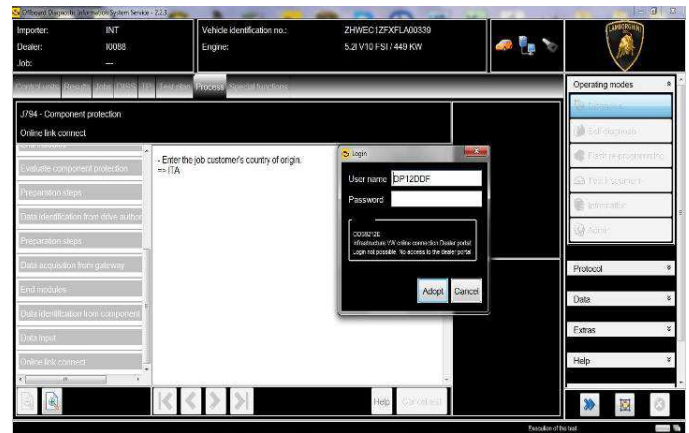
**D.** If the authentication error as shown in the following screenshot is displayed (error code: ODS1007E):

- Ensure you have a valid GeKO user account
- Ensure that the “Geko” label is printed on the token you are using
- Ensure you have entered the correct password
- Click on “Cancel” and run the application test (see document “Controllo\_conessioni\_SVM\_ver2.0” (\*)).

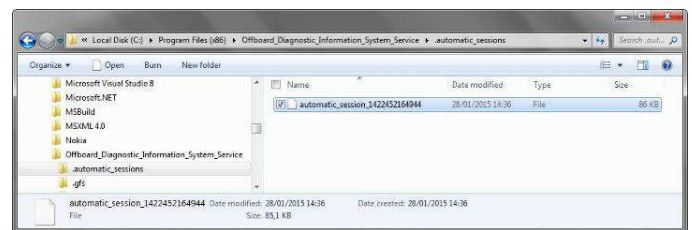
**E.** If the infrastructure error as shown in the following screenshot is displayed (error code: ODS9212E):

- Ensure you have a valid GeKO user account

- Delete the only file which will be in the folder
- Restart ODIS Service, ensuring that:

1. You have a network connection
  2. The ODIS connection is set to **Internet**
- Run the connection test again, and perform the SVM again with your GeKO Token.

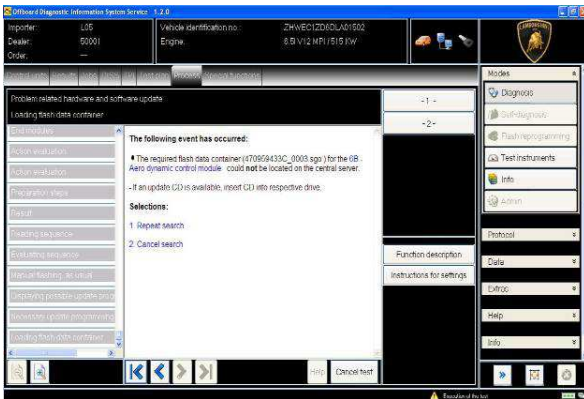
**F.** If the flash container is not found (see figure):

- Ensure you have recently synced with Mirrorserver by checking the last synchronization date at:

- Ensure you are correctly connected to the mirrorserver.
