L625-
A.06.16

To: Official After Sales Network
Subject: Soft top latch update
Pages: 21

L625-A.06.16

Soft top latch update

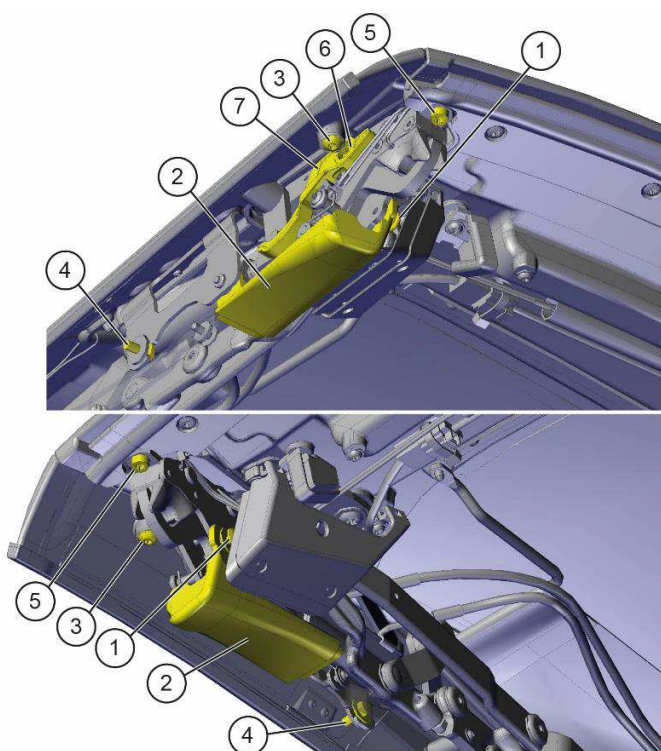
Involved components:

1. front latch cover locking screw;
2. latch cover;
3. front seal mounting screw;
4. rear seal mounting screw;
5. front latch mounting screw (replace during re-assembly) and 2 washers;
6. lever mounting screw (replace during re-assembly).
