L73X-A.02.15	To: Official After Sales Network Subject: Engine Software Update Date: 31st/07/2015 Pages: 20

Subject
Engine Software Update

Model
All Lamborghini Aventador SV MY 15 and Aventador Coupé, Roadster MY 16, all versions, until VIN GLA04356 US vehicles excluded

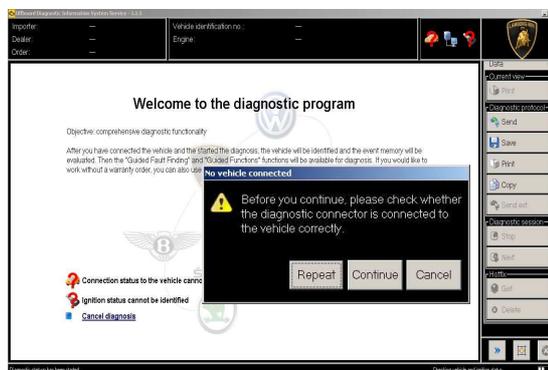
A. If the error message regarding the VAS5054 interface and the 2 icons for status of on board connection and key on are shown as in the picture below:

- Click “Cancel”;
- Repeat the VAS5054 HW interface installation following the procedure (*) “VCI Manager v2.0”, by entering in the menu “Extras” on the right side and clicking on “Diagnostic interface”.

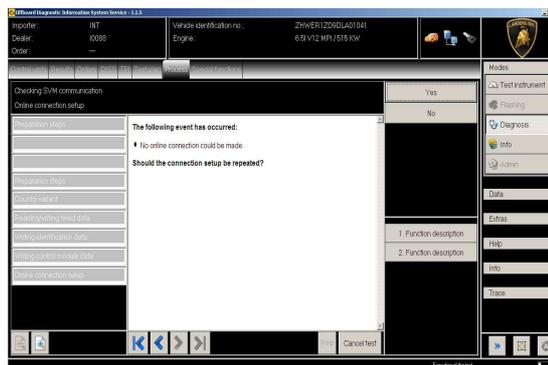
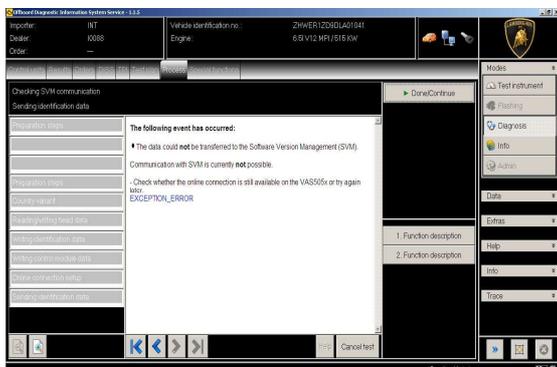
B. If one of the connection errors screens is shown as in the pictures below:

- it is not possible to establish a connection with the central server. Please check carefully that the diagnosis laptop is properly connected to the internet network and retry clicking “Yes” or “Done/Continue”.

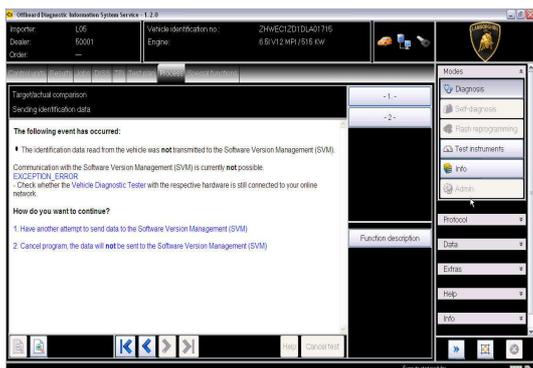
C. If the loss of connection happens during the target/actual comparison.

- It is not possible to connect to central server, check the working connection of internet and retry by clicking “1”.

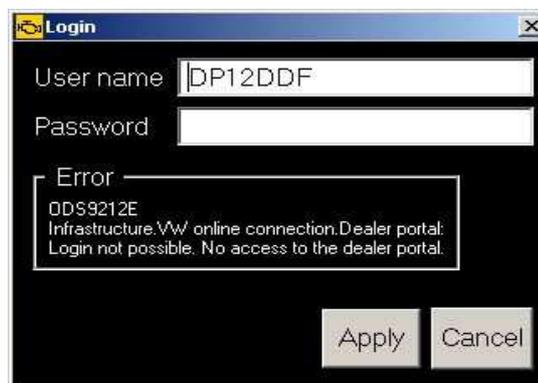
E. If the infrastructure error message is shown as in the picture below (error code: ODS9212E):

- be sure that your Geko account is valid
- be sure that the label “Geko” is written on the token that you are using for the authentication
- verify in ODIS settings you have “Internet” instead of “CPN” (see document “ODIS_Initial_Setup_2.0” (*))
- click on Cancel and perform the application test (see document “ODIS_Checking_ConnectionServer_SVM_2.0” (*))

If the same error was present during the application test, try following procedure:

- quit ODIS;
- Enter the folder C:\Program Files (x86)\Offboard_Diagnostic_Information_System_Service\automatic_sessions on your diagnosis laptop;
- delete the only file present in that folder.
