L83X-
A.03.14

To: Official After Sales Network
Subject: Cross member bolts.
Date: 14th/03/2014
Pages: 4

Cross member bolts.

All Lamborghini Aventador Coupè & Roadster LP700 Model Year **12,13** and **14** From VIN **CLA00091** to **ELA02427**.

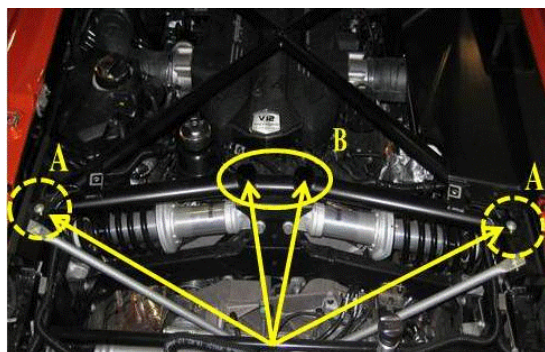
1. Locate working area: engine bay.
2. Identify bolts to be replaced with new ones.

A. At the sides:

- Bolt to be replaced (X2)

B. In the middle:

- To be replaced (X2).

- New type (X2).

GREEN thread locker.

PINK thread locker.

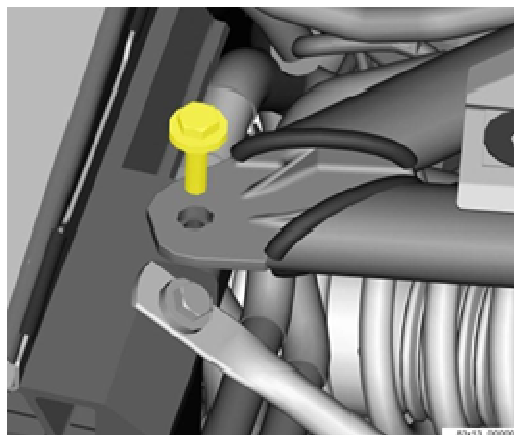
As a result of continuous product monitoring, Automobili Lamborghini Spa has found that on some vehicles, the bolts which secure the engine cross member may get loosen and consequently cause noise.

8. Unscrew and replace engine cross member side bolts with new green coloured thread-locker ones (p/n N0195306).

Bolt tightening.

Pressure torque: **27 Nm ± 10%**.
