L83X-
A.11.14

To: Official After Sales Network
Subject: Kombi s.w. update.
Date: 01st/08/2014
Pages: 15

Kombi s.w. update.

All Lamborghini Aventador Coupé and Roadster MY 14 starting from VIN ELA02757.

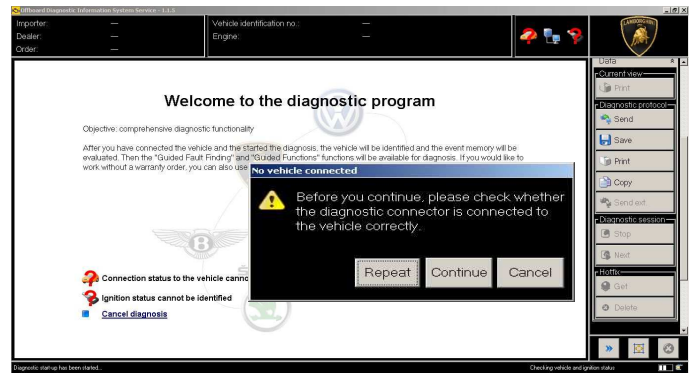
A. If the error message regarding the VAS5054 interface and the 2 icons for status of on board connection and key on are shown as in the picture below:

- Click “Cancel”;
- Repeat the VAS5054 HW interface installation following the procedure (*) “VCI Manager v2.0”, by entering in the menu “Extras” on the right side and clicking on “Diagnostic interface”.

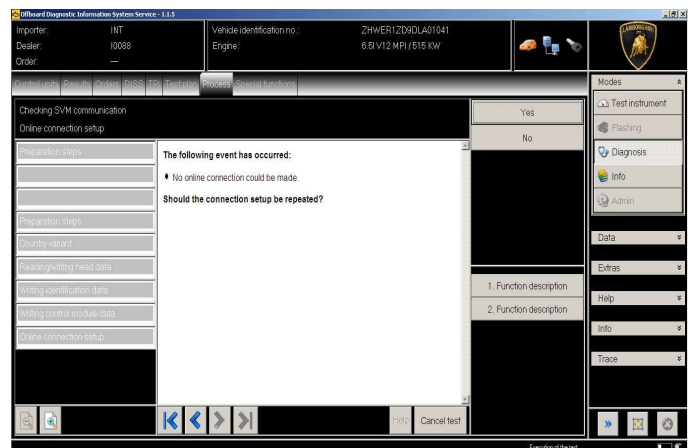
B. If one of the connection errors screens is shown as in the pictures below:

- it is not possible to establish a connection with the central server. Please check carefully that the diagnosis laptop is properly connected to the internet network and retry clicking “Yes” or “Done/Continue”.

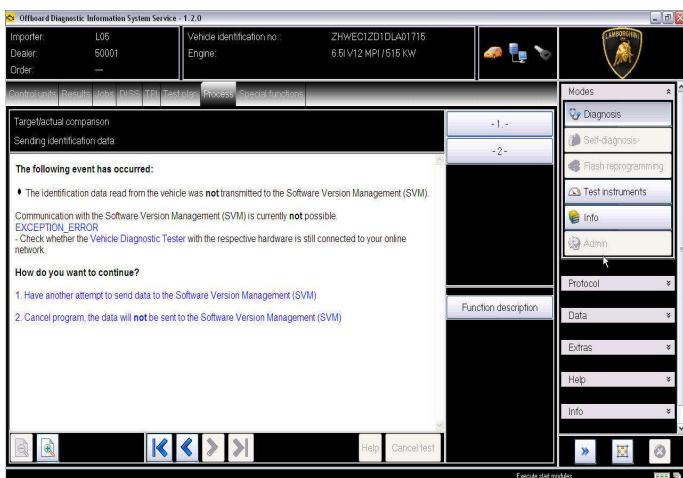
C. If the loss of connection happens during the target/actual comparison.

- It is not possible to connect to central server, check the working connection of internet and retry by clicking “1”.

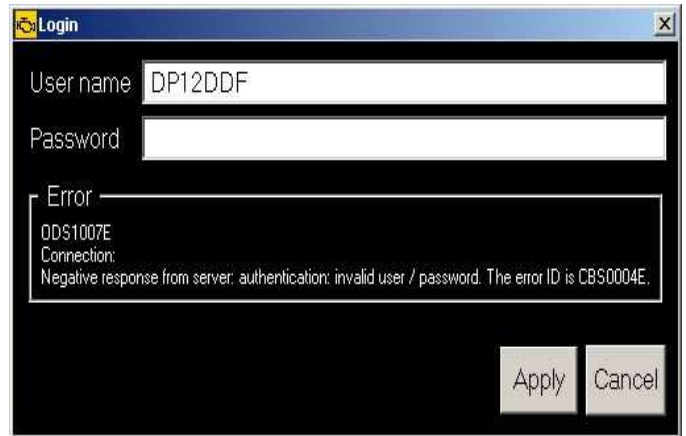
D. If the incorrect identification message is shown as in the picture below (error code: ODS1007E):

- be sure that your Geko account is valid;
- be sure that the label “Geko” is written on the token that you are using for the authentication;
- be sure the Password inserted is correct;
- click on Cancel and perform the application test (see document

“ODIS_Checking_ConnectionServer_SVM_2.0” (*).

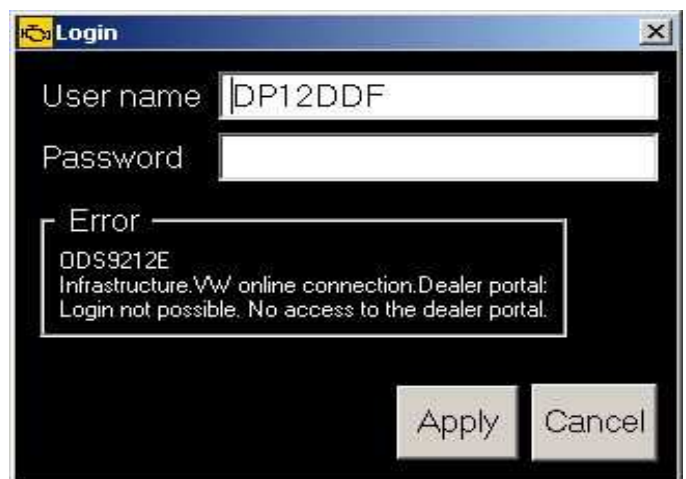
E. If the infrastructure error message is shown as in the picture below (error code: ODS9212E):

- be sure that your Geko account is valid
- be sure that the label “Geko” is written on the token that you are using for the authentication
- verify in ODIS settings you have “Internet” instead of “CPN” (see document “ODIS_Initial_Setup_2.0” (*))
- click on Cancel and perform the application test (see document “ODIS_Checking_ConnectionServer_SVM_2.0” (*))
