L83X-
A.12.14

Subject
Wheel housing rework.

Model
All Lamborghini Model Aventador Coupé and Roadster MY 12, 13 and 14 from VIN ELA00091 to VIN ELA02597.

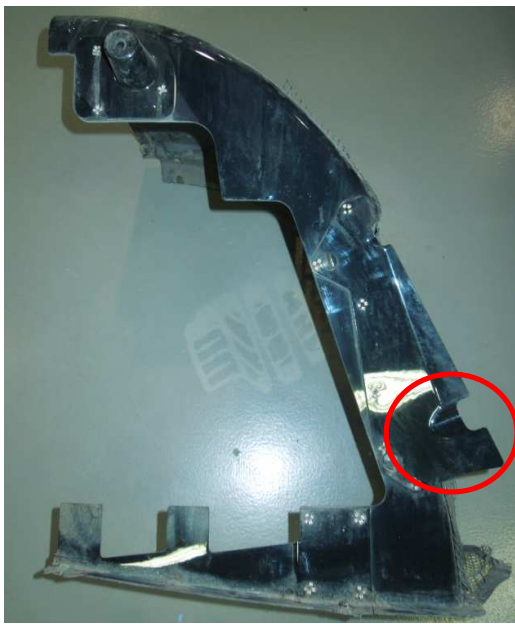
Left rear wheel housing (p/n 470810981B).

As a result of continuous product monitoring, Automobili Lamborghini Spa has found that on some vehicles rear wheel houses may become distorted due to high temperature.

surface which needs to be reworked can be detected by mean of a visual inspection: check in the pictures below the area circled in red.

Rework both rear wheel housings.
