L83X-
A.14.14

To: Official After Sales Network
Subject: Drivability enhancement
Date: 03rd/10/2014
Pages: 25

Drivability enhancement

All Lamborghini Aventador MY 12.

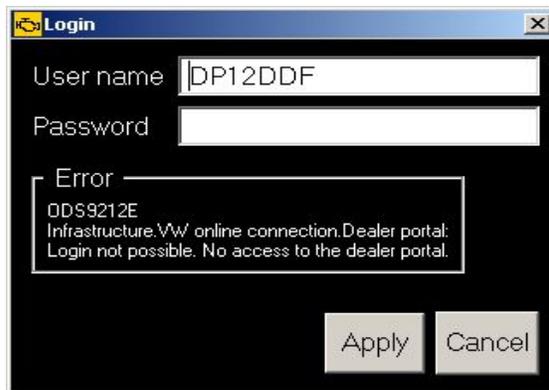
E. If the infrastructure error message is shown as in the picture below (error code: ODS9212E):

- be sure that your Geko account is valid
- be sure that the label “Geko” is written on the token that you are using for the authentication

- verify in ODIS settings you have “Internet” instead of “CPN” (see document “ODIS_Initial_Setup_2.0” (*))
- click on Cancel and perform the application test (see document “ODIS_Checking_ConnectionServer_SVM_2.0” (*))

If the same error was present during the application test, try following procedure:

- quit ODIS;
- Enter the folder C:\Program Files\Offboard_Diagnostic_Information_System_Service\automatic_sessions on your diagnosis laptop;
- delete the only file present in that folder.
- re-Start ODIS Service under following conditions:
 1. Network connection available;
 2. ODIS connection set on “Internet”;
- Retry the application test and the SVM with your GeKO Token.
