To All Lamborghini Dealers and Licensed Service Point
From Customer Service Department
Subject Wiring Fixing
Group LB715.9.71
Attachments -
Date 28.08.2006
Pages 6

Wiring fixing

All MY06 Gallardo Spyder from VIN 3750 until VIN 4015.

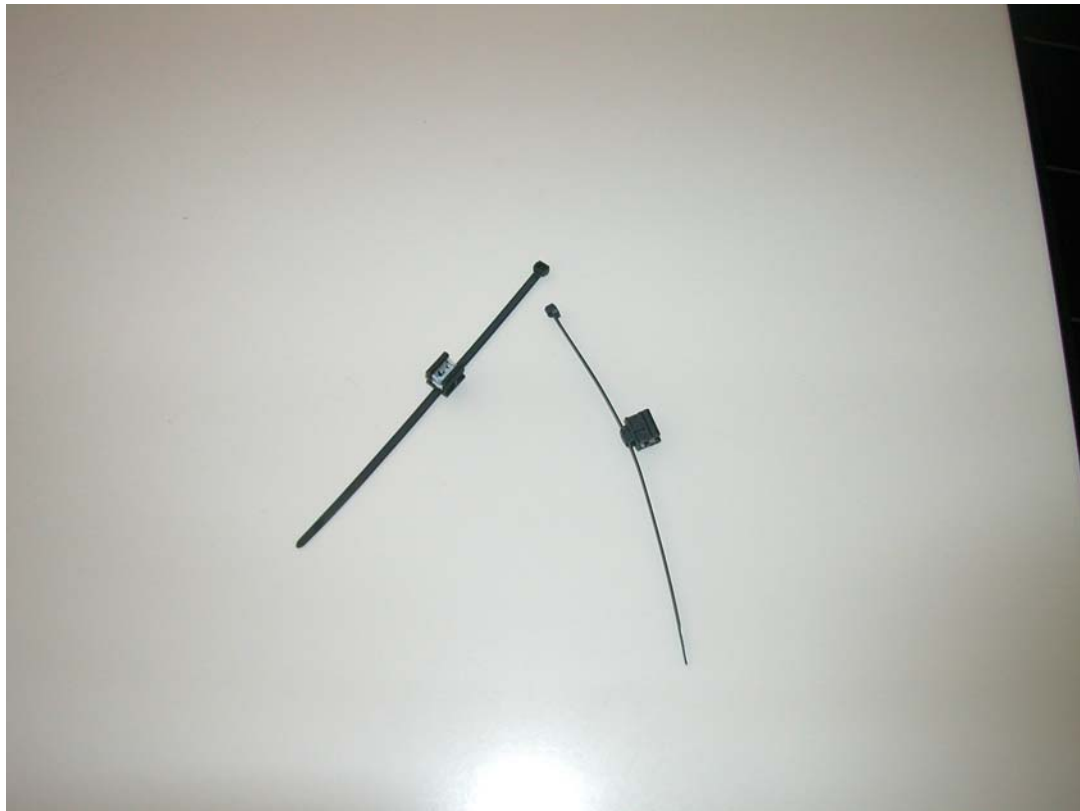
Pict.1

1.1 Two plastic clamps p/n: N 106 598 01.

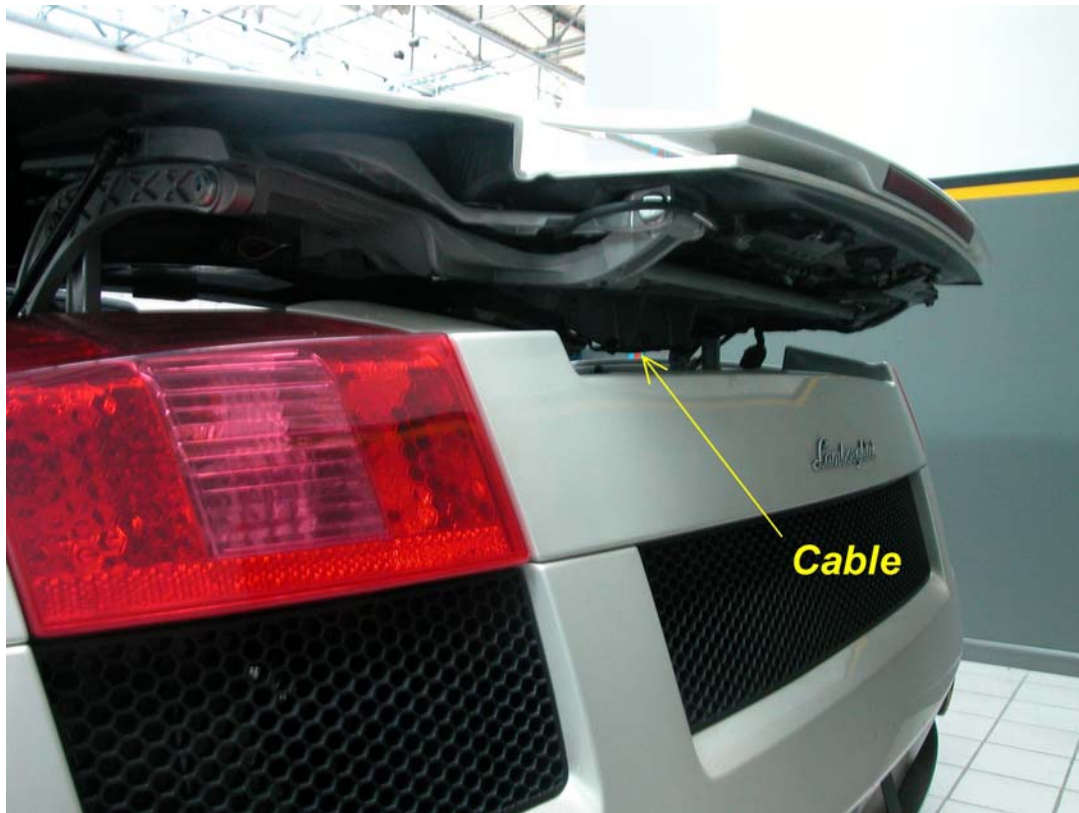
Pict. 2

- 1.2 Adopt all precautions to work safe and prevent car damages.
- 1.3 Open the engine bonnet as in picture 2, look at the bonnet support and at the fixing cable from the rear of the car.

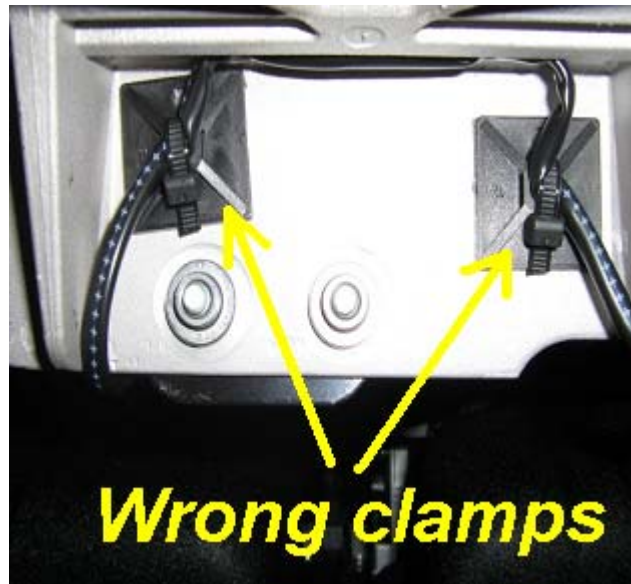
Pict. 3

The heat from the engine could unglue the wiring clamps from the bonnet support .

- 1.4 If the fixing device appears similar to picture 3, this should be replaced. The engine heat could unglue the clamps from the support.
- 1.5 Remove the incorrect clamps and replace them with the new ones as in pict. 4.
