To All Lamborghini Dealers and Licensed Service Point
From Customer Service Department
Subject New ground fixing point
Group LB824.9.71
Attachments -
Date 12.12.2006
Pages 6

New ground fixing point

Murciélago LP640 from VIN B71805 to VIN B72269.

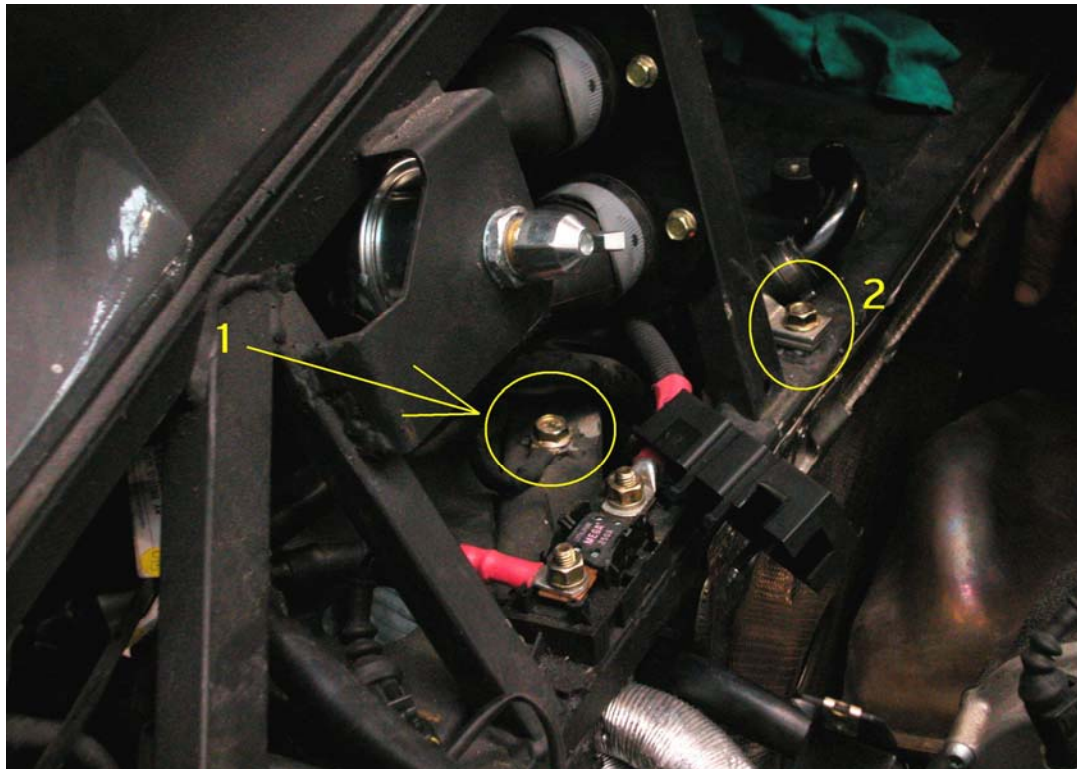
Pict.3

There is the possibility that a ground connection in the engine compartment can become rusty.

1.8 Look at the incorrect ground cable position as shown in picture 3, (reference nr. 1). Please move this cable onto the second ground fixing (reference nr. 2 of pict. 3). To do this you must replace the stud bolt because the old one is not long enough.

To avoid trouble with electric grounding system and a possible car-down issue, it is necessary to move the ground cable on to a different protected ground fixing point.

Stud bolt code: 008300814
