# Service Bulletin

Bulletin No.: PI0432C

**Subject:** Shorter Front Bumper Fascia Air Deflector Available for Service

**Models:** 2011-2013 Chevrolet Volt

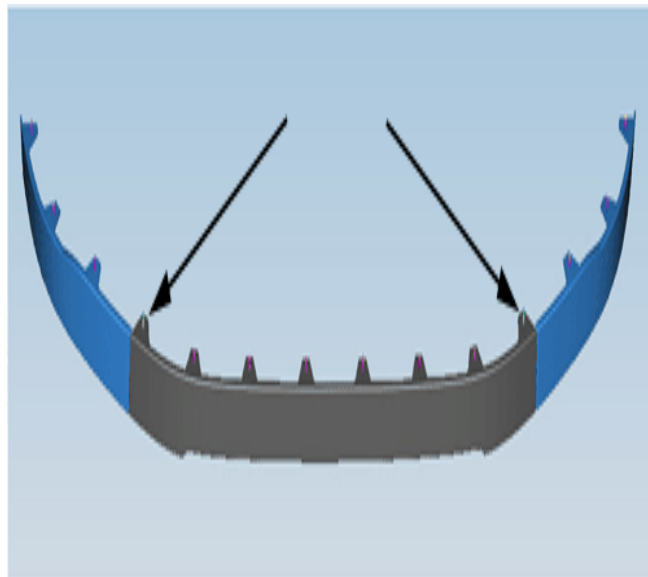
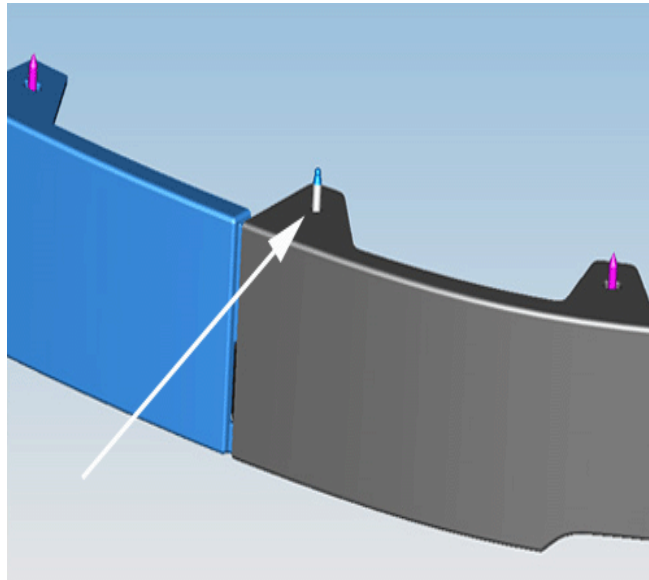
2582397

Some customers may comment about the low ground clearance of the front bumper fascia air deflector. The air deflector contacts the ground, scraping at short inclines, because there is not enough clearance between the ground and the front bumper fascia air deflector on an inclined surface.

1. The two screws shown above are preinstalled at the plant and need to be removed from the wheelhouse liner prior to air deflector installation. Reinstall these screws first when installing the air deflector.
