# Service Bulletin

Bulletin No.: 16-NA-159

**Subject:** Squeak and/or Rubbing Noise from Steering Column Area

Brand:	Model:	Model Year:		Breakpoint:	Engine:	Transmission:
		from	to			
Chevrolet	Colorado	2015	2016	Vehicles Built Prior to April 25, 2016		
GMC	Canyon	2015	2016

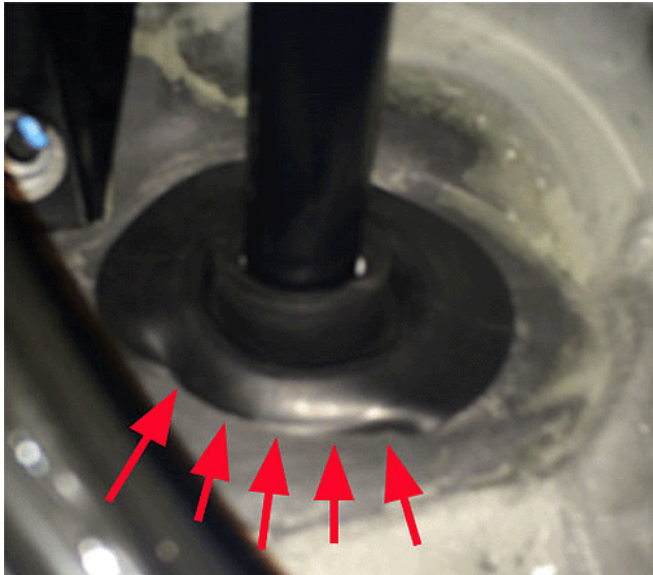
4512167

<b>Involved Region or Country</b>	North America
<b>Condition</b>	Some customers may comment on a squeak and/or rubbing noise coming from the steering column area.
<b>Cause</b>	This condition may be due to the inner and/or outer intermediate steering shaft boots (seals) being out of position.

Inspect the intermediate steering shaft inner and outer boots (seal) for being out of position as shown above. If the boots are out of position, use a flat trim stick to properly seat the boots.
