Service Bulletin

Subject: Instrument Panel Cluster (IPC) Warning Lamps And / Or MIL Are Illuminated Diesel Exhaust Fluid (DEF) Message Displayed Various DTCs Set (Inspect Wiring Harnesses for Chafing)

Brand:	Model:	Model Year:		VIN:		Engine:	Transmission:
		from	to	from	to		
Chevrolet	Colorado	2016	2016	All	All	2.8 LWN	All
GMC	Canyon	2016	2016	All	All	2.8 LWN	ALL

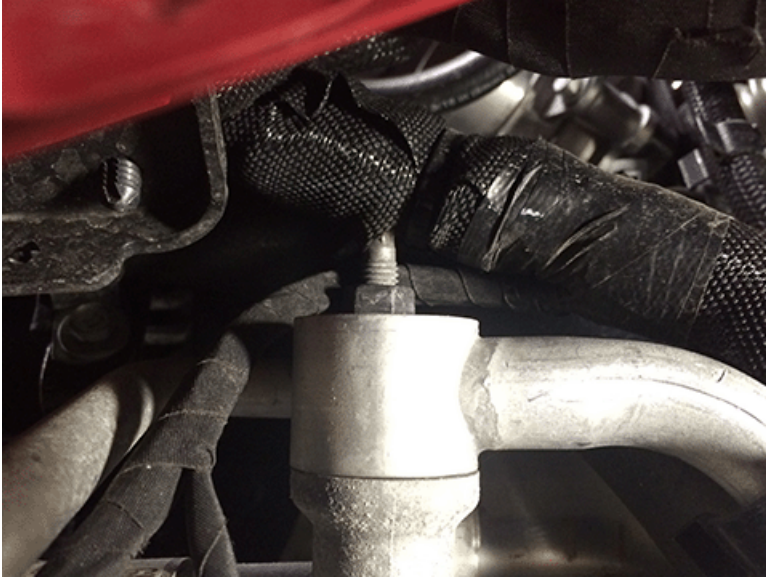
Air Conditioning (AC) compressor, AC compressor suction and discharge line manifold, AC line and AC compressor clutch.

Concerns in the area of the AC compressor, lines or suction / discharge pipes may cause:

The Check Engine Light to illuminate.

The Driver Information Center (DIC) may display a reduced power message or service power steering message.

The engine to run rough.

The Service Four Wheel Drive (4WD) Light or Stabilitrak light may illuminate.

A possible extended crank or a crank no start.

The oil pressure gauge may read erratically or read no oil pressure.

The Air Conditioning (AC) may not cool or blow hot air.

An open fuse in the Underhood Bussed Electrical Center (UBEC)

DTCs associated with chaffing in this area include:

B127E, C0306, C0321, C0398, C0800, P0117, P0119, P0340, P0341, P0406, P0483, P0522, P0628, P0641, P06A3, P0700, P20BB, P20BF, P227E, P24B1, U0073, U0077, U0121, U0131, U0140, U0151, U0415, U2099, U0401, U0415 and U0420

If you encounter these scenarios, inspect, repair (as necessary) and route the wiring harness away from these possible chafe points.

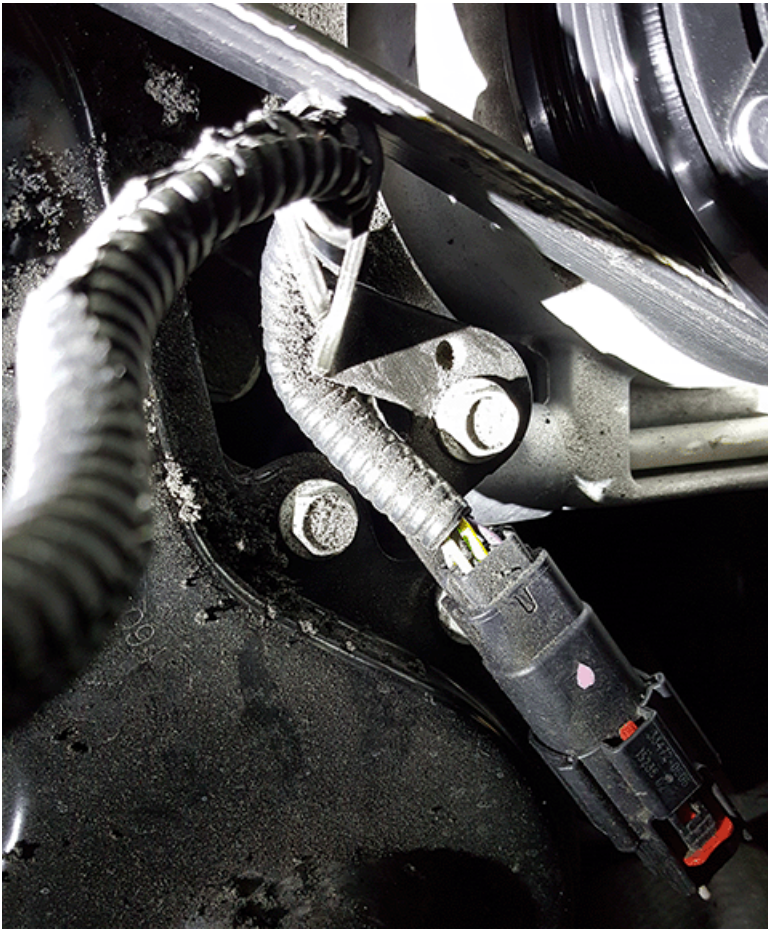
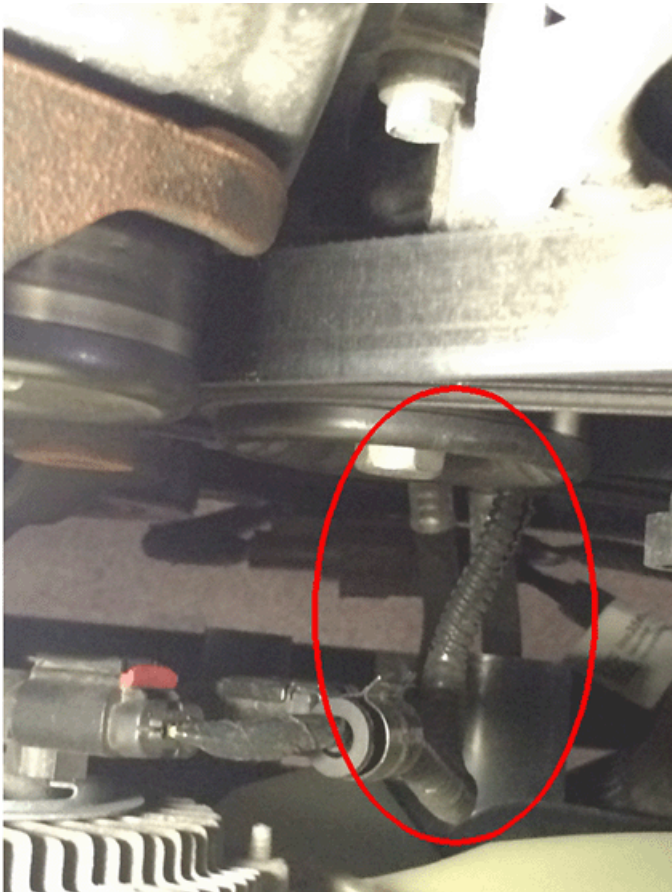
Serpentine Belt. The fan clutch wiring harness support bracket may be out of position allowing the harness to rub on the belt.

Concerns in the area of the serpentine belt may cause:
Various IPC warning lights to illuminate.

A crank no start concern.

The check engine light to illuminate.

The engine may run rough or misfire.

The Service Four Wheel Drive (4WD) light may illuminate.

The Stabilitrak light may illuminate.

The Air Conditioning (AC) may not cool or may blow hot air.

DTCs associated with chafing in this area may include:

C0273, P0526, P0480, P0336, P0526, P0641 and P0651.

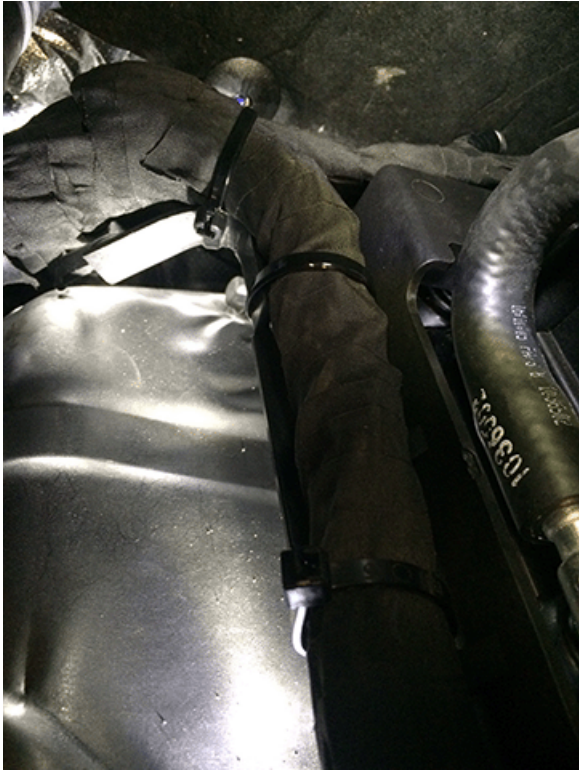
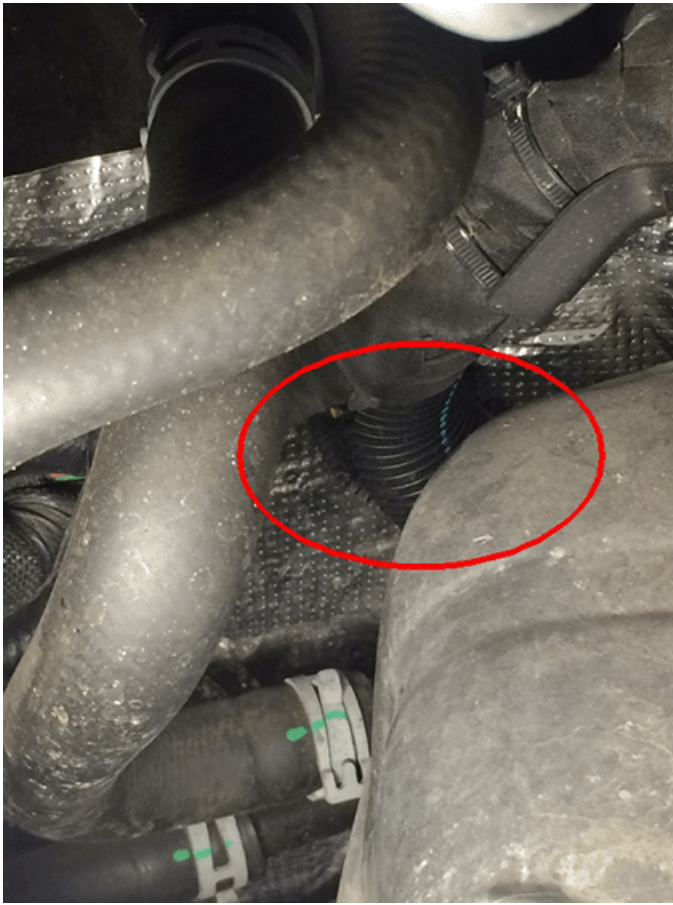
Right rear of engine. Check for harness damage on the exhaust heat shield as described in the latest version of bulletin 16-NA-081.

Concerns in the area of the right rear of engine / exhaust heat shield may cause:

Various IPC warning lights to illuminate.

The Service Four Wheel Drive (4WD) light may illuminate.

The Stabilitrak light may illuminate.

The check engine light to illuminate.

The Driver Information Center (DIC) may display a reduced power message.

An open fuse in the Underhood Bussed Electrical Center (UBEC)

DTCs associated with chafing in this area may include:

B1011, C0306, P0201, P0202, P0203, P0204, P0410, P0575, P062D, P0697, U0073, U0100, U0121, U0140, U0415 and U0420.

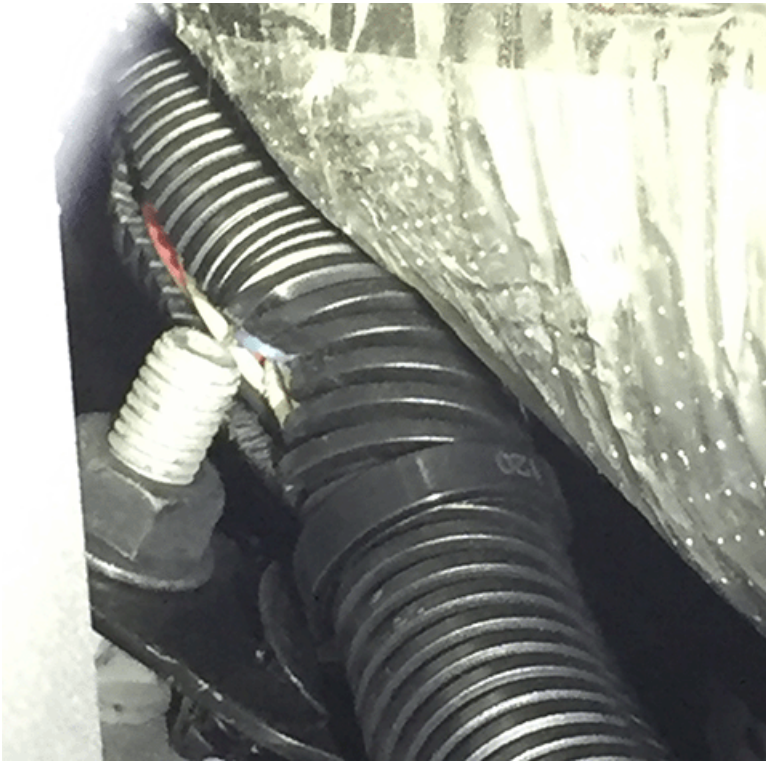
Transmission bell housing bolt / stud.

Concerns in the area of the rear of engine / transmission bell housing bolt / stud may cause:

Various IPC warning lights to illuminate.

The Service Four Wheel Drive (4WD) light may illuminate.

The Stabilitrak light may illuminate.

The check engine light to illuminate.

DTCs associated with chaffing in this area may include:

P0201, P0202, P0203, P0204, P0392, P0401, P0420, P062D and U0073.

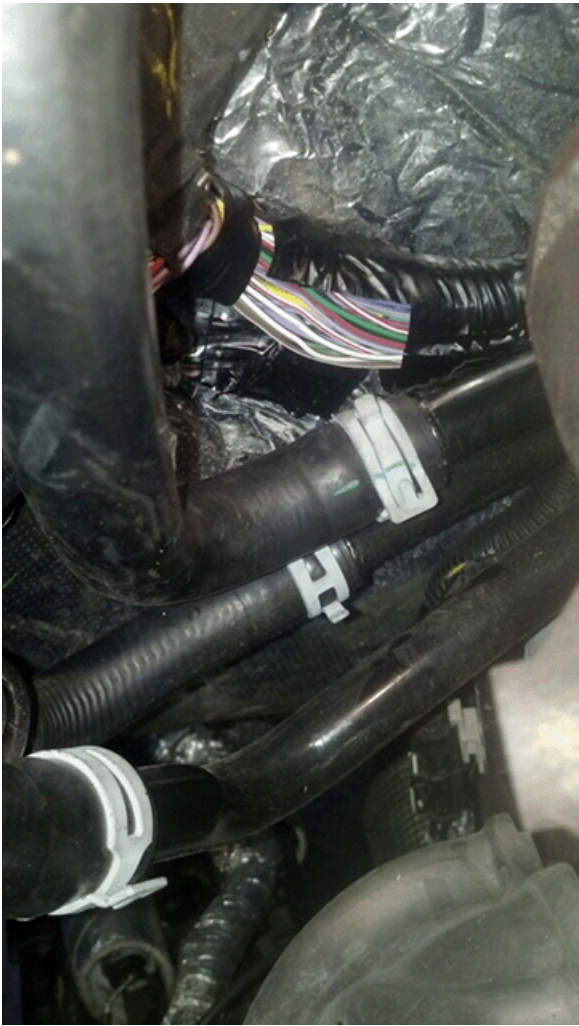
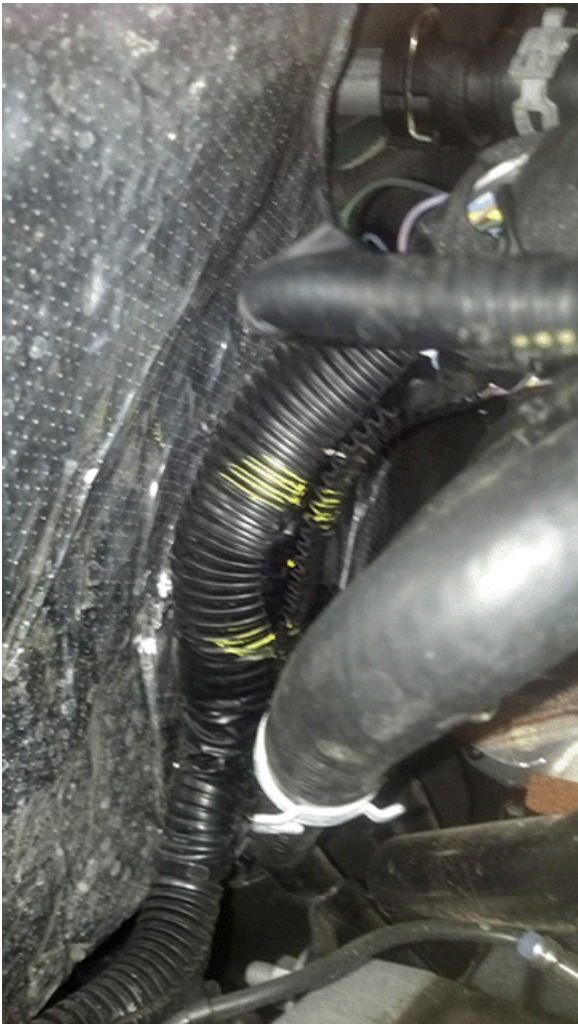
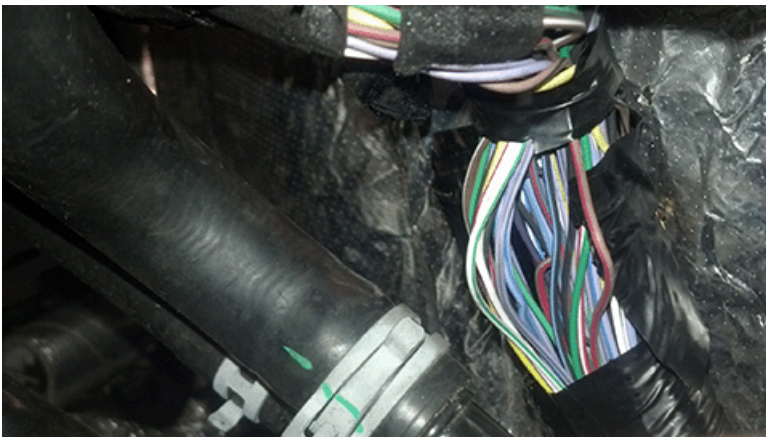
Coolant pipe and clamp tabs between engine and cowl.

Concerns in the area of the coolant pipe / clamp / clamp tabs between engine and cowl may cause:

Various IPC warning lights to illuminate.

The Service Four Wheel Drive (4WD) light may illuminate.

The Stabilitrak light may illuminate.

The check engine light to illuminate.

DTCs associated with chafing in the area may include:

B1011, P0575, U0073, U0100, U0121, U0140, U0415 and U0420.

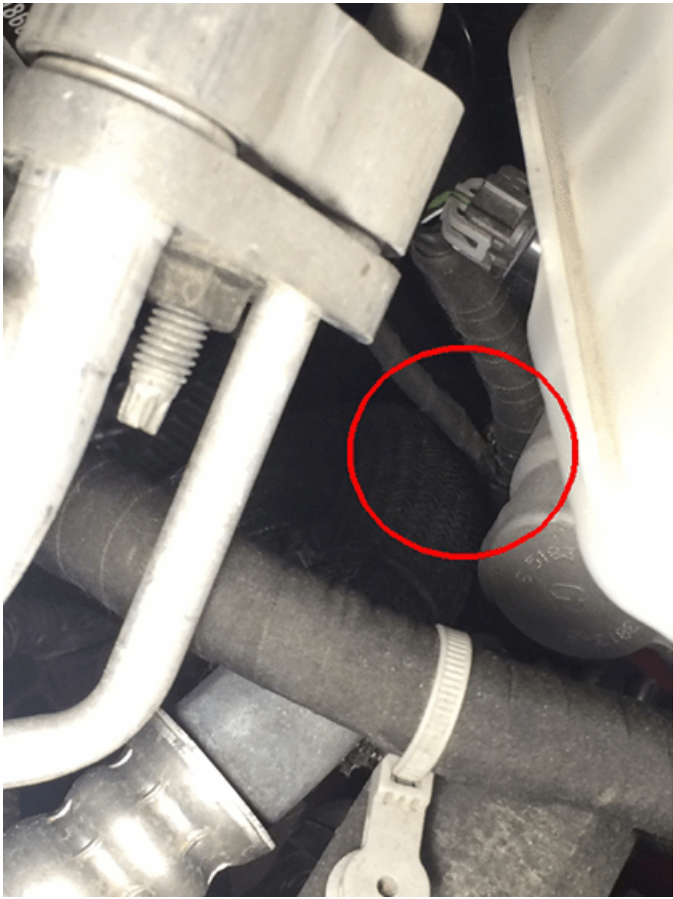
Near the brake fluid level switch.

Concerns in the area near the brake fluid level switch may cause:

The service brake light to illuminate.

The DIC may display that the brake fluid is low.

The check engine light to illuminate.

DTCs associated with chafing in this area may include:

C0273 and P0641.

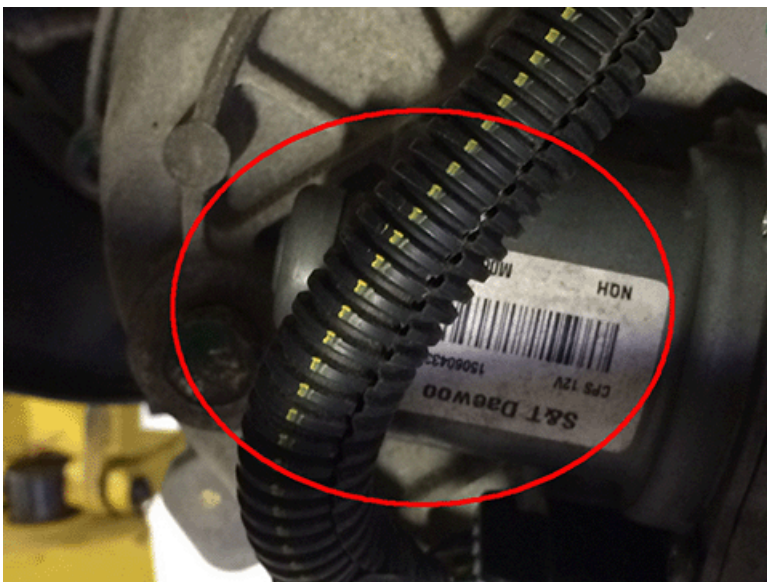
Transfer case encoder motor.

Concerns in the area near the encoder motor on the transfer case may cause:

Various IPC warning lights to illuminate.

DTCs associated with chafing in this area may include:

C0396.

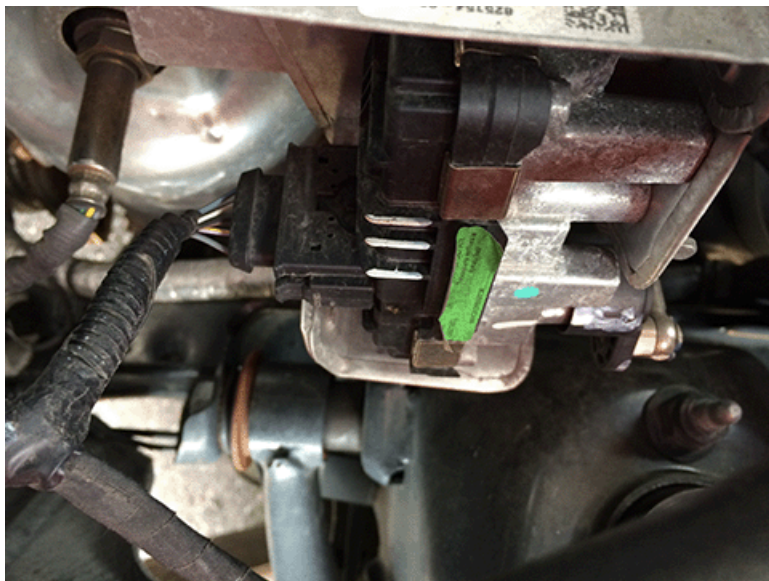
Turbocharger Vane Position Actuator Connector

Concerns with loose terminals or connector not fully seated at the Turbocharger Vane Position Actuator may cause:

The Check Engine Light to illuminate.

The Driver Information Center (DIC) may display a reduced power message.

The vehicle may have a low power concern.

DTCs associated with a loose connector or terminals include:

P0045 or P2599.
