# Service Bulletin

## PRELIMINARY INFORMATION

**Subject:** Uneven Front Brake Pad Wear

**Models:** 2015-2016 Cadillac Escalade Models

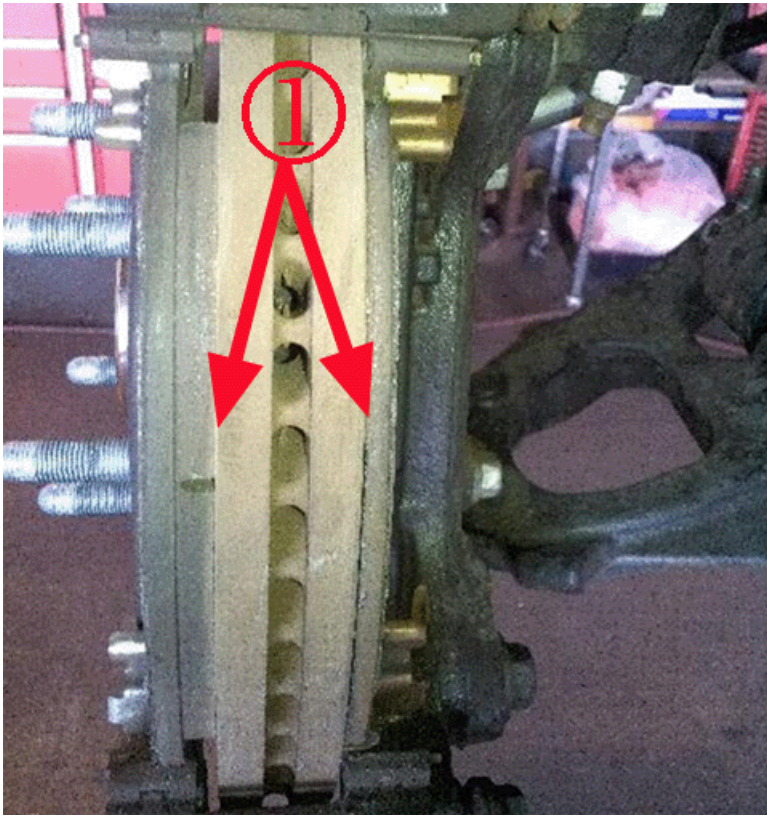
During a brake inspection, some complaints of uneven front brake pad wear have been reported. The vehicle may have low mileage, typically around 10K miles. The inner pad on either the front left or right side may be worn out. It is considered uneven pad wear if one of the following is true:

Shown below is an example from one vehicle with uneven wear. Photo 1 is of the left front brake pads where the inner pad is worn completely out, while the outer pad still has plenty of pad life. Photo 2 is from the same vehicle, but of the right front inner and outer brake pads, which both have plenty of pad material left.

Inspect and measure the brake pads thickness. Determine the type of driving the owner does and compare the measurements to the information listed above (3mm or 6mm).

If the pads are out of specification, perform normal SI diagnostics to determine the cause of the concern (caliper piston binding, binding pads or guide pins in bracket, brake hose restriction, etc).

After completing normal diagnostics, if a root cause for the uneven pad wear is not found, replace the front brake pads and both rotors with the part numbers in the table below.
