Service Bulletin

PRELIMINARY INFORMATION

Subject: DTC P0016 P0017 P0018 P0019 P0008 P0009

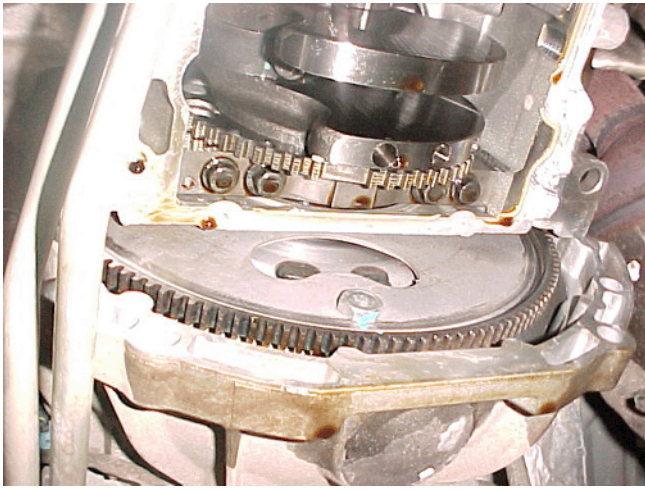
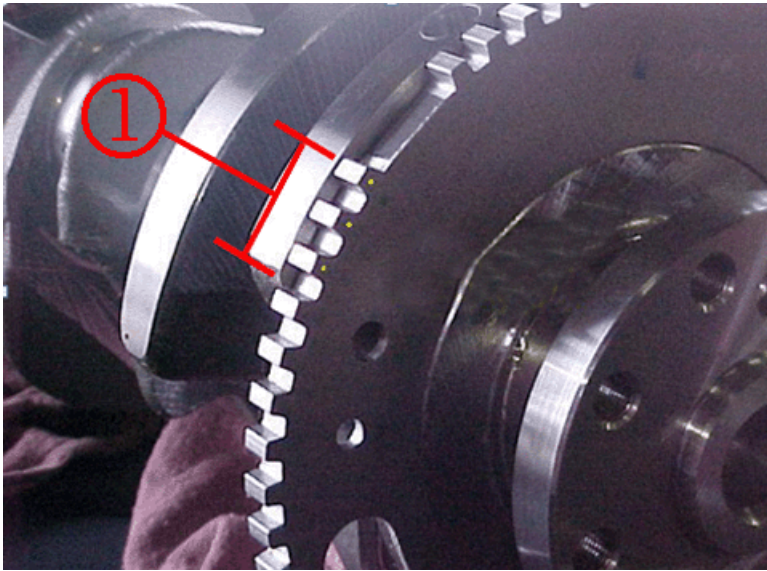
1= The actual measurement of a good Reluctor wheel.

25 to 26 mm This measurement is from the end of the machined surface of the crankshaft throw to the edge of the open space in the reluctor. (approximately 3 1/2 teeth)

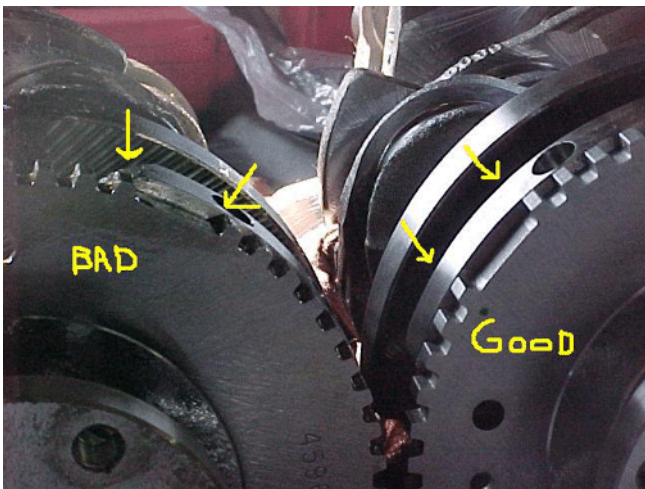
2 and 3 = Show a good reluctor next to a bad reluctor.
