Service Bulletin

PRELIMINARY INFORMATION

Subject: HVAC Blower Motor Is Noisy Or Vibrates

Models: 2014 Chevrolet Silverado 1500
2015 Chevrolet Silverado, Suburban, Tahoe
2014 GMC Sierra 1500
2015 GMC Sierra, Yukon Models

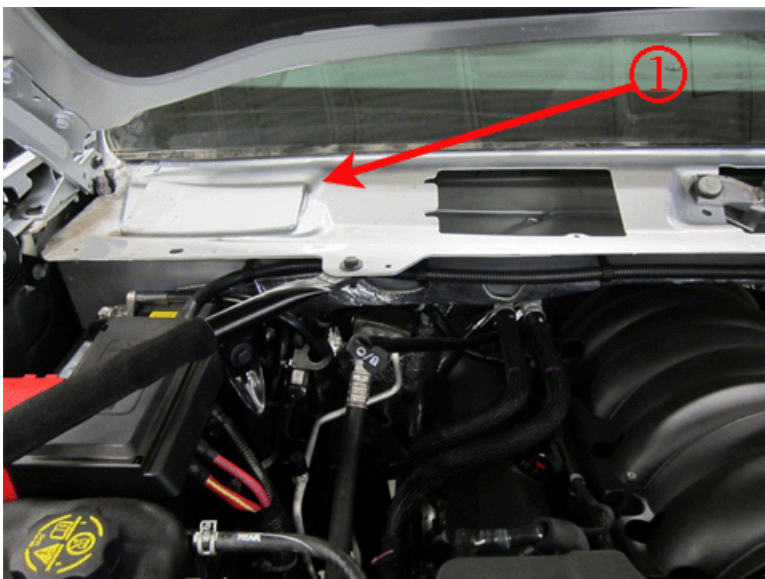
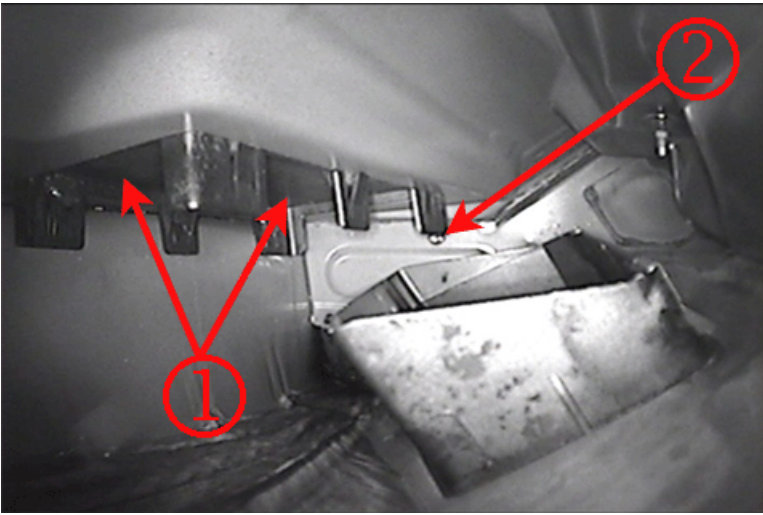
Some owners may comment that when the HVAC blower motor is running, it is noisy or may vibrate. This concern will only occur when temperatures are below 32 deg F (0 deg C). If the blower motor is removed while it is still cold, ice may be found on the blower motor cage. If the cabin air filter is removed while still cold, snow and/or ice may be found on the filter. This concern could be caused by either a water leak into the HVAC case or snow ingestion into the HVAC case.

1. Perform normal water testing diagnostics while the HVAC is running (high blower and in fresh/outside air mode). Inspect for any water leaking past the plenum cover cap, as shown below (1). Water could drip off the bottom of the plenum cover cap (1) into the HVAC fresh air inlet, as shown below (2).

2. If water is leaking past the plenum cover cap (1) it will need to be removed and resealed. While the plenum cover cap is removed also complete the next steps to add a low pressure drop fine snow resistant screen over the fresh air inlet to prevent snow ingestion.
3. Install a 12" x 12" snow resistant screen material over the HVAC fresh air inlet (2), as shown below. The water resistant screen can be ordered from Outerwears at www.outerwears.com or by calling 800-967-3450. When searching for the product on the website, use part number WR12 and then select color Black (WR12BK).
