# Service Bulletin

## PRELIMINARY INFORMATION

**Subject:** Power Liftgate Erratic Operation Will Not Power Close DTC B153A And/Or Motor Running But Does Not Move

**Models:** 2015 Cadillac Escalade Models  
2015 Chevrolet Tahoe, Suburban  
2015 GMC Yukon Models

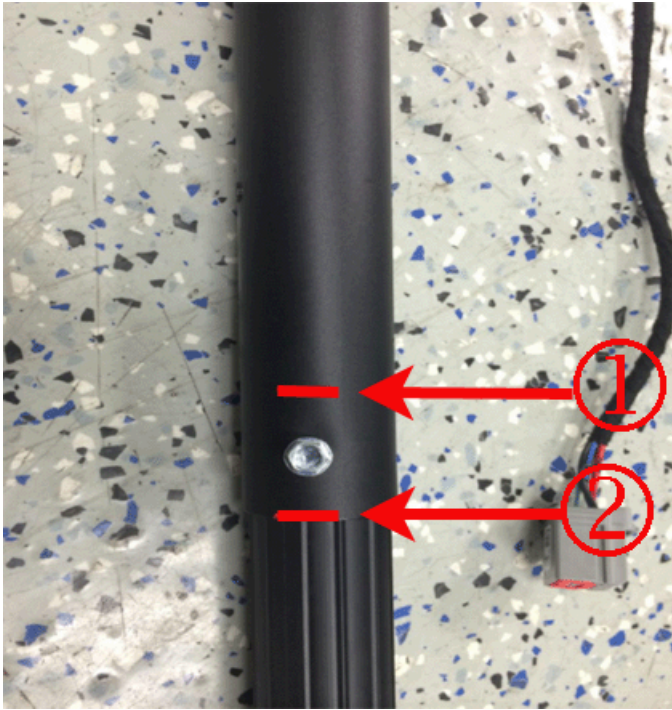
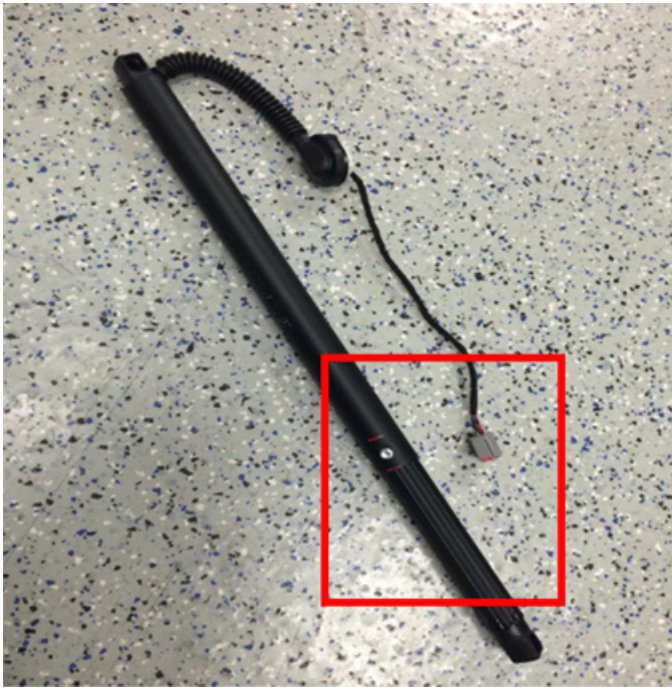
These concerns may occur if the left liftgate strut/motor actuator is internally coming apart. It will need to be replaced, but care must be taken when removing the left liftgate strut/motor actuator from the vehicle. There is an assist spring inside the strut. If the internal portion of the strut has completely separated, and if it is removed from the vehicle without following the procedure listed below, the end of the strut can become a projectile.

1. Obtain one #8 self-tapping screw 1 1/2 inches long.
2. Fully open the liftgate.
3. Install the self-tapping screw any place in the 30 mm space (from the bottom of the smooth tube) between location 1 and 2. As reflected below, a location of 20 mm (approximately 3/4") is ideal to secure the tubes.

**Note:** The screw will hold the strut together for removal.
