# Service Bulletin

**Subject:** Engine Runs With Intermittent Crank No Start With P0011 Or P00C6 May be Current Or Set In History

**Models:** 2014-2015 Chevrolet Corvette, Silverado, Suburban, Tahoe  
2014-2015 GMC Sierra, Yukon, Yukon XL  
Equipped with 4.3L, 5.3L 6.2L Engine (RPOs LV3, L83, L86, LT1)

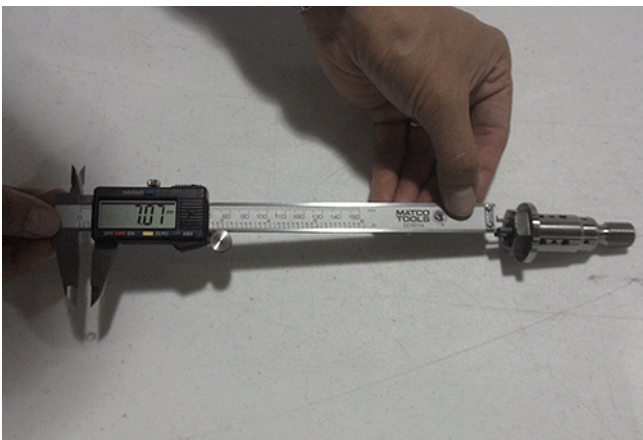
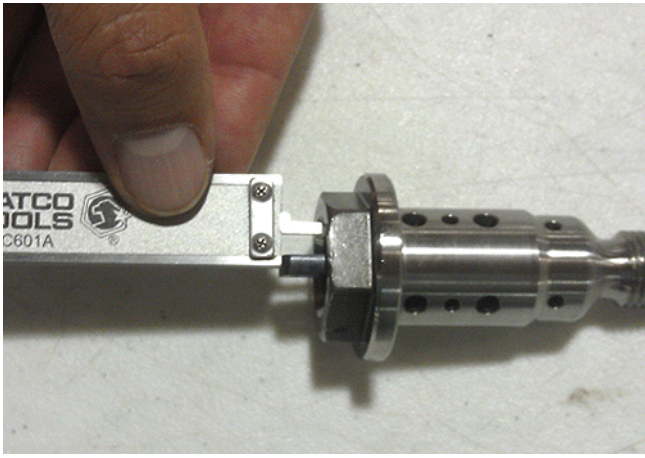
Reference the pictures below for measurements

The Camshaft Position Actuator Solenoid Valve may be sticking or binding causing the valve timing to be retarded.

Before removing the camshaft position actuator solenoid valve, measure the height of the center portion (called the spool) to the outer body with calipers.

A stuck valve will measure less than 6 mm

If this is found replace the Camshaft Position Actuator Solenoid Valve

If the concern is an intermittent no start or crank no start, Then record the depth of the plunger and replace the Camshaft Position Actuator Solenoid Valve.
