Service Bulletin

PRELIMINARY INFORMATION

Subject: Wind Buffeting Droan Type Noise And/Or Body Pressure Booming

Models: 2015 Cadillac Escalade Models
2015 Chevrolet Suburban, Tahoe
2015 GMC Yukon Models

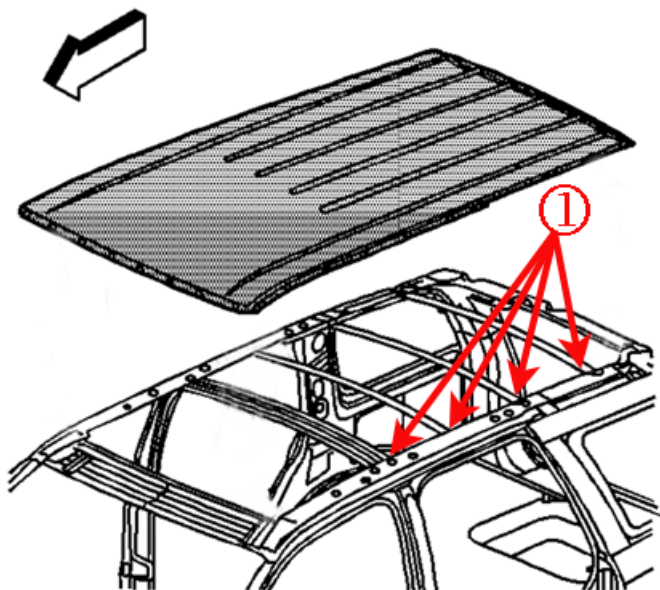
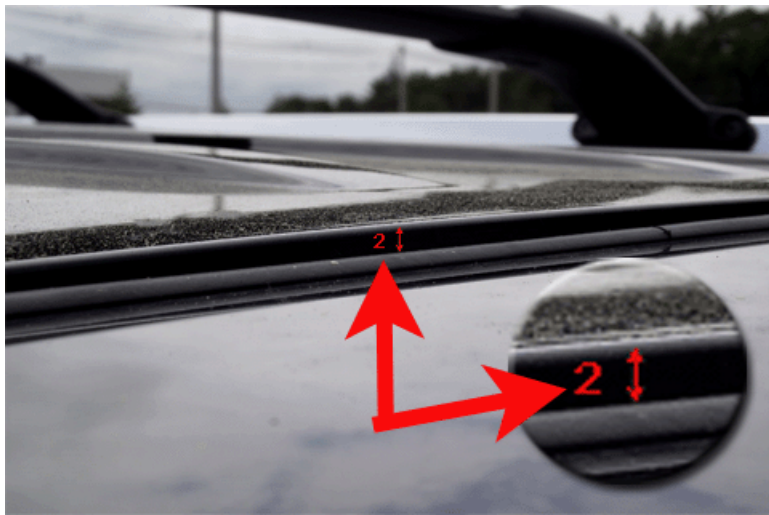
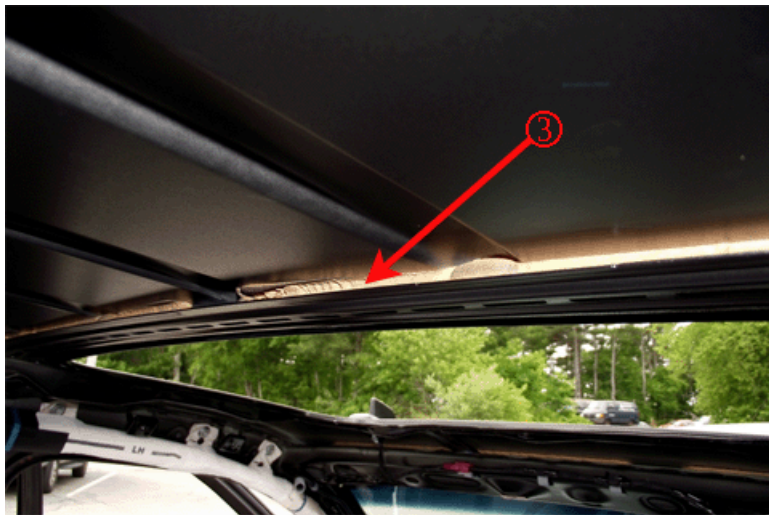
Some owners may comment of a wind buffeting/droan noise or body/pressure booming (the feeling of pressure in the ears) while driving. The body booming issue may be more noticeable when the engine is in V4 mode. In some cases, they may also notice a water leak from the headliner area, if equipped with a sunroof. These concerns could be caused by the roof sheet metal no longer being attached to the roof bows (1). On trucks with a sunroof, it may be noticed that the rear edge of the sunroof glass is considerably lower than the roof (2). This is due to the roof sheet metal being detached from the roof bow directly behind the sunroof opening (3).

To correct this concern, apply panel vibration control material between the roof bow and roof sheet metal, along with foam shim material when necessary.

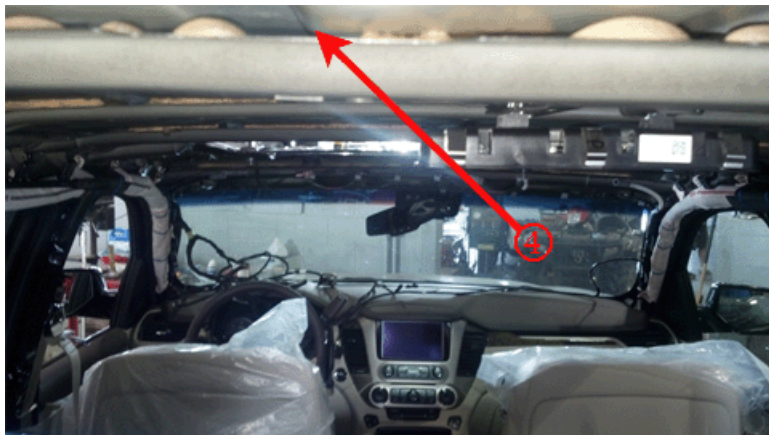
Remove the headliner to access the underside of the roof. Inspect all 4 roof bows for insufficient bonding to the roof sheet metal (4). Any roof bow that is not bonded to the sheet metal will need to be repaired.

Use a plastic scraper or similar tool to remove the old foam. Measure the gap between the top of the roof bow and bottom of the roof sheet metal. If the gap is 5/16 (8mm) or greater, use a combination of 3/4" wide by 5/16" or 7/16" thick foam shim material (as listed below) to fill the gap between the roof bow and the sheet metal. Care should be taken to add only the correct thickness of foam to fill the gap so it does not push up on the roof. Cut the foam into 5 inch lengths and place in three spots along the roof bow, one piece in the middle and one at each outer edge. With the foam shim material in place, or if the gap is less than 5/16" (8mm), use the panel control vibration material (as listed below) to fill the voids between the roof bow and sheet metal. In some cases, it may take a couple layers of material to fill the void.
