Service Bulletin

Subject: DTCs P0011 P0014 P0016 Or P0017 After Cylinder Head Or Cam Actuator Removal

Models: 2012 Chevrolet Sonic
2011 - 2012 Chevrolet Cruze
2009 - 2011 Chevrolet Aveo
2009 - 2010 Pontiac Wave (Canada Only)
2009 - 2010 Pontiac G3
2008 - 2009 Saturn Astra
With 1.6L or 1.8L Engine RPO LXV, 2HO, LUW

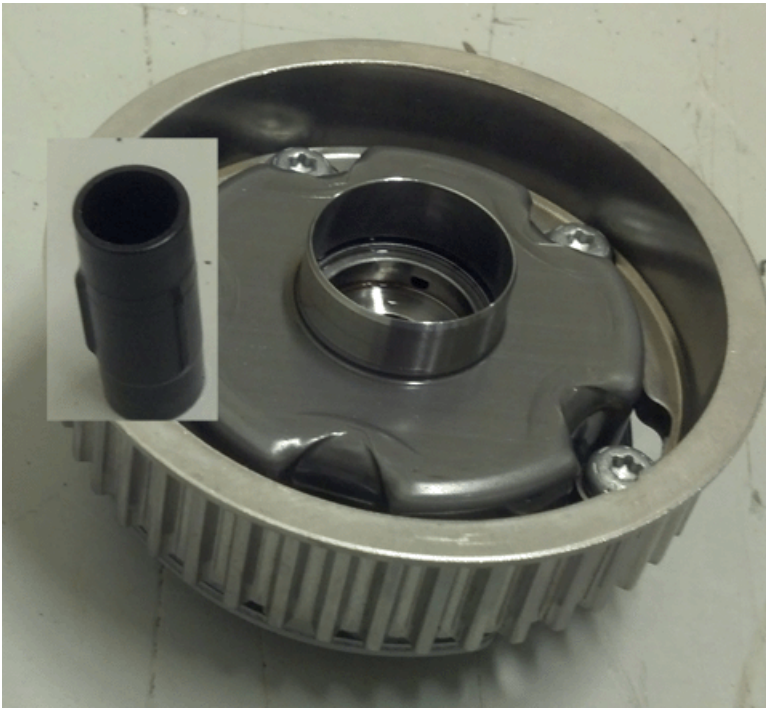
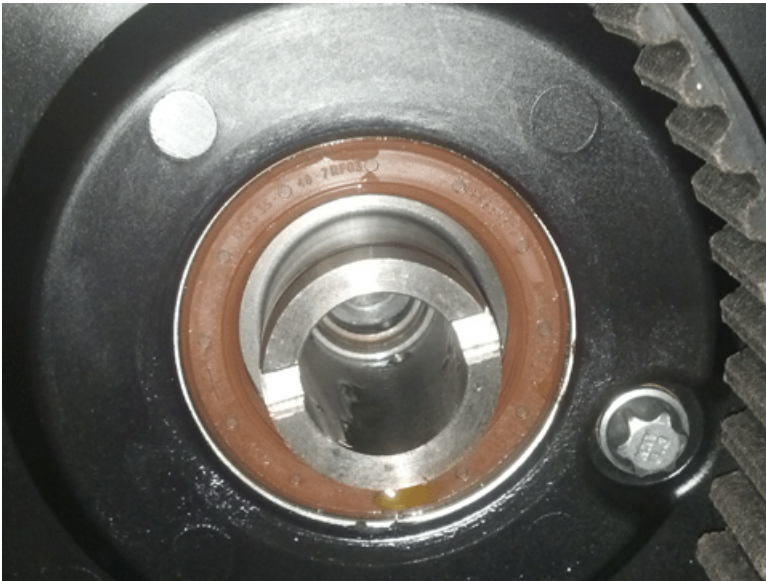
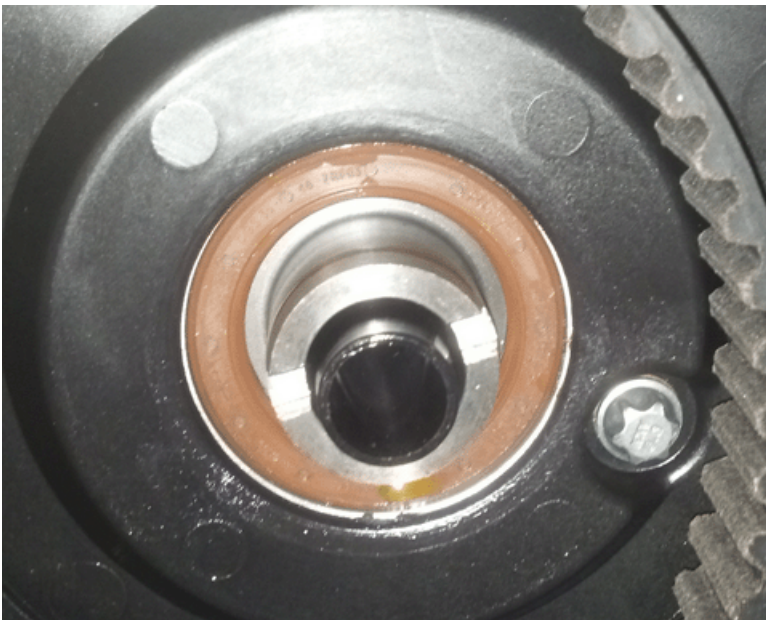
Remove the cam actuators and inspect for a missing actuator oil sleeve. These engines have a unique black plastic oil sleeve that is between the end of the cam actuator and camshaft. This sleeve directs oil to the actuator to advance or retard the cam timing. If a sleeve is missing or damaged, the ECM cannot control the actuator movement, which may result in one or more timing DTCs.

See Photos below.

Note: When removal of the actuator is required, insure installation of these sleeve's during the reassembly of the engine. These sleeves are not shown in the parts imager and are only available as part of the camshaft actuator assembly.
