Service Bulletin

Subject: Convertible Roof Cloth Sags At Rear / Large Gap Between Number 5 Bow And Rear Panel

Models: 2011 - 2013 Chevrolet Camaro Convertible

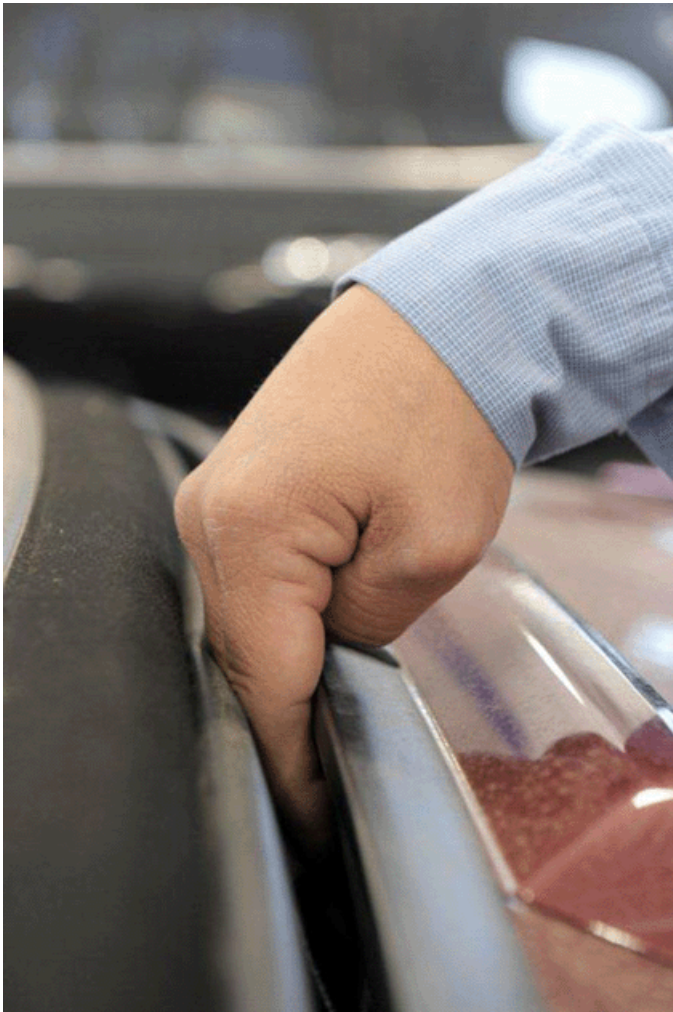
A dealer may report that there is a large gap between the #5 bow and the rear "tulip" panel when the top is closed and latched. This may cause a sag in the cloth top material, causing the appearance of a loose fit.

Replace the #5 bow following repair procedures in SI.

Immediately following replacement of the #5 bow assembly or any time the top assembly has been removed from the vehicle and prior to cycling the top for the first time, it is necessary to follow the latest version of PI0406 to ensure that the Folding Top Quarter Outer Drain Panel (water management bag) is not interfering with the top assembly.
