**Bulletin No.: PIT5234**

# Service Bulletin

Subject: **Ignition Key Cannot Be Turned**

Models: 2014 Chevrolet Silverado 1500

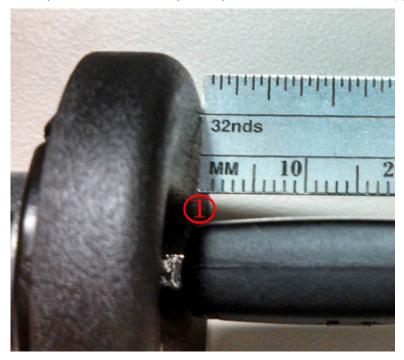
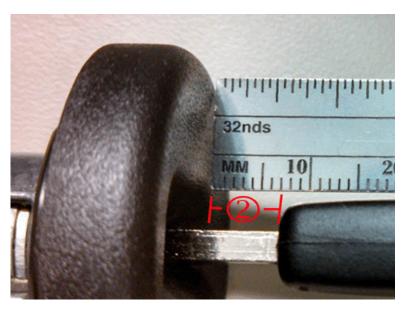
- Insert key into ignition and confirm key will not turn.
- With key inserted, measure the key to the cylinder, shown below is the correct (1) and incorrect (2) insertion measurements.

- 3. The ignition lock cylinder will need to be replaced to correct this issue, if the key is not going in fully. To remove and replace the ignition lock cylinder, it must be rotated to the start position so the ignition cylinder retaining tab can be pressed down. Since the lock cylinder will not rotate continue with the following steps.
- 4. Obtain a new key that is cut to the vehicle. Reference the latest version of TSB 09-00-89-029: Key Cutting Procedure for Obtaining Replacement Key. The purpose of ordering a new key is so that the original customer's keys are left intact.
- 5. Shorten the key shank by grinding or cutting 6-7mm (1/4 inch) off the tip of the key.
