Preliminary Information

PIP5240B Mil On With DTC P0171 And / Or P1101

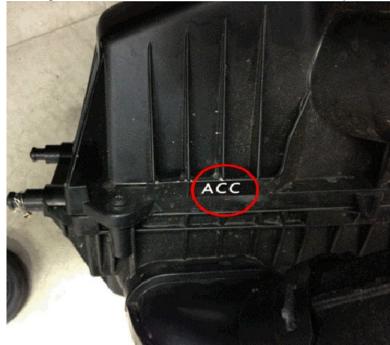
A technician may encounter a DTC P0171 And / Or P1101 set current or in history.

If SI diagnostics do not isolate the cause of the concern, inspect the ID code on the Air Cleaner Housing. (See photo below).

If the Hydro Carbon Absorber is missing, or the ID code is other than ACD, replace the Air Cleaner Housing with the latest listing in the Electronic Parts Catalog.

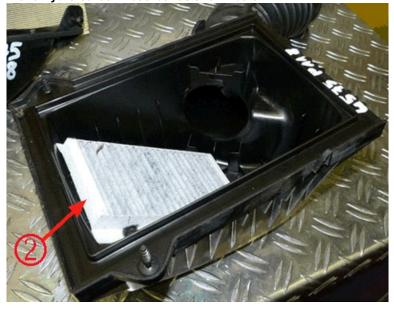
The correct application for the 2013-2015 Buick Encore and 2013-2015 Chevrolet Trax will have an ID code of ACD and will be fitted with a Hydro Carbon Absorber as shown below.

If the Hydro Carbon Absorber is present and the ID code is ACD, refer back to current SI diagnostics.
