PIT5426A Second Row Seat Belt Wet And / Or Carpet Wet From The C-Pillar Area Rearward

Product Investigation Review Required

Brand:	Model:	Model Years:	VIN:		Engine:	Transmissions:
			from	to		
Cadillac	Escalade	2015 - 2017	All	All	All	All
Chevrolet	Tahoe	2015 - 2017	All	All	All	All
Chevrolet	Suburban	2015 - 2017	All	All	All	All
GMC	Yukon	2015 - 2017	All	All	All	All

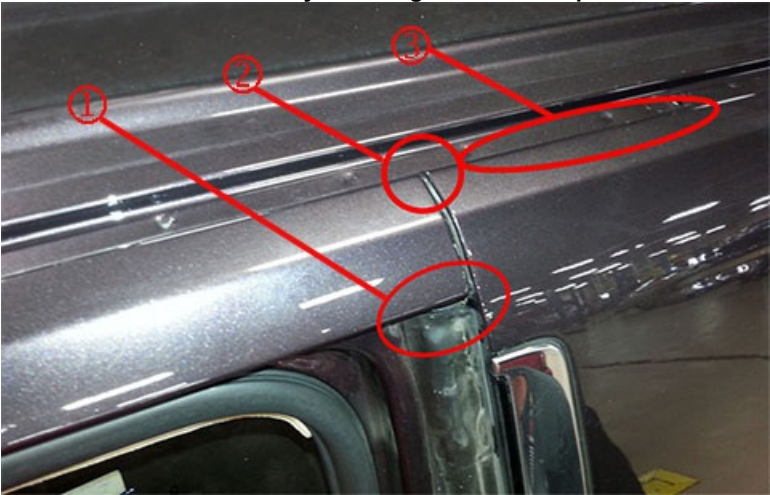
To correct the condition there are 3 areas of body seam sealer that needs to be addressed. Clear flowable seam sealer can be applied to the areas as shown in the pictures below. To allow for proper repair, the luggage carrier roof side rail on the affected side will need to be removed, (with pillar trim being repositioned and the headliner partially lowered for rail access), see SI for removal instructions.

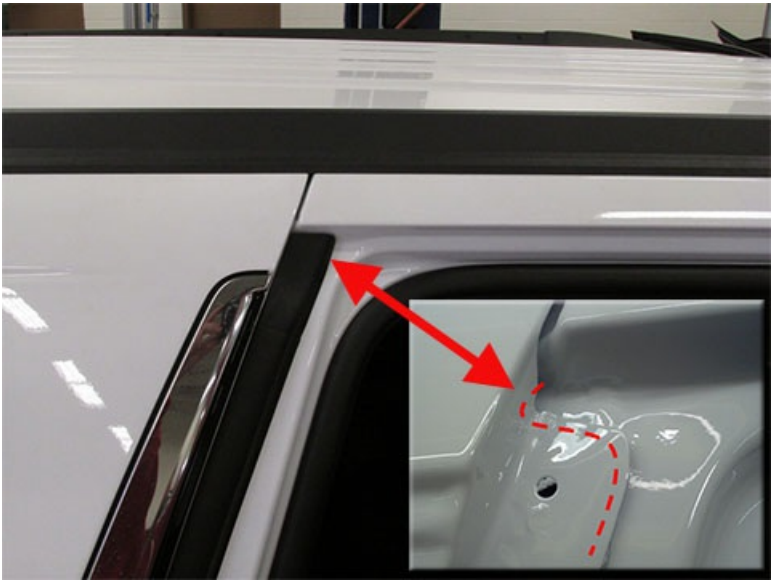
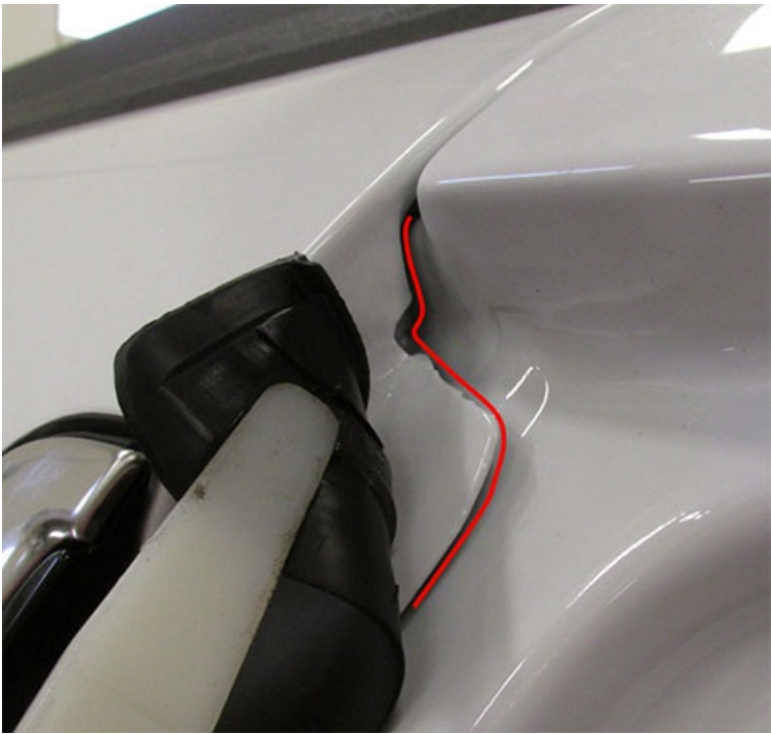
- 4 - With the quarter panel weather strip removed, inspect for clear seam sealer between the c-pillar and rear quarter panel (Area 1 as seen above).
- 5 - If seam sealer is not present, or if any gaps are found in the sealer, apply clear flowable seam sealer between the c-pillar and rear quarter panel sheet metal as shown per red line in picture.

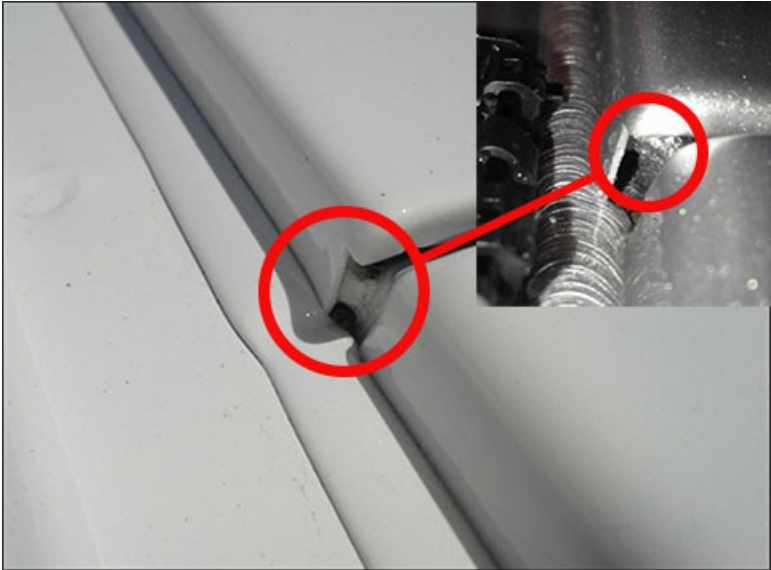
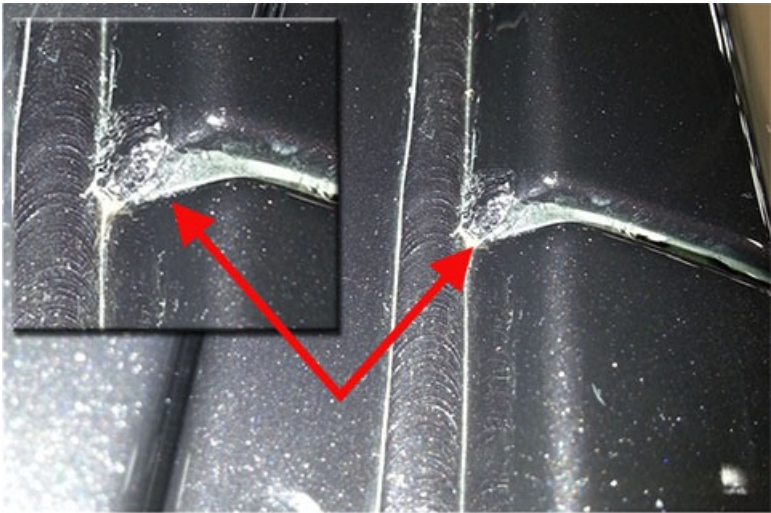
6 - With the roof rail removed on the affected side, inspect existing seam sealer in the area shown; door surround to quarter panel and roof panel (Area 2 as seen above) for skips or pin holes in the sealer.

7 - Fill any voids or pins holes found in the existing seam sealer with clear flowable seam sealer.

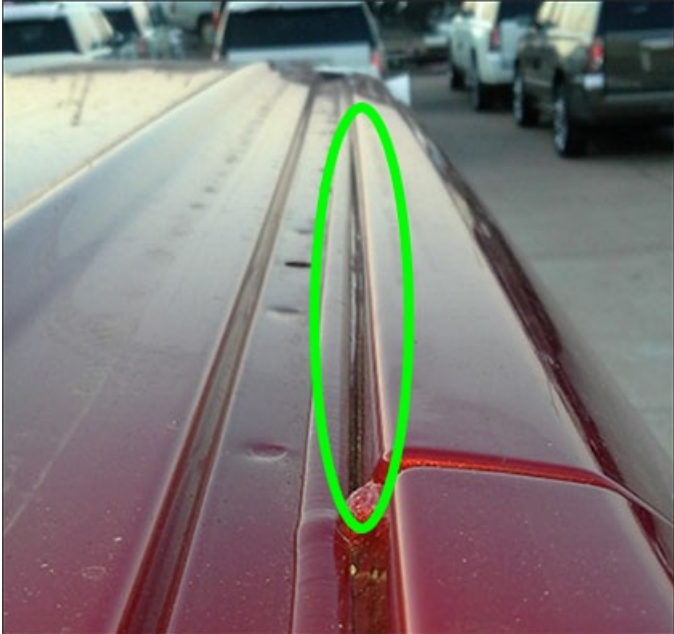
8 - With the roof rail removed on the affected side, inspect existing seam sealer in the area shown; quarter panel to roof panel (Area 3 as seen above) for skips or pull-away along the outboard edge.

9 - Apply clear flowable seam sealer along the rear quarter panel to roof seam as illustrated in picture above.
