Preliminary Information

PIP5421B Malfunction Indicator Lamp Illuminated With DTC P0300

Brand:	Model:	Model Years:	VIN:		Engine:	Transmissions:
			from	to		
Chevrolet	Malibu	2016 - 2017	All	All	1.5L LFV	All

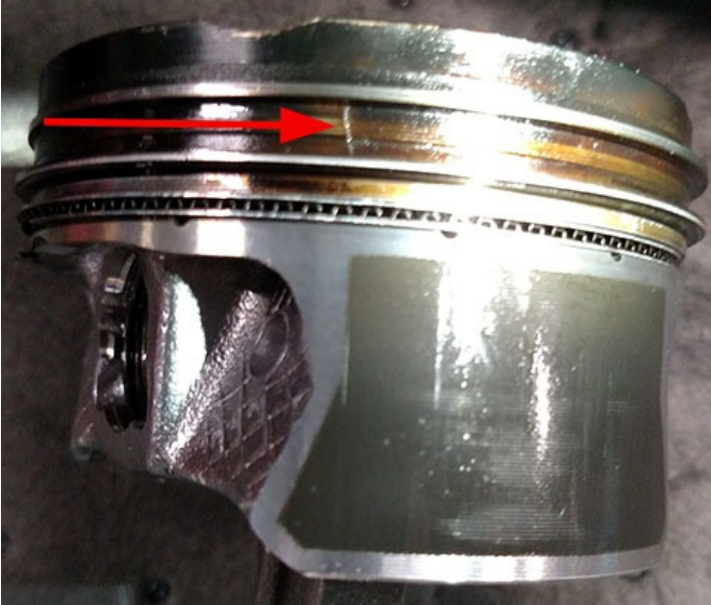
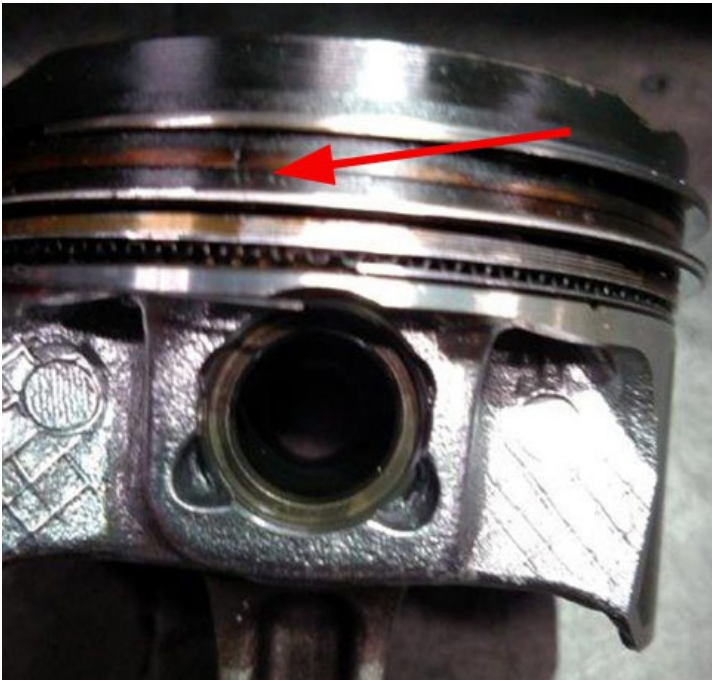
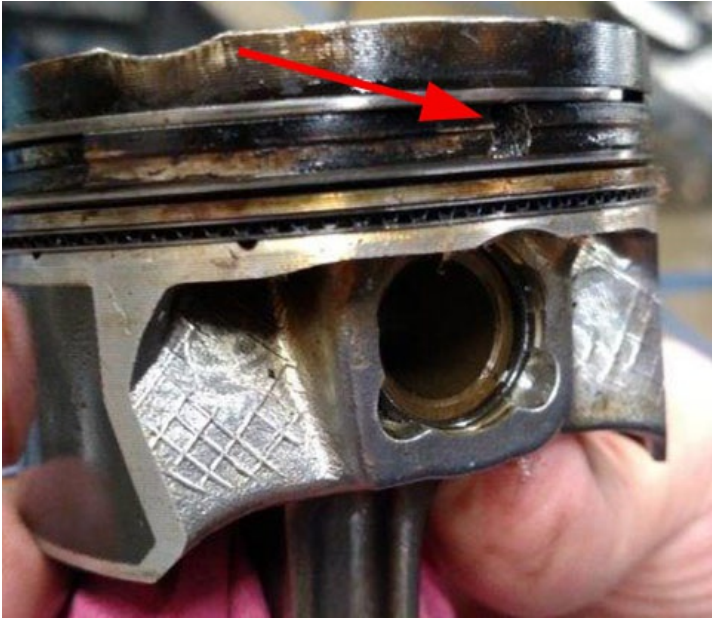
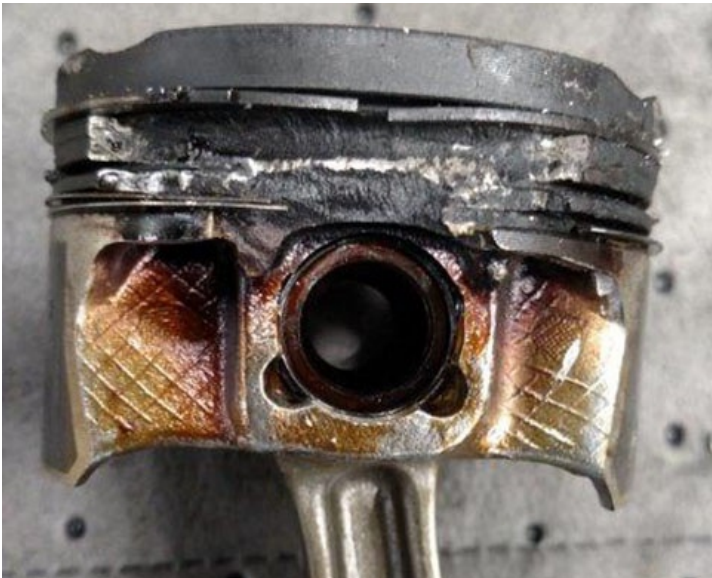
Involved Region or Country	USA, Canada
Additional RPOs:	LFV
Condition	Some customers may comment on a rough running engine with the Malfunction Indicator Lamp on. Upon inspection, a technician may find DTC P0300 set along with a misfire and low compression in one or more cylinders.
Cause	This condition may be caused by a damaged piston requiring replacement of all four piston and rod assemblies with an updated part number.

Shown below are examples of pistons with varying levels of damage.

If the cylinder wall surface has not been compromised, replace all four piston and rod assemblies.

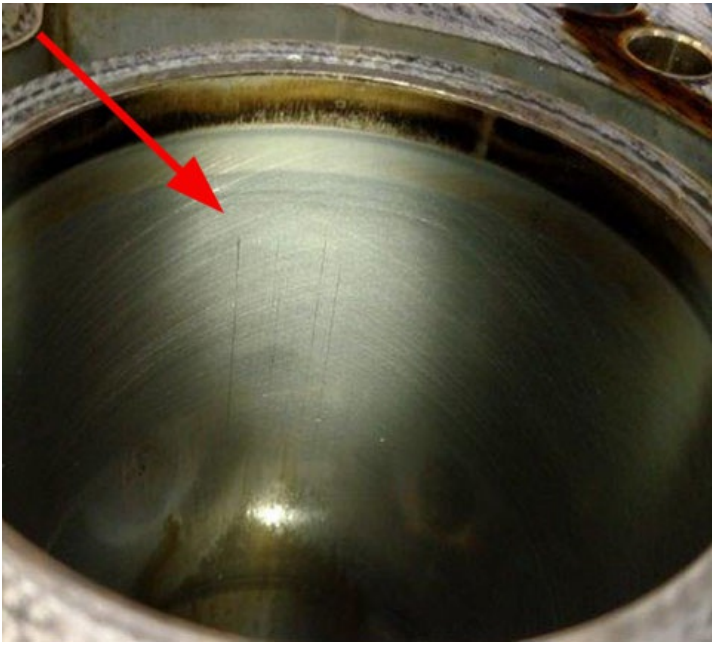
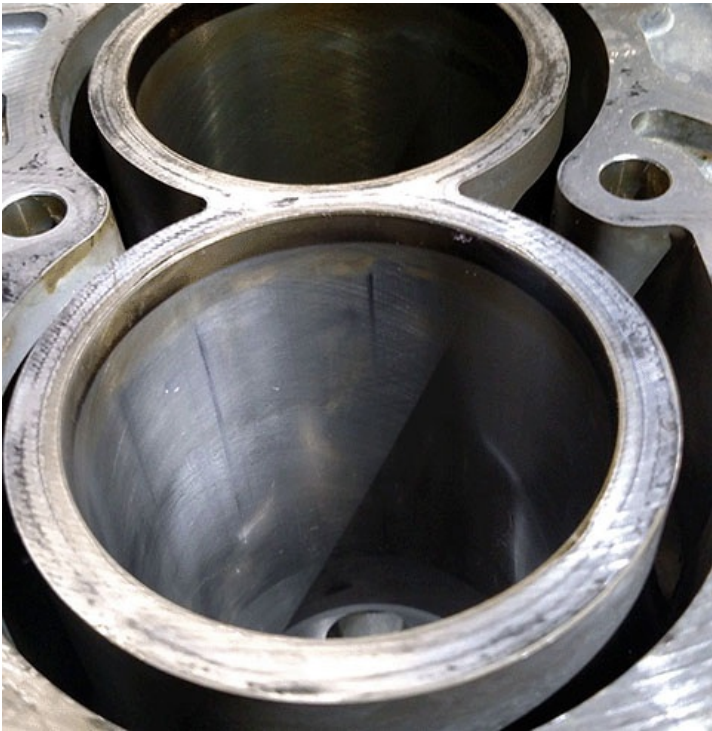
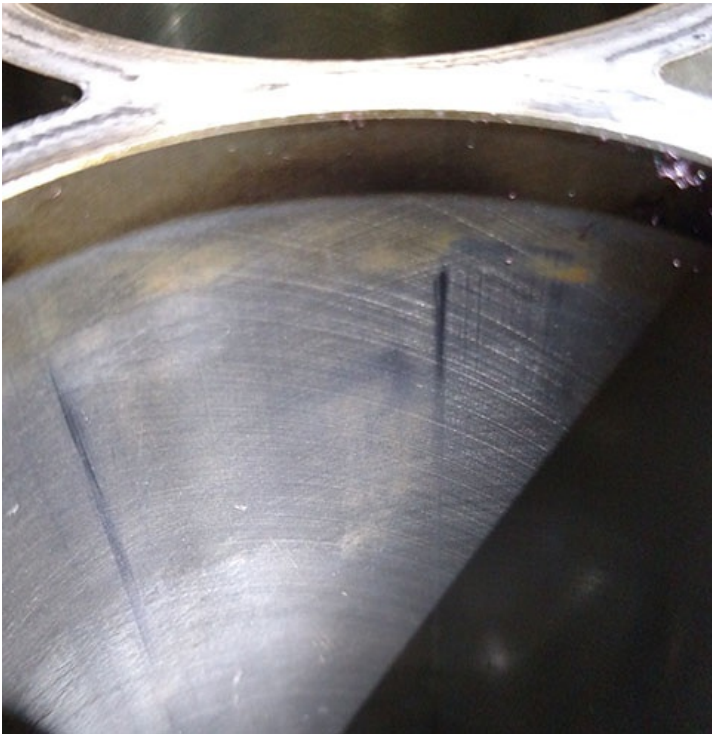
Shown below are several examples of light vertical marks visible on the cylinder wall.
In these examples, none of the marks in the cylinder walls could be felt with the finger tip or nail and engine replacement is not recommended.

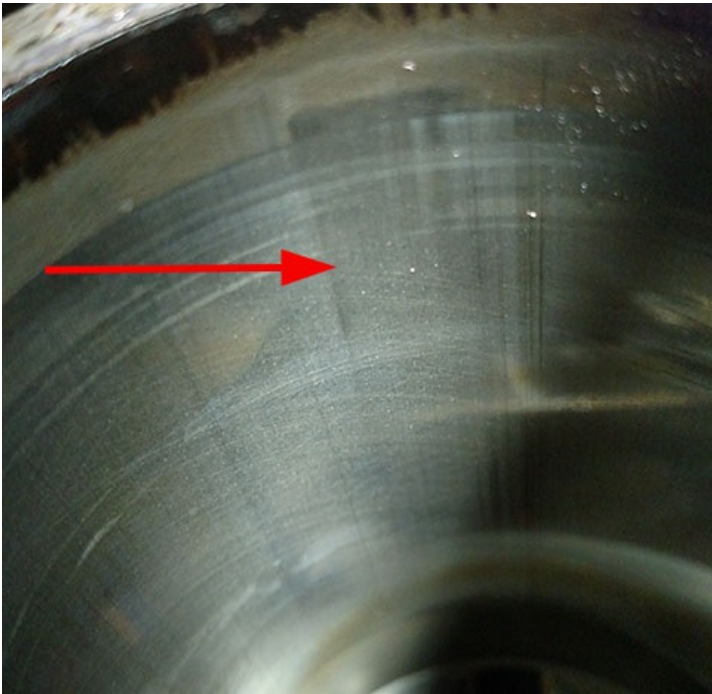
**Shown below is an example of a damaged cylinder wall.
In this example the scuffing is wide and has removed the crosshatch from the cylinder wall in the area above the arrow.
This would result in oil consumption and requires engine replacement.**
