Service Bulletin

Subject: Information on Vibration Analysis and Diagnostic

Models: 2014 Chevrolet Silverado 1500
 2015 Chevrolet Silverado
 2014 GMC Sierra 1500
 2015 GMC Sierra

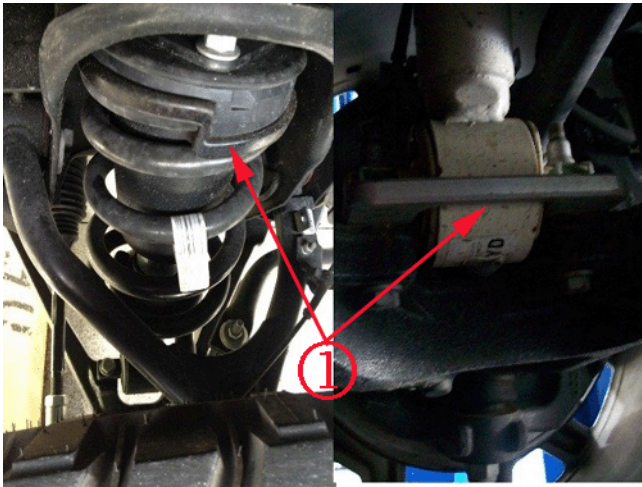
1. Inspect the truck for any aftermarket equipment installations. For example: non factory tires, wheels and/or lift kits or leveling kits – shims (1) installed as shown above. Aftermarket equipment does include running boards, bug deflectors, and window shades, etc. Remove any aftermarket that might cause vibration transmission paths.
2. Mark each tire valve stems location on the tire. This will be utilized to check for tire slippage on the rim.

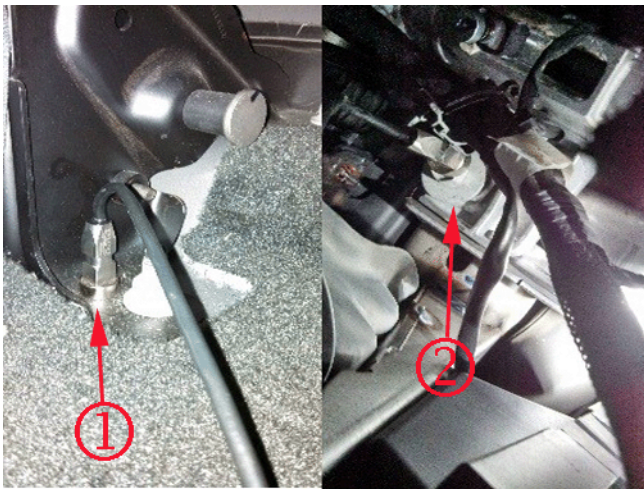
3. Using a Pico Oscilloscope Diagnostic Kit, mount the PicoScope vibration sensor on one of the two locations shown above.

- Seat Vibration – mount the sensor to the rear seat bracket (1).
- Steering Wheel Vibration – mount the sensor to the steering wheel bracket (2) under dash.

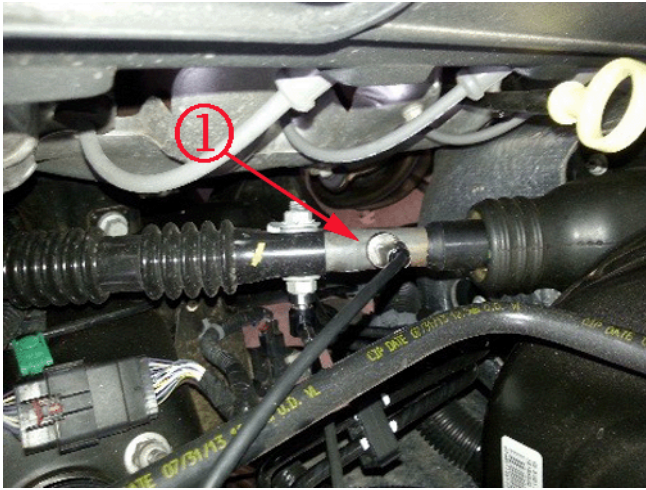
4. This step should be only be used if the vibration can be felt while running the vehicle on the rack. Mount the sensor on the steering shaft(1), under the hood as illustrated above.
5. Measure the vibration. Typically trucks should be driven in M5 to keep from switching in and out of active fuel management (AFM).

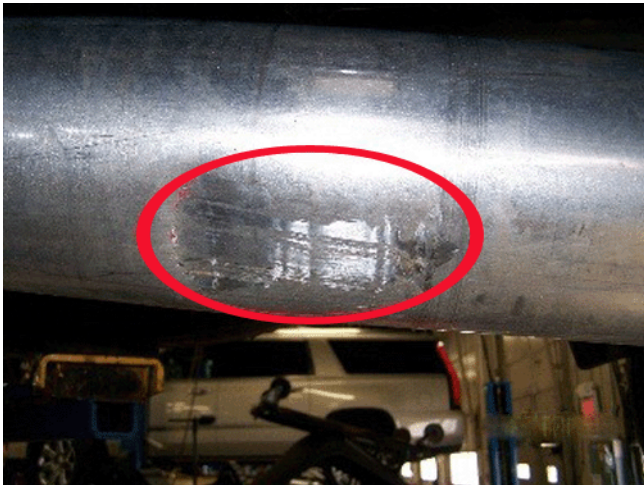
- Inspect the propeller shaft for dents or damage. There have been many cases of dented propeller shafts.
- For 4WD Trucks, remove the rear propeller shaft, seal output shaft and drive the vehicle in 4WD. If the vibration is gone, the rear prop shaft could be the problem.
- For vehicles with a 3:08 with a one-piece steel shaft, this can be replaced with a one-piece aluminum one that is utilized on all 3:42 and 3:73 ratios (K15543 and K15753 Models only).
- PIP5140: Low Speed Vibration 30-35 mph (48-56 km/h).
- Inspect the transmission output shaft bushing for irregular wear.

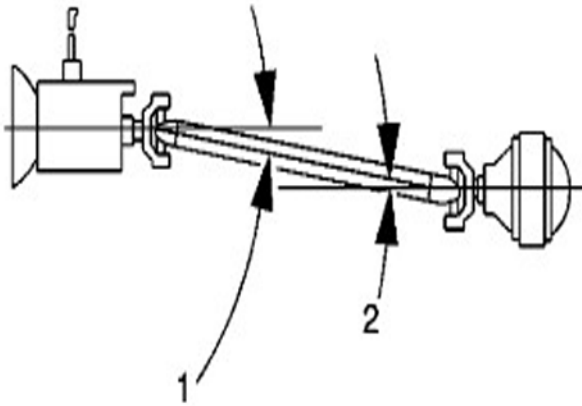
Measurement	Notes:
Yoke to Shaft		The first (forward most) U-joint action on a two piece driveshaft system is not canceled out by another U-joint. Because of this, the first U-joint working angle should be between 0.5 and 0.75 degrees.
Front Shaft to Center Support Bearing (if equip)		U-joint pairs cancel each other. Neither U-joint working angle should exceed 4 degrees, nor the allowable range of difference between cancelling U-joint working angles is 0.00 to 1.0 degrees.
Shaft to Diff Yoke

Propeller systems containing only 1 U-joint: The U-joint working angle should be between 1/2 and 3/4 degrees.

Allowable range of difference between cancelling U-joint working angles: 0.25 to 1.0 degrees.

1. Originally, trucks were built with a 14 mm spacers under the transfer case (4WD only). In some cases, reducing this shim to a 7 mm shim may correct the condition.
2. A 2 degree axle shim (P/N 23469809 – Qty 2) can be placed between the leaf spring pack and the axle perch. To rotate the pinion up to correct this; the “fat end” of the shim must face backwards, to the rear of the truck.

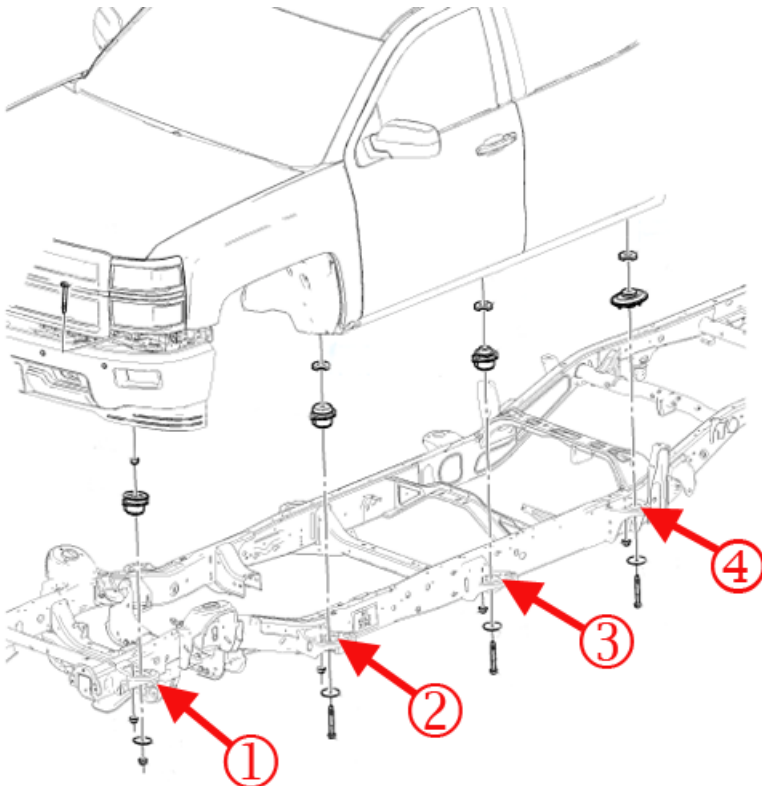
The cab / body mount position location

The numbers in the picture below indicate the specific mount position. The mounts on the passenger side of the vehicle are identified the same way. This will assist the technician to identify the correct location of each mount so they can be torque to the proper specification.

- 1 = body mount cushion front
- 2 = body mount cushion position number 1
- 3 = body mount cushion position number 2
- 4 = body mount cushion position number 3

Visually verify that the cab to box alignment is correct before re-torqueing all mounts to specification found in Service Information, body repair, frame and under body section.
