Service Bulletin

Subject: Instrument Panel Cluster (IPC) Air Bag Indicator Illuminated (Install Protective Material)

Models: 2007-2009 Chevrolet Cobalt
2008-2009 Chevrolet HHR SS
2006-2009 Pontiac Solstice
2007-2009 Pontiac G5
2007-2009 Saturn SKY
2007-2009 Opel GT
2007-2008 Daewoo G2X
Built Prior to February 2, 2009

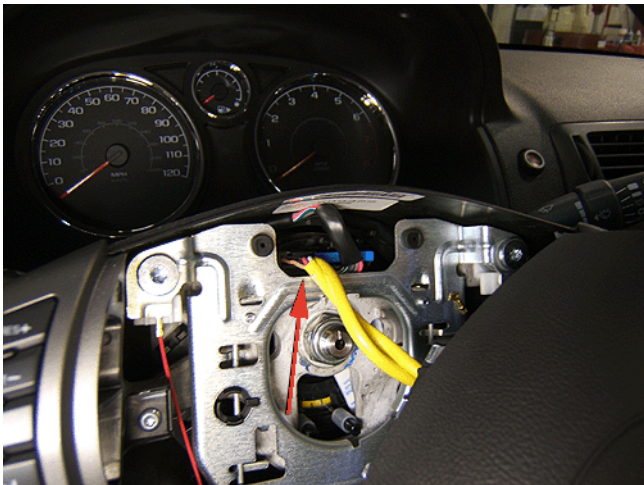
This condition may be caused by a short to ground in the yellow SIR wiring harness. This wiring harness is located within the steering wheel assembly and connects the steering wheel inflatable restraint module to the steering wheel inflatable restraint module coil. A sharp edge on the steering wheel stamped steel horn plate may rub through the yellow SIR wiring harness insulation, allowing the harness to ground to the horn plate.
