Service Bulletin

Bulletin No.: 08-08-57-003E

Subject: Floor Wet Under Carpet/Engine Continues to Run with Key Off/Possible No Crank/No Start/Communication

Models: 2008-2016 Buick Enclave

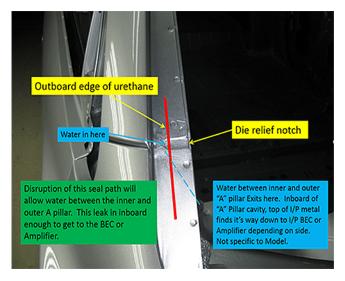
• Inspect the right side A-pillar/windshield area and water test for any leaks.

- Inspect the front drain hoses to ensure that they are free of clogs or kinks, and that water is properly flowing through the hoses.
- Inspect the IP BEC for wetness and/or any green colored corrosion.

Water from the right front sunroof drain hose exits the vehicle through the plenum (upper arrow) and may re-enter through the un-sealed seam at the front of the dash. Refer to lower arrow in the illustration.

4. Seal the seam INSIDE the opening at the bottom and to the right and left of the arrows in the illustration. Seal the full length of the dotted line. Seal the seam with P/N 12378500 (in Canada, use 10952233) Medium Body Seam Sealing Compound or equivalent.
