Service Bulletin

Subject: Availability of Insulator Service Part for Prevention of Liftgate Rust/Corrosion at Center Applique

Models: 2010-2015 GMC Terrain

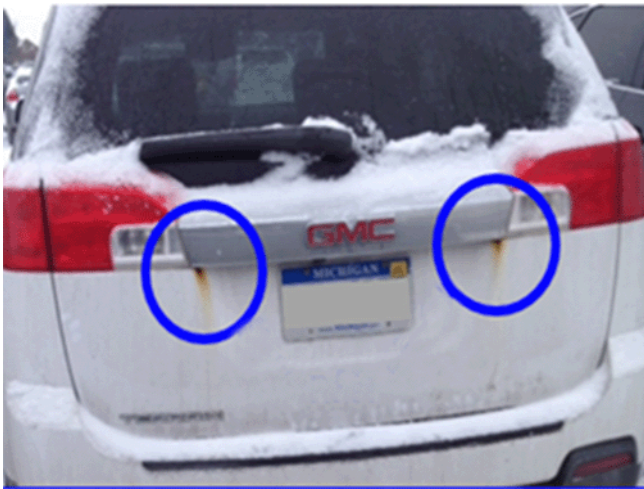
On some vehicles, due to the applique contacting and rubbing on the liftgate painted surface, rust spots (shown circled above) may be evident at the lower corners of the center chrome applique on the rear liftgate.
