Service Bulletin

Subject: BAS+ (HYBRID) eAssist Drive Motor Generator Belt Broken Noisy Worn Or Misaligned

Models: 2012 - 2013 Buick LaCrosse and Regal eAssist
2013 Chevrolet Malibu Eco eAssist
All with RPO HP6

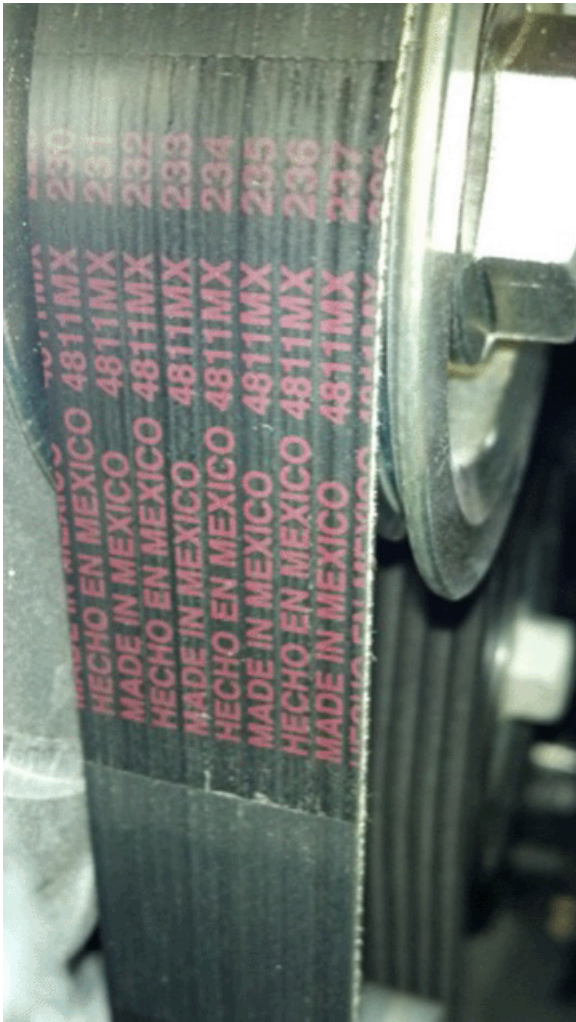
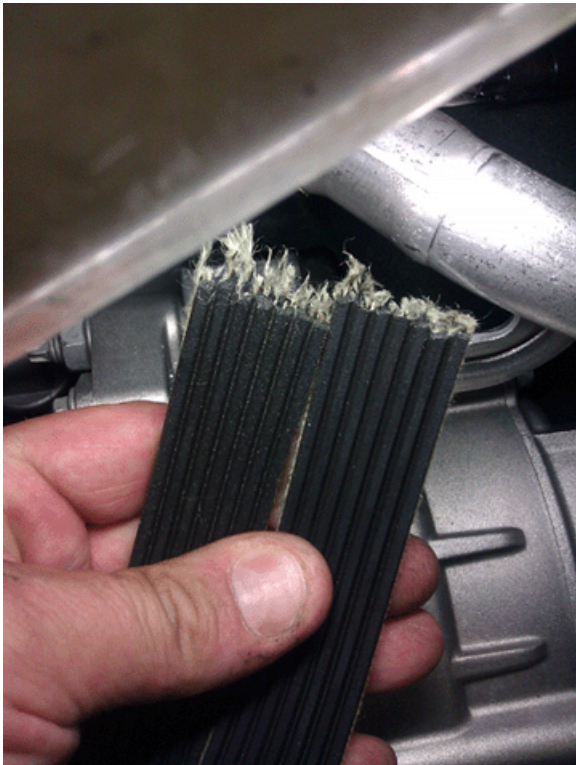
1. Inspect the under hood area for any damage (engine, CV boots, etc.) that may have been induced when the belt had broken.
2. Inspect the Drive Belt and note whether it looks like the belt just snapped cleanly, if it is shredded or worn due to misalignment, incorrect tension, or damaged due to contamination from any fluids. Take a digital photo of the broken belt ends and note the belt date code. The code is four numbers followed by "MX" printed in red lettering as shown below.

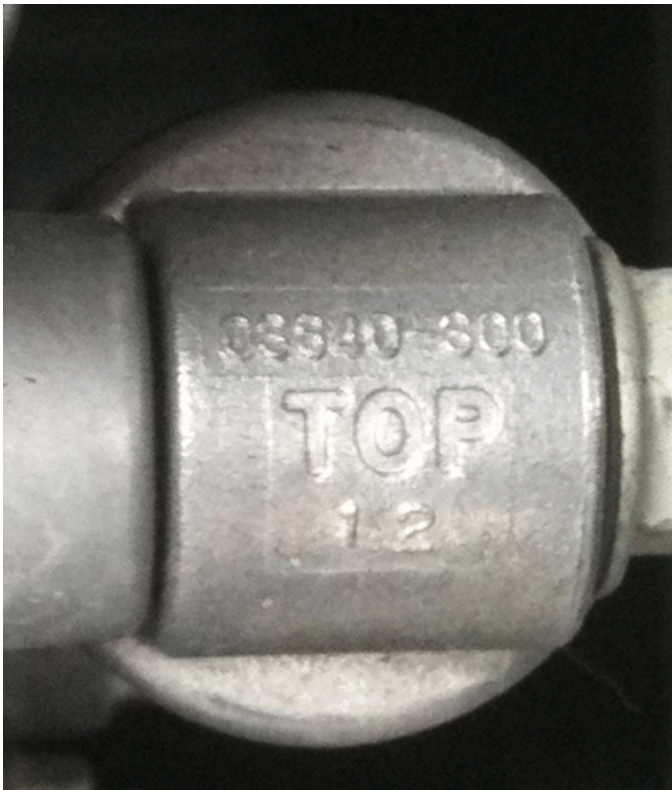
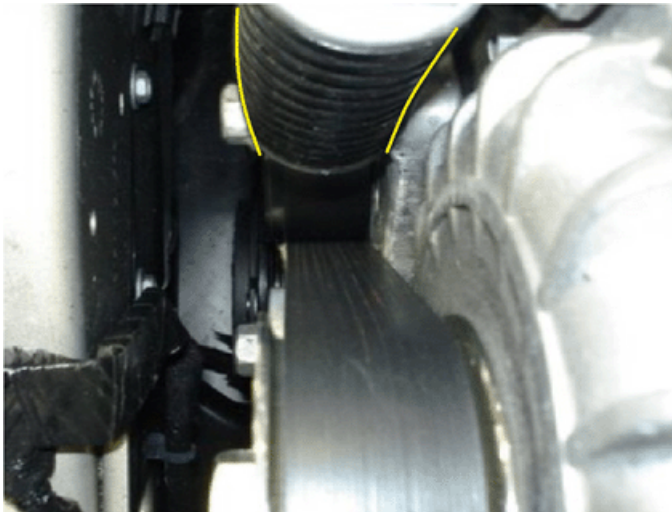
3. If a Laser Belt Alignment Tool (EN-49228 or equivalent) is available, use it to check for proper pulley alignment.
4. Inspect the drive belt Tensioner strut assembly to ensure that it is installed correctly - "TOP" is stamped on the upper rounded end of the tensioner strut housing as shown below. If it is installed upside down or if the upper and lower retaining bolts have been reversed during previous repairs, it could

cause an alignment concern as shown below. It is not necessary to remove the tensioner bolts from the bracket or remove the spring from the tensioner. The upper bolt of the tensioner is longer than the lower bolt.

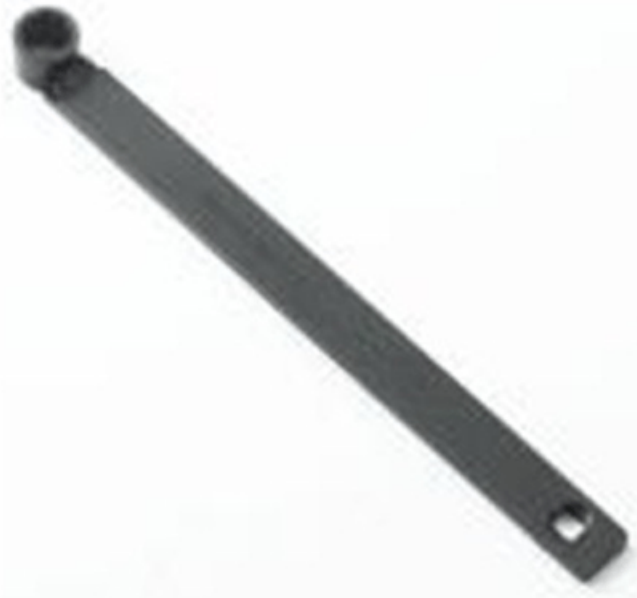
Important: When checking the center pivot bolt torque, it is necessary to use the Torque Wrench Adapter J-45025 when performing this repair. Without this tool, the torque specification in SI will be inaccurate. Achieving the correct torque specification is critical or the bolt may loosen, resulting in premature wear or breakage. The specification in SI is considering that the tech has the Torque Wrench Adapter installed on a 3/8 drive Torque Wrench while they are both kept in a straight line with each other.

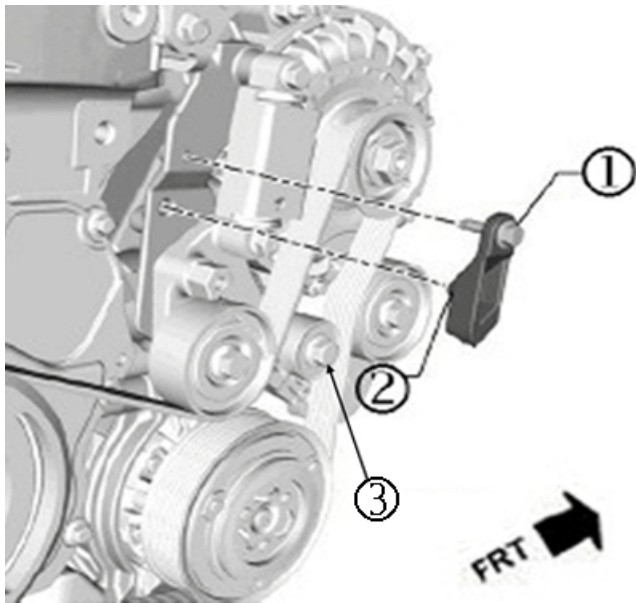
6. Check the Tensioner pivot bolt torque by marking the head of the tensioner pivot bolt with a marker (see call-out 3 in photo below), torquing it to 42 Nm (31 lb/ft) with the J-45025 / EN-45025 torque tool, and noting the mark again. Please take a digital photo if several degrees of movement (90 Degrees, etc.) are noted.

7. After following the steps above and gathering all of the requested information, follow order a new drive belt.
8. Follow the 2.4L Drive Belt Replacement Procedure in SI to install the new drive belt. As mentioned in this SI procedure, the tensioner stop below (1) must be removed before the tensioner is compressed with the EN-48932 compressor or tensioner/bracket damage may occur. Also, as mentioned, the tensioner assembly should be rotated out of the way to allow more clearance, which will make it easier to install the tensioner stop. Once the stop is installed, ensure that the dowel (2) is fully engaged to the bracket and that the tensioner stop sits flush against the bracket before the tensioner stop bolt is torqued to specification.
