Service Bulletin

PRELIMINARY INFORMATION

Subject: Click Rattle Or Squeak Noise From Dash Area

Models: 2015 - 2016 Cadillac Escalade Models
2014 Chevrolet Silverado 1500
2015 - 2016 Chevrolet Silverado, Suburban, Tahoe
2014 GMC Sierra 1500
2015 - 2016 GMC Sierra, Yukon Models

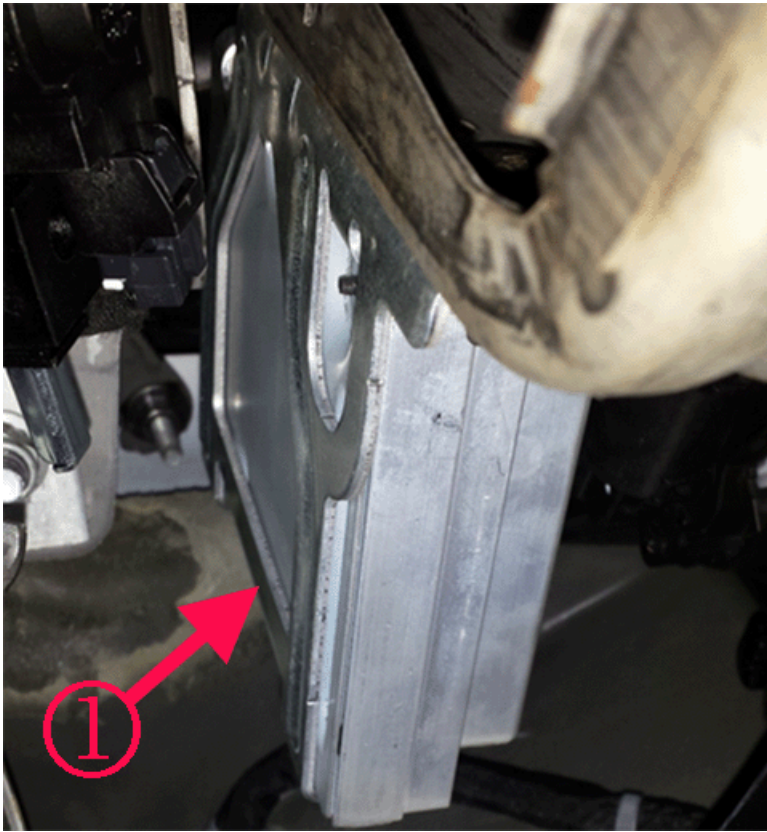
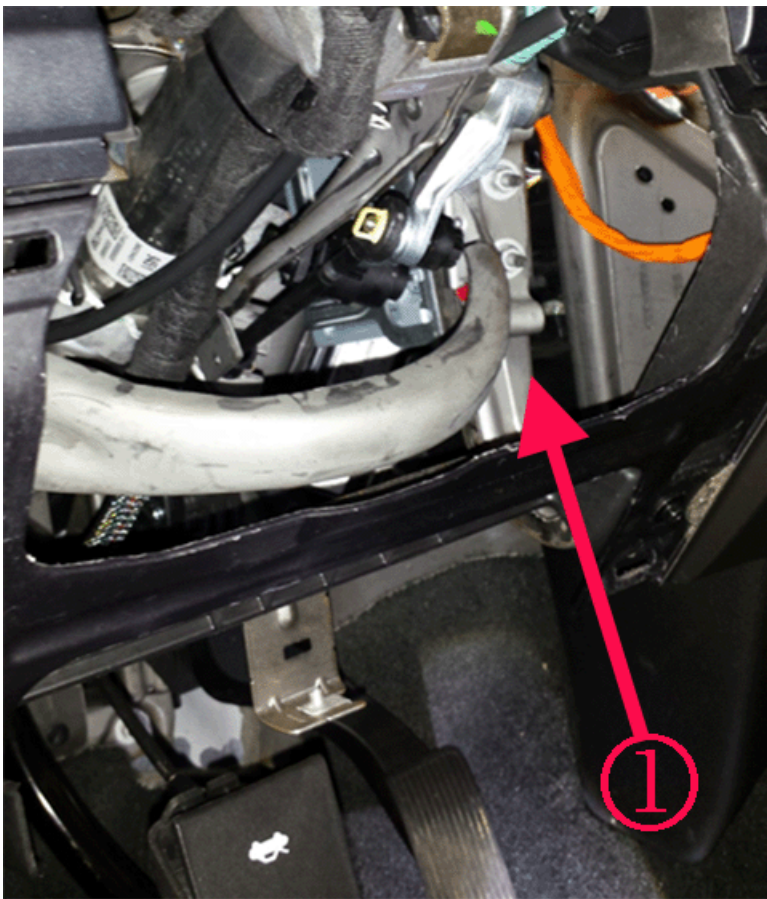
See #1 in photos below:

Condition 1: A tinny or metallic rattle type noise from the IP area to the left of the steering column.

The noise may be caused by the 110 Volt Power Inverter Module not being seated properly in the mounting bracket (if equipped with RPO K14).

Inspect the power inverter module for possibly moving slightly against mounting bracket and creating the noise.

Follow SI to locate the Accessory AC and DC Power Control Module located to the right of the steering column.

Remove the K14 power inverter module and apply two-sided tape to the module bracket to insulate it from the mount.

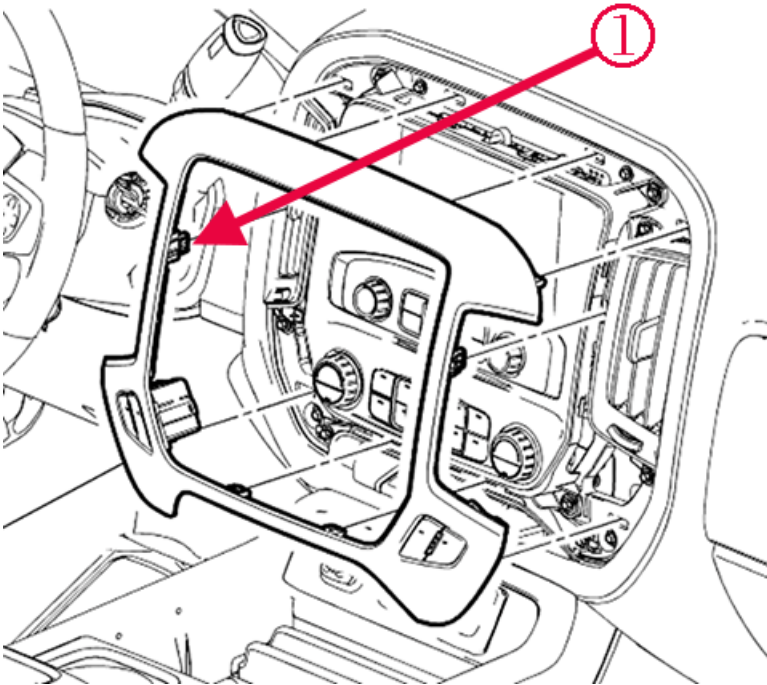
Condition 2: A rattle, squeak or itch type noise from the center of the dash in the radio area.

The instrument panel accessory bezel may be rattling due to insufficient tension of retainers. Press on the bezel while duplicating noise to see if it is eliminated.

Wrap Kent automotive BRS flocking tape part number KT13487 over retainers (#1 in illustration) and reinstall bezel.

This will require an application of BRS flocking tape on ten retainers (one strip @ 1" x 10"). Two sheets should repair 16 vehicles

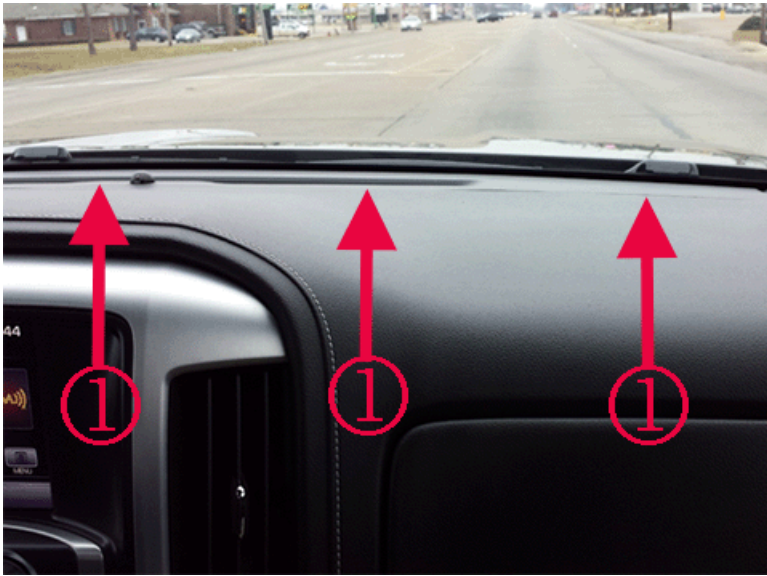
Condition 3: A rattle or itch type noise from the dash area near the windshield

Defroster grill may be rattling due to insufficient retention of retainers. Press on defroster grill (# 1 in illustration) while duplicating concern to see if it is eliminate

Remove defroster grill.
