## PIC6293 Installation of the GM Accessory Interior Spectrum Lighting Kit

Brand:	Model:	Model Years:	VIN:		Engine:	Transmissions:
			from	to		
Chevrolet	Camaro	2016 - 2018	All	All	All	All

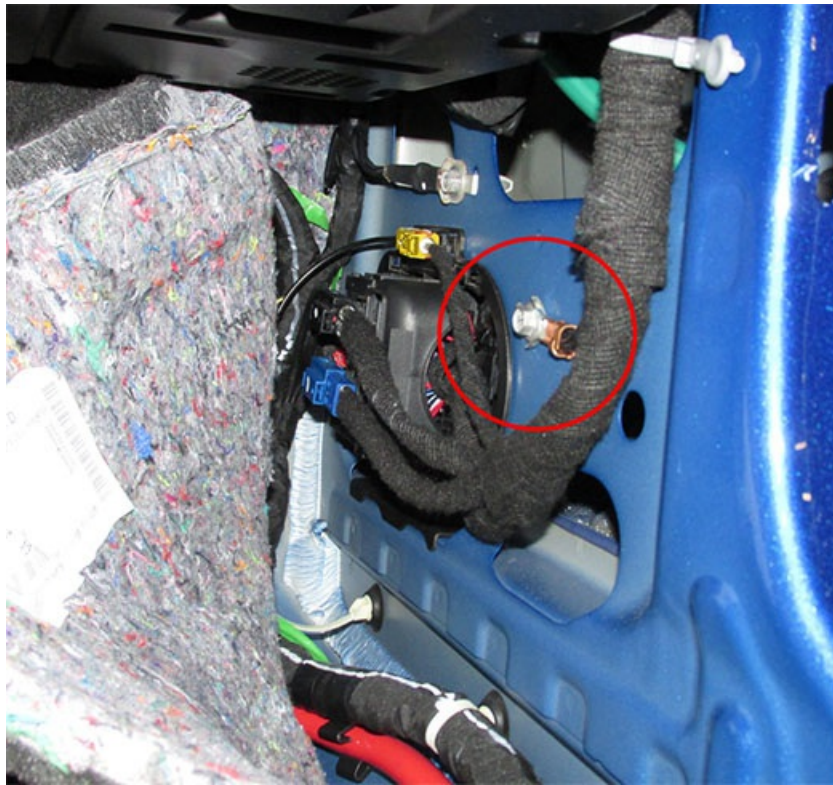
Condition

- If the entire kit has been installed and the lighting is entirely inoperative, there are a few things to go back and check. The most common area for concern is G202, which is located at the RH kick panel. Typically, this ground has paint on it when the kit's eyelet is installed. Just tightening the fastener does not provide a good ground path if there is still paint covering the sheet metal. The fastener will have to be removed, the paint needs to be cleaned or ground off, and the ground path verified.

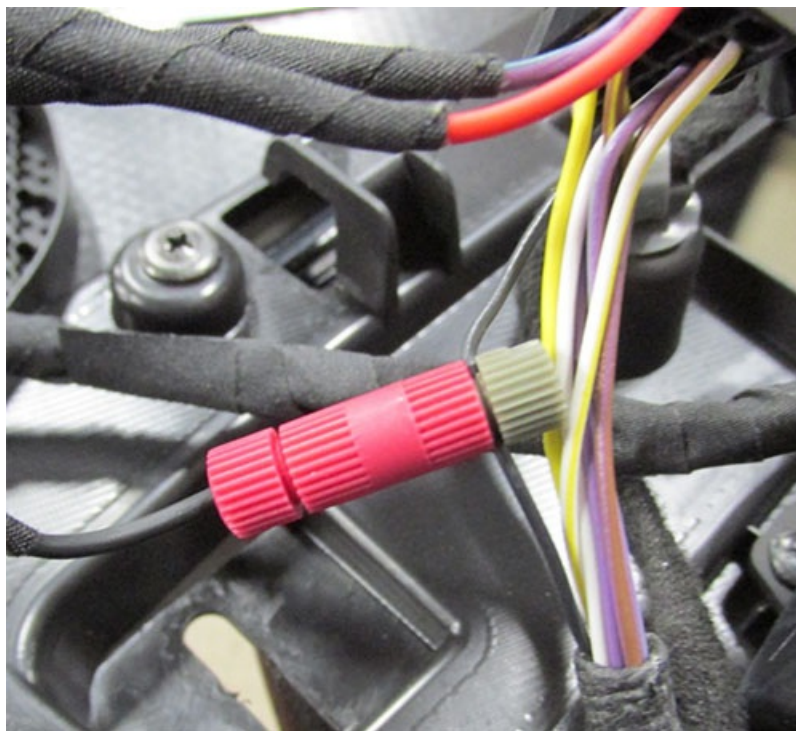
- Another common issue that is seen relates to the Posi-Tap connectors used in the kit. These connectors are used to splice the accessory harness to the vehicle's wiring harness. Dealership technicians are to go back through the installation and verify that each connector is tight. If one or more of these connectors was loose, this will cause any number of performance issues with the kit. The connector shown in the photo below does not have tape or a zip tie covering it for clarity. Once the connector is properly installed, the instructions have the technician tape back the splice to the main harness using cloth tape. This will prevent the connector from loosening up over time.

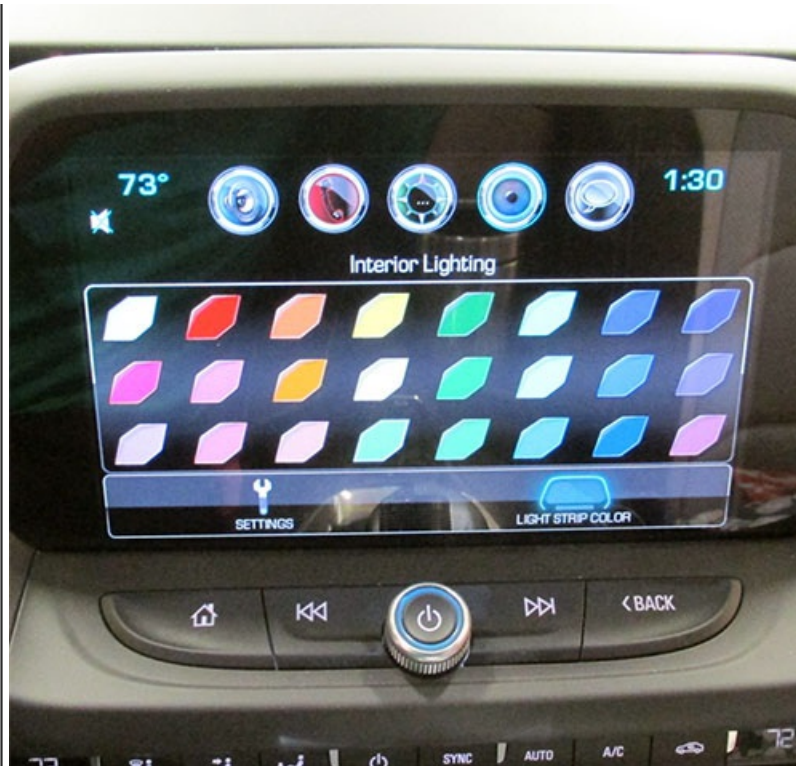
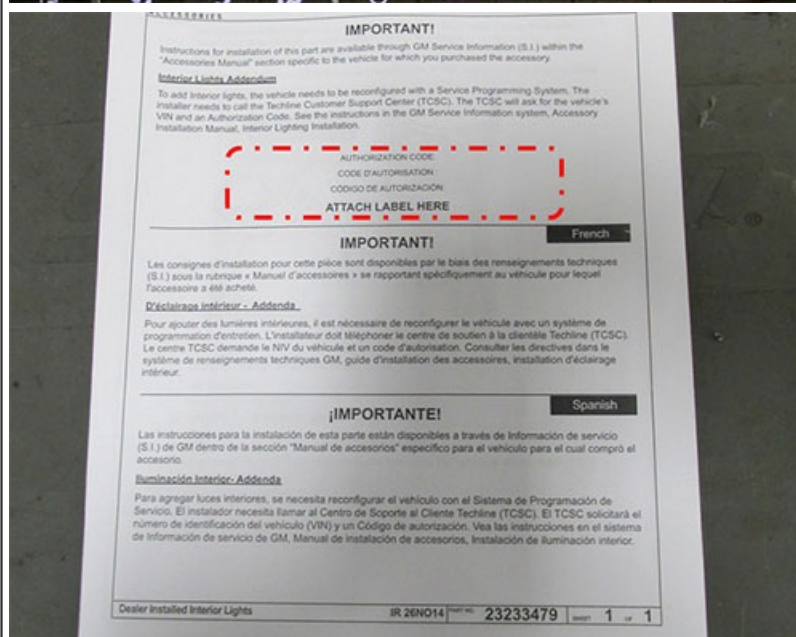
- If the vehicle is equipped with the uplevel radio (RPO I05 or I06) the BCM and the HMI will require reprogramming through Techline. This programming allows the customer to select the various lighting colors on the radio's touchscreen, as seen in the color palette photo below. As seen in the second photo below, there will also be a sheet of paper included in the kit that has an authorization code printed on it. Once that code is provided to Techline, they will be able to assist in correctly programming the vehicle.

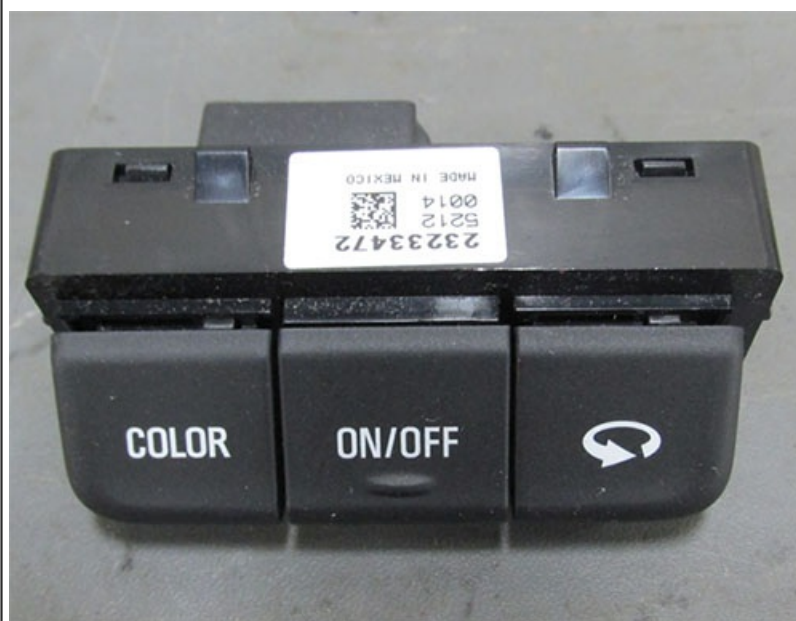
- Vehicles equipped with the base radio (RPO I0B) do not require any programming. That is why the color selections are not available on the radio screen. This system uses a switch to change the system's lighting colors. It is installed on the LH side of the steering column. This switch can be seen in the photo below.
