Service Bulletin

PRELIMINARY INFORMATION

- Subject: Diagnostic Tips for Reduced Acceleration at Low Speed and/or Transmission Slipping from a Launch, DTC P0751 Set
- Models: 2010-2013 Cadillac Escalade EXT 2010-2015 Cadillac CTS, Escalade, Escalade ESV 2013-2015 Cadillac ATS 2010-2013 Chevrolet Avalanche 2010-2014 Chevrolet Corvette 2010-2015 Chevrolet Camaro, Express, Silverado, Suburban, Tahoe 2011-2015 Chevrolet Caprice 2014 Chevrolet SS 2015 Chevrolet Colorado 2010-2015 GMC Savana, Sierra, Yukon, Yukon XL 2015 GMC Canyon Equipped with 6L45/50/80/90 Automatic Transmission (RPOs MYA, MYB, MYC, MYD)

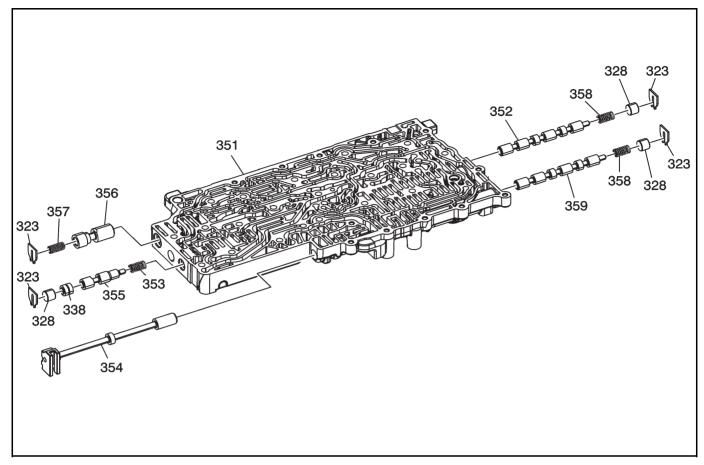
1537645

This condition may be caused by the Clutch Select Solenoid Valve 2 (359), located in the lower valve body, sticking in its bore resulting in a 4th gear start.

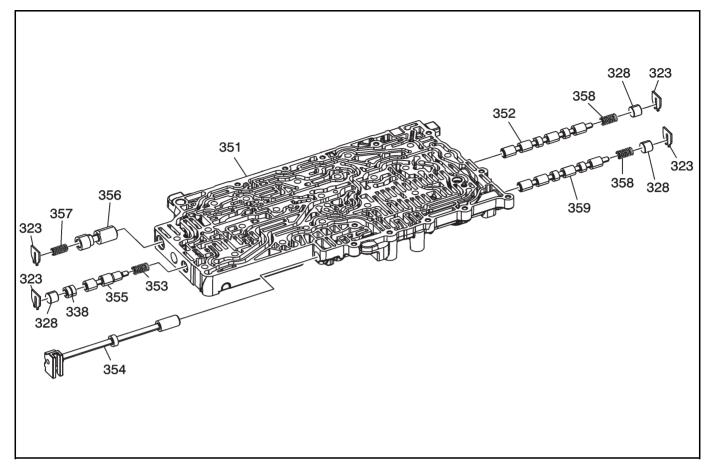
1537645

During inspection of the Clutch Select Solenoid Valve 2 (359), the valve may or may not be stuck in the bore due to the valve body bolts being loosened.

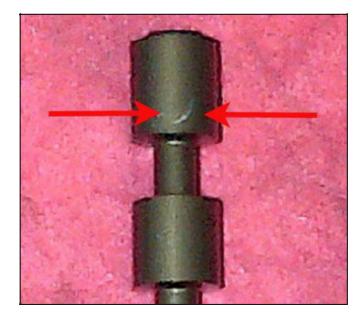
3988456

The recommended inspection procedure is to remove the valve and inspect it for any scratches on the valves. The illustration above shows an example of a valve with a scratch mark on it. If the valve is stuck in the bore or shows signs of scratching or damage, the lower valve body should be replaced.
