Service Bulletin

Subject: Diagnostic Tips for Reduced Acceleration at Low Speed and/or Transmission Slipping from a Launch, DTC P0751 Set

Models: 2010-2013 Cadillac Escalade EXT 2010-2015 Cadillac CTS, Escalade, Escalade ESV 2013-2015 Cadillac ATS 2010-2013 Chevrolet Avalanche 2010-2014 Chevrolet Corvette 2010-2015 Chevrolet Camaro, Express, Silverado, Suburban, Tahoe 2011-2015 Chevrolet Caprice 2014 Chevrolet SS 2010-2015 GMC Savana, Sierra, Yukon, Yukon XL Equipped with 6L45/50/80/90 Automatic Transmission (RPOs MYA, MYB, MYC, MYD)

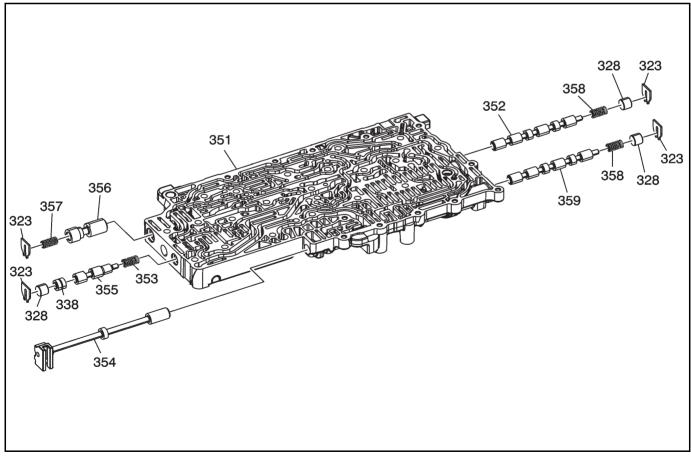
This condition may be caused by the Clutch Select Solenoid Valve 2 (359), located in the lower valve body, sticking in its bore resulting in a 4th gear start.

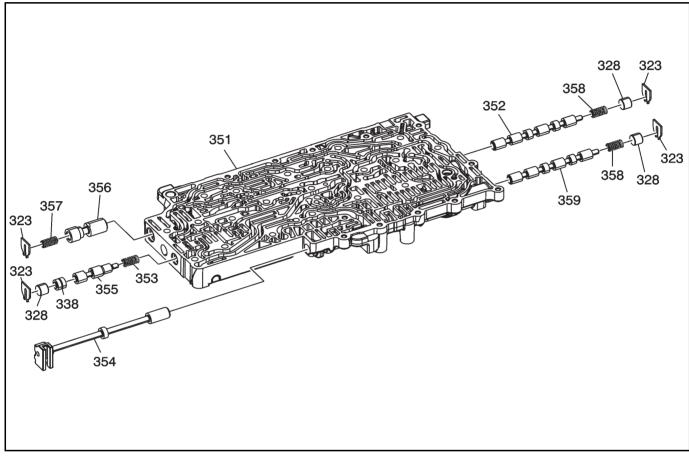
1537645

During inspection of the Clutch Select Solenoid Valve 2 (359), the valve may or may not be stuck in the bore due to the valve body bolts being loosened.

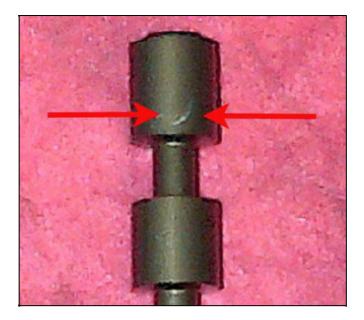
3988456

The recommended inspection procedure is to remove the valve and inspect it for any scratches on the valves. The illustration above shows an example of a valve with a scratch mark on it. If the valve is stuck in the bore or shows signs of scratching or damage, the lower valve body should be replaced.
