Service Bulletin

PRELIMINARY INFORMATION

Subject: Engine Misfire May Be Due To loose Spark Plug Wires

Models: 2014- 2015 Chevrolet Corvette
2014-2015 Chevrolet Silverado 1500 Suburban, Tahoe
2014-2015 GMC Sierra 1500 Yukon
Built with RPO's 4.3L 5.3L 6.2L L83 L86 LT1 LV3

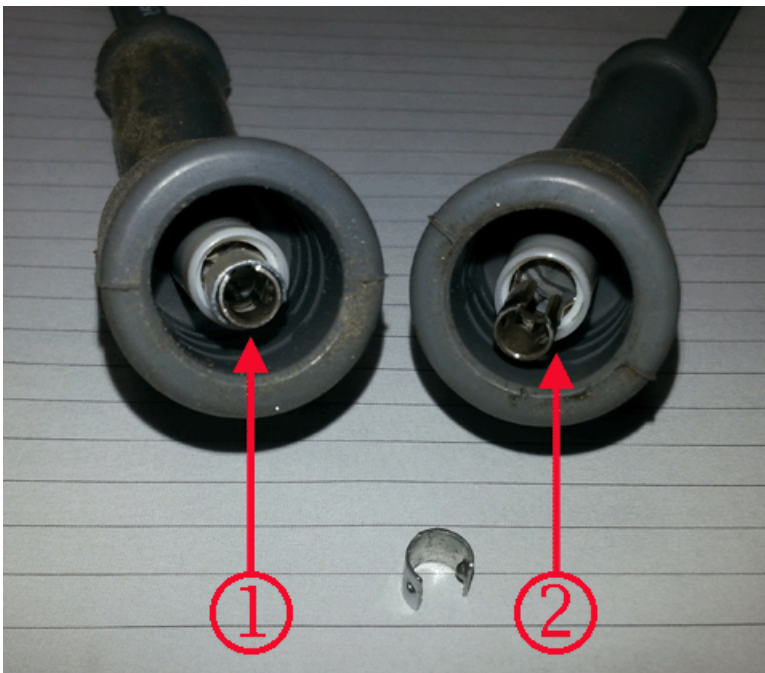
SES lamp on, DTC P0300 - P0308 may set, inspect for a possible loose sparkplug wire at the ignition coil.

If a loose sparkplug wire is found, inspect for missing "C" clip on wire end that connects to the ignition coil.

1. Shows a good sparkplug wire
2. Shows the wire with the C clip missing.

Replace the sparkplug wire if you find the "C" clip missing or damaged

If this concern is not found reconnect the sparkplug wire to the ignition coil.
