Service Bulletin

PRELIMINARY INFORMATION

Subject: MIL On With DTC P0016 And/Or P0017 Setting On A Properly Timed Engine Or Crank No Start

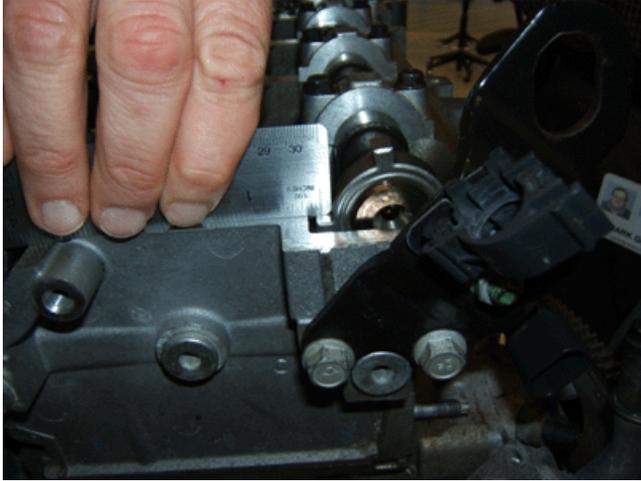
To check the Exhaust Cam reluctor position LE5 ONLY:

This may be the result of a camshaft reluctor that has moved on the camshaft. The reluctor is a press fit and is not indexed/keyed to the camshaft--it is an interference type fit. An overheat condition may contribute to the concern, causing the reluctor to spin on the camshaft when hot. If the reluctor spins far enough, it can create a crank no start condition.

With the exhaust camshaft positioned so that the valves for #4 cylinder are at maximum lift (fully opened valves), the reluctor should be flush/parallel to the rocker cover gasket surface as shown in the photo below. If the reluctor position does not line up correctly, the exhaust camshaft must be replaced. To check

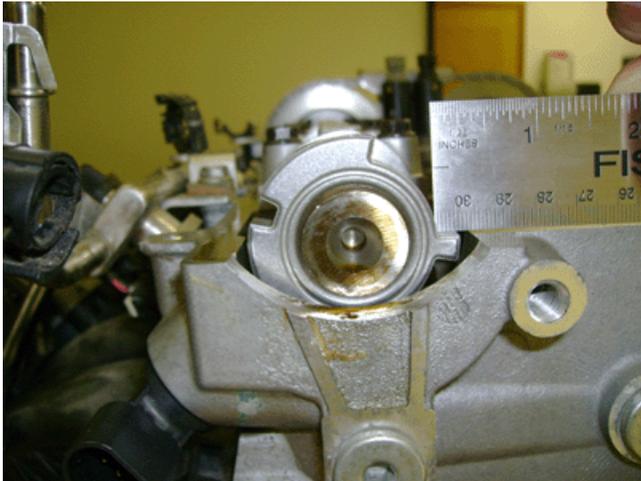
To check the Intake Cam reluctor position LE5 ONLY:

With the Intake camshaft positioned so that the valves for #1 cylinder are at maximum lift (fully opened valves), the reluctor should be flush/parallel to the rocker cover gasket surface as shown in the photo below. If the reluctor position does not line up correctly, the intake camshaft must be replaced.
