Service Bulletin

Subject: (EREV) Whine, Scrape, Whistle Type Noise While Driving

Models: 2011-2015 Chevrolet Volt
2014-2015 Cadillac ELR
2012-2014 Opel Ampera

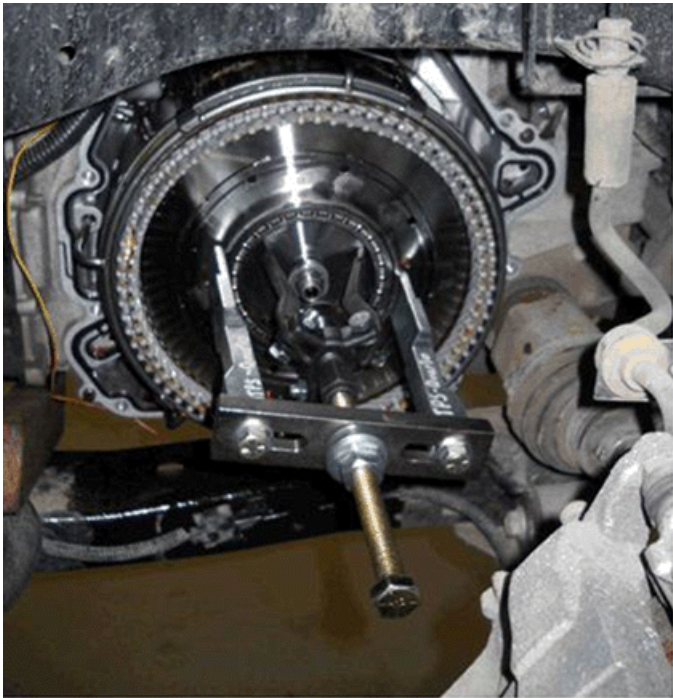
Important: Please ensure that the Special Tools DT-47865 - Bearing Remover and J-45124 - Removal Bridge are used to remove bearing. If proper tools are not used the rotor may be damaged leading to a repeat repair. DO NOT TRY TO PRY OUT.

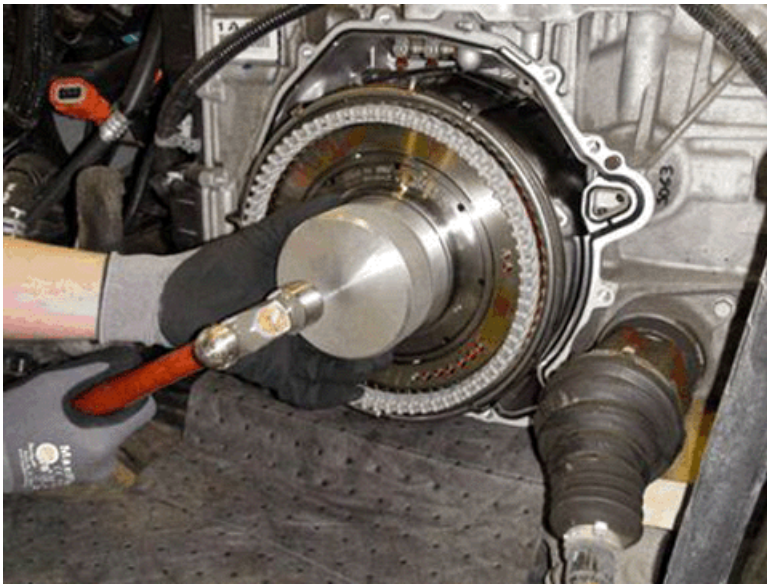
Important: To install bearing use Special Tools DT-22928-B Seal Installer per SI, as damage may occur if the proper tools are not utilized. Proper bearing orientation is the writing up or visible to technician.
