Service Bulletin

Subject: Diagnostic Tips: Unwanted Content Theft Alarm Sounds

Models: 2015 Cadillac Escalade
2015 Chevrolet Suburban, Tahoe
2015 GMC Yukon
With Theft Protection Package (RPO UTT)

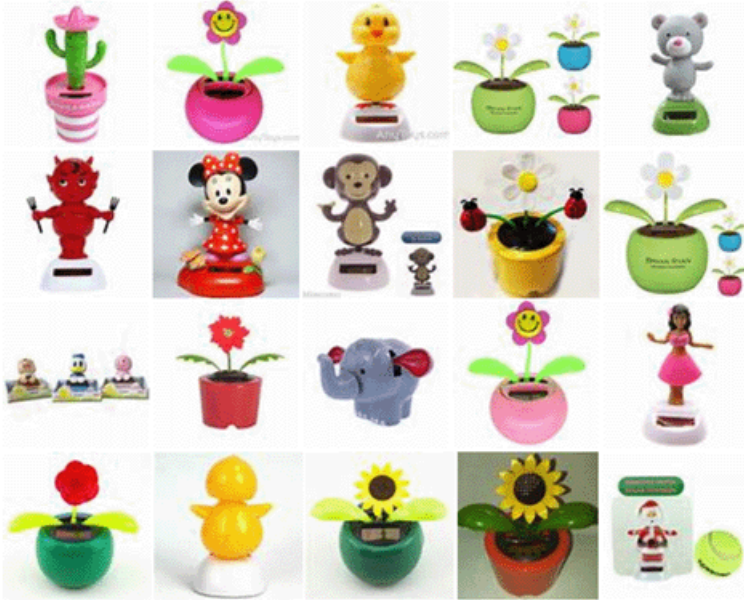
1. Intrusion- Located in the over-head console are ultrasonic intrusion sensors. These sensors are used to detect motion inside the vehicle. There have been reports of pets, items hanging from the rear view mirror, solar powered dancing characters (examples below), etc. moving inside the vehicle and triggering the alarm. These items will have to be removed and the system retested before performing any additional diagnostics.
