# Service Bulletin

## PRELIMINARY INFORMATION

**Subject:** Diagnostic Tips - Diagnosing High Speed LAN Concerns

**Models:** 2007-2014 Cadillac Escalade, ESV, EXT  
2007-2013 Chevrolet Avalanche, Silverado, Suburban, Tahoe  
2014 Chevrolet Silverado HD, Suburban, Tahoe  
2007-2013 GMC Sierra and Yukon Model  
2014 GMC Sierra HD and Yukon Models  
2008-2009 Hummer H2

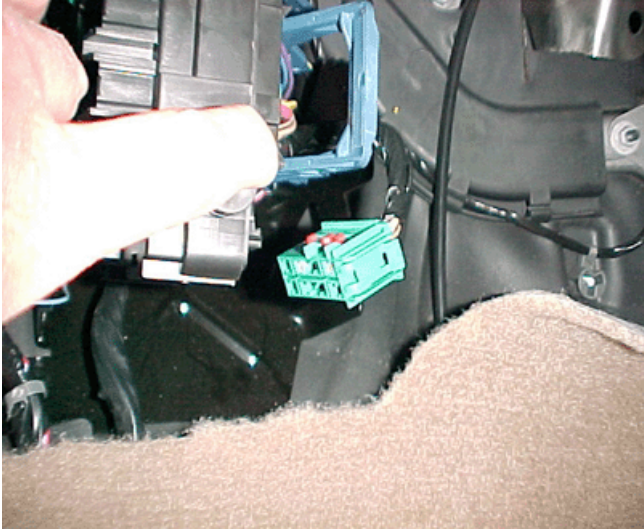
the left I/P junction block. The following steps listed below will explain how to locate and disconnect the C3 (X3) connector. With the C3 (X3) connector removed, only the ECM, TCM, and BCM will be online with the scan tool. If you are able to communicate with these modules, the concern is on the side of the bus that is disconnected.

Remove the C3(X3) connector from the bottom of the IP fuse block, this will isolate the high speed LAN modules in two halves.

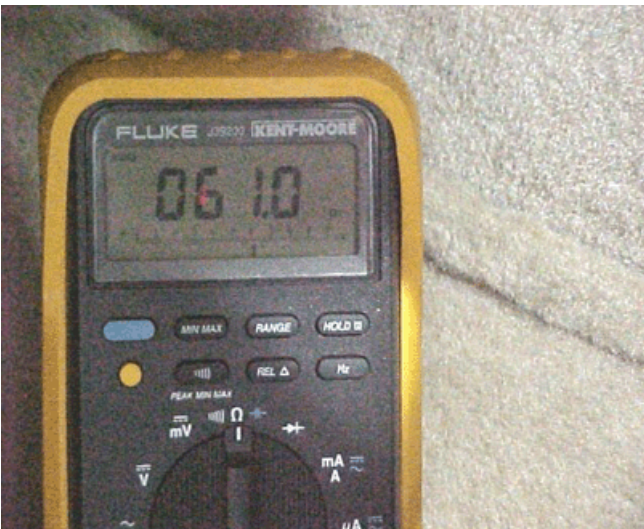
- Using a DVOM, measure the resistance across terminals 6 & 14 at the DLC connector. The resistance should be around 60 ohms and remain steady.
- Have an assistant wiggle test the wiring at each high speed LAN module while monitoring the DVOM reading looking for any type of fluctuation. If the reading varies while wiggle testing the wiring, check for proper terminal drag/terminal to wire crimp/ and circuit integrity at the effected module and repair as needed.

- Locate the DLC connector and probe terminals 6 & 14 using the proper test terminals contained in terminal test kit J-35616-14 or -2A.
