Service Bulletin

PRELIMINARY INFORMATION

Subject: Uneven Front Brake Pad Wear

Models: 2015 Cadillac Escalade Models
2014-2015 Chevrolet Silverado 1500
2015 Chevrolet Suburban, Tahoe
2014-2015 GMC Sierra 1500
2015 GMC Yukon Models

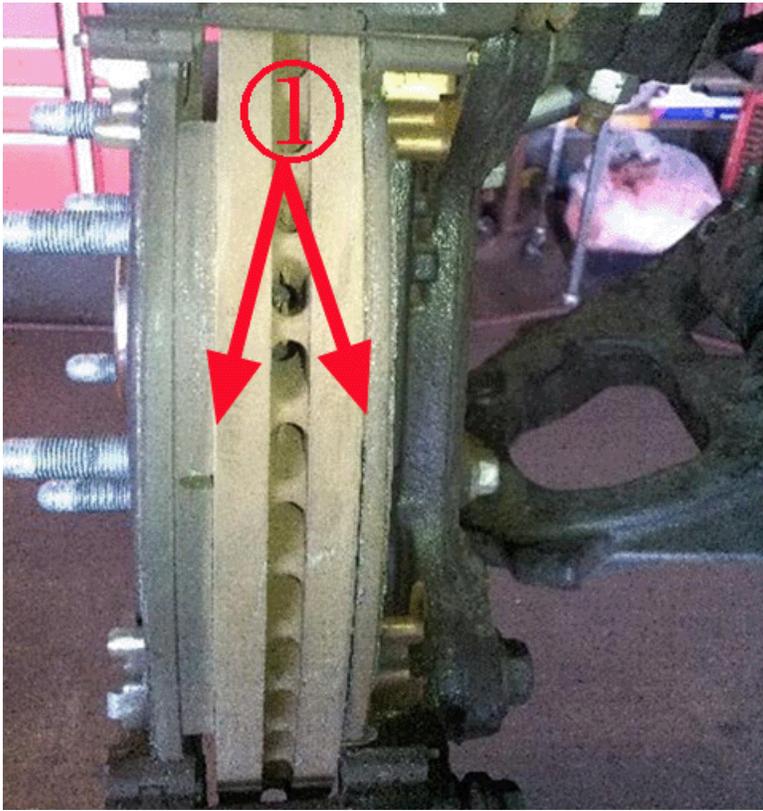
During a brake inspection, some complaints of uneven front brake pad wear have been reported. The vehicle may have low mileage, typically around 10K miles. The inner pad on either the front left or right side may be worn out. It is considered uneven pad wear if one of the following is true:

Shown below is an example from one vehicle with uneven wear. Photo 1 is of the left front brake pads where the inner pad is worn completely out, while the outer pad still has plenty of pad life. Photo 2 is from the same vehicle, but of the right front inner and outer brake pads, which both have plenty of pad material left.

Inspect and measure the brake pads thickness. Determine the type of driving the owner does and compare the measurements to the information listed above (3mm or 6mm).

1. Perform normal SI diagnostics to determine the cause of the concern (caliper piston binding, binding pads or pins in bracket, brake hose restriction,

2. After completing normal diagnostics, if a root cause for the uneven pad wear is not found, perform a normal brake repair (replace pads, turn or replace rotors, etc). After repairs and pad burnishing have been completed, test drive the vehicle for 20-30 miles. The test drive needs to be performed on an open road at cruising speeds (55 mph+) where very little braking is actually performed. Immediately after returning from the test drive, lift the truck up on a hoist and spin both front wheels by hand, checking for a wheel that is hard to spin. If a wheel is hard to spin, it may be an indication of a brake drag. While the condition is present, perform normal SI diagnostics to determine the cause of the drag (caliper piston binding, binding pads or pins in the bracket, brake hose restriction, etc). Repair as necessary and re-evaluate the concern. If the concern is corrected, no further action is required.
