Service Bulletin

PRELIMINARY INFORMATION

Subject: Click - Rattle Or Squeak Noise From Dash Area

Models: 2015 Cadillac Escalade Models
2014 Chevrolet Silverado 1500
2015 Chevrolet Silverado, Suburban, Tahoe
2014 GMC Sierra 1500
2015 GMC Sierra, Yukon Models
with 110 Volt AC Converter (RPO K14)

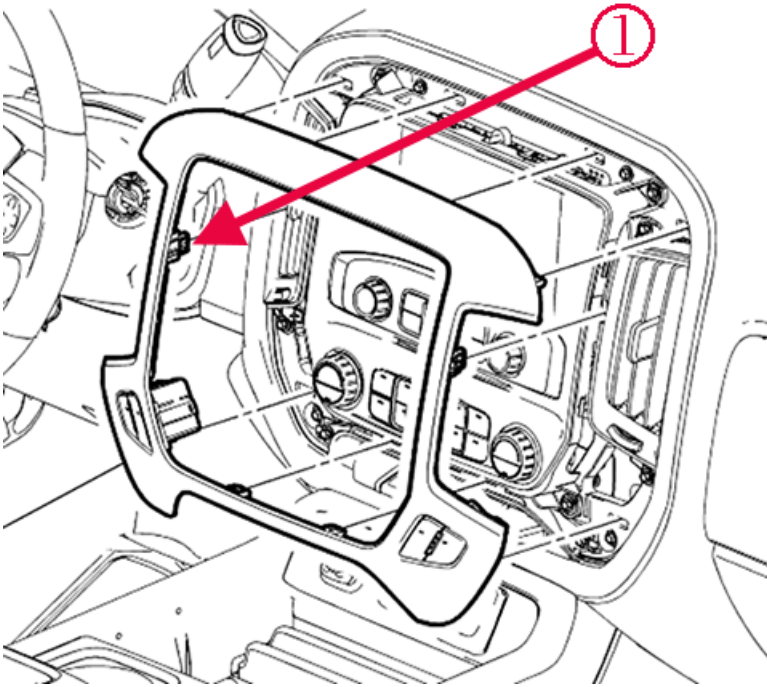
Condition 2: A rattle, squeak or itch type noise from the center of the dash in the radio area.

The instrument panel accessory bezel may be rattling due to insufficient tension of retainers. Press on the bezel while duplicating noise to see if it is eliminated.

Wrap Kent automotive BRS flocking tape part number KT13487 over retainers (#1 in illustration) and reinstall bezel.

This will require an application of BRS flocking tape on ten retainers (one strip @ 1" x 10"). Two sheets should repair 16 vehicles.
