Service Bulletin

Subject: Steering Column Grind Pop Bind Shudder Noise And/Or Feeling When Turning

Models: 2015 Cadillac Escalade Models
2014 Chevrolet Silverado 1500
2015 Chevrolet Silverado, Suburban, Tahoe
2014 GMC Sierra 1500
2015 GMC Sierra, Yukon Models
With Tilt and Telescoping Steering Column RPO N38 or N37

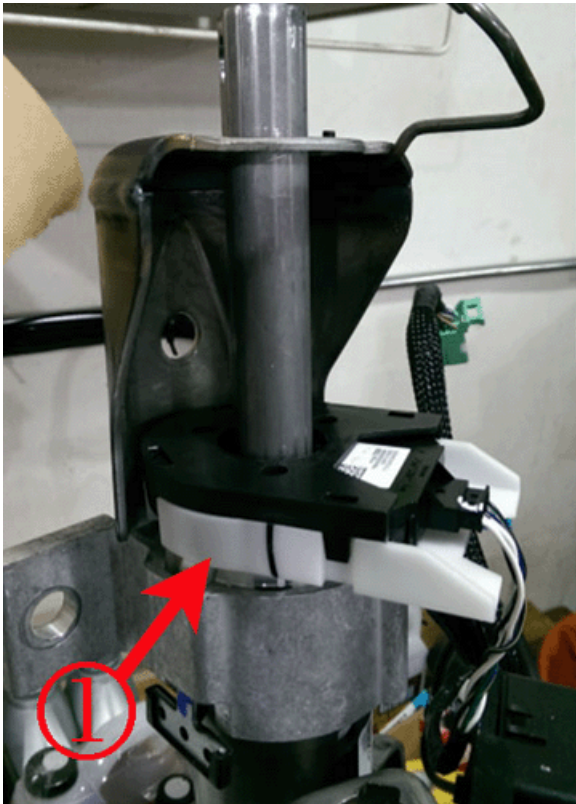
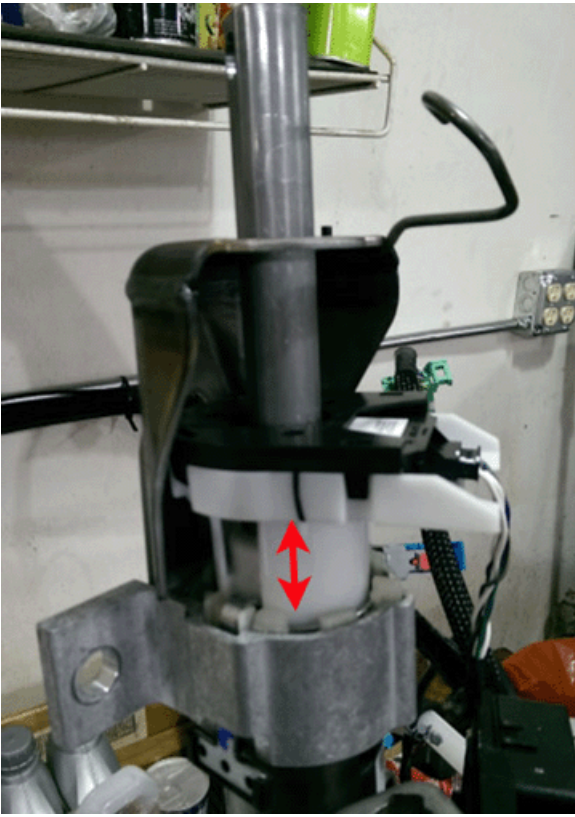
Some owners may comment on a grind, pop, shudder or bind feeling/noise in the steering column when turning left or right. This concern could be caused by either of the following:

1. The lower column bearing housing assembly (1) may be out of position. The 1st picture shows the lower column bearing assembly (1) in its correct position, while the 2nd picture below shows the lower column bearing out of position.

Important: To correct either above condition, repair the steering column assembly by replacing the column lower bearing adapter assembly and retainer as instructed in the following. Below are the highlighted steps for the repair, but please refer to SI "Steering Shaft Lower Bearing Adapter Replacement" for the complete procedure and torque specifications.

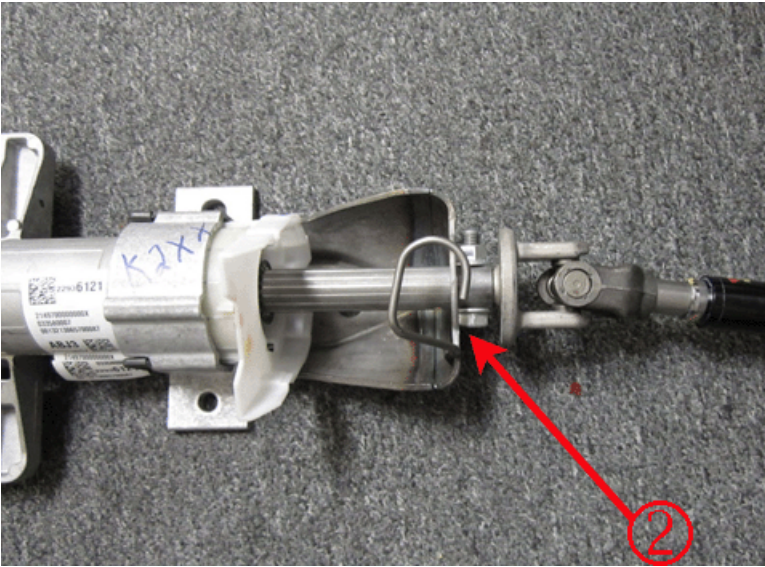
2. The upper intermediate steering shaft to lower column shaft bolt and nut (2) may be contacting the inhibitor/shifter cable bracket, as shown below.
