Service Bulletin

Bulletin No.: PIT5318A

Subject: Wind Buffeting Droan Type Noise And/Or Body Pressure Booming And/Or Water Leak

Models: 2015 Cadillac Escalade Models

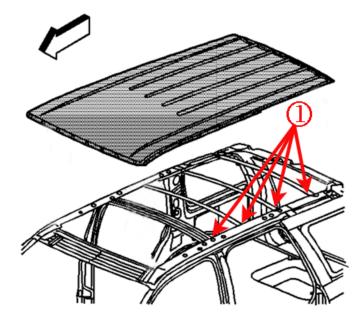
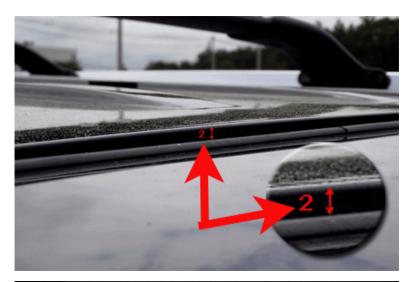
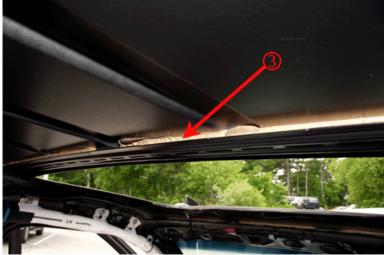
Some owners may comment of a wind buffeting/droan noise or body/pressure booming (the feeling of pressure in the ears) while driving. The body booming issue may be more noticeable when the engine is in V4 mode for active fuel management (AFM). In some cases, they may also notice a water leak from the headliner area, if equipped with a sunroof.

These concerns could be caused by the roof sheet metal no longer being attached fully to the roof bows (1). On trucks with a sunroof, it may be noticed that the rear edge of the sunroof glass is considerably lower than the roof (2). This is due to the roof sheet metal being detached from the roof bow directly behind the sunroof opening (3).

To correct this concern, apply panel vibration control material between the roof bow and roof sheet metal, along with foam shim material when necessary.

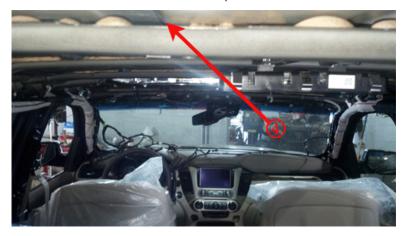
Remove the headliner to access the underside of the roof. Inspect all 4 roof bows for insufficient bonding to the roof sheet metal (4). Any roof bow that is not bonded to the sheet metal will need to be repaired.

Use a plastic scraper or similar tool to remove the old foam. Measure the gap between the top of the roof bow and bottom of the roof sheet metal. If the gap is 5/16 (8mm) or greater, use a combination of 3/4" wide by 5/16" or 7/16" thick foam shim material (as listed below) to fill the gap between the roof bow and the sheet metal. Care should be taken to add only the correct thickness of foam to fill the gap so it does not push up on the roof. Cut the foam into 5 inch lengths and place in three spots along the roof bow, one piece in the middle and one at each outer edge. With the foam shim material in place, or if the gap is less than 5/16" (8mm), use the panel control vibration material (as listed below) to fill the voids between the roof bow and sheet metal. In some cases, it may take a couple layers of material to fill the void.
