Service Bulletin

Bulletin No.: PIP5029F

Subject: Rough Idle Crank No Start Extended Crank Or Misfire Due to Excessive Carbon On Top of the Valves or

Models: 2000-2015 All Passenger Cars with Gasoline Engines

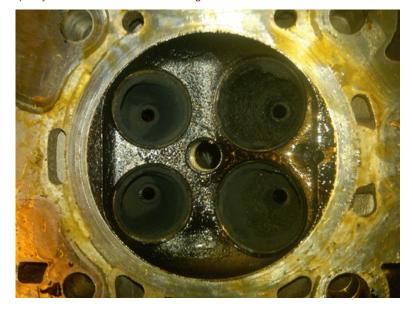
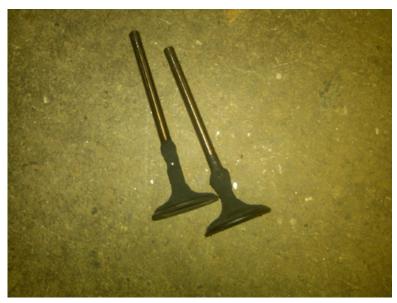
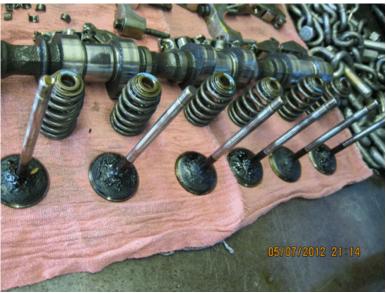
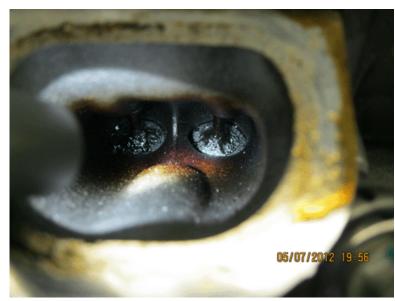
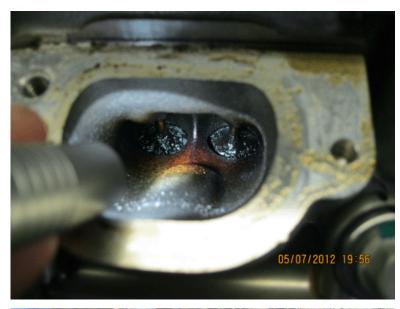
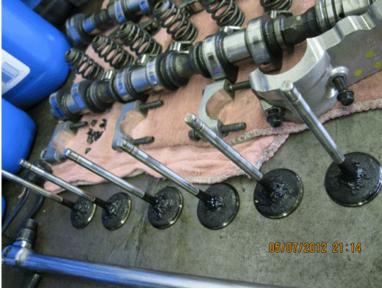
This may be the result of major carbon build up on the intake and/or exhaust valves due to fuel contamination or incomplete burning of the fuel as shown below so the misfires should not have appeared until accumulating at least 5,000 miles or more.

Perform an upper engine and valve cleaning procedure as outlined below.

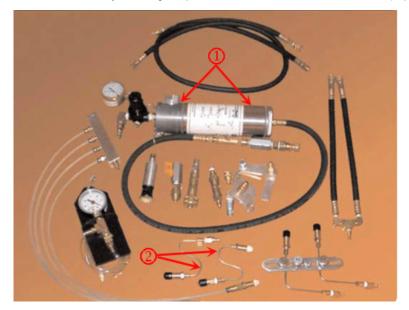
Kent Moore Tool Kit # J-45076

- 1. Pressurized Canister from J-45076 is Shown J-35800-A is Similar (Equivalent Pressurized Canister Acceptable)
- 2. Throttle Body Cleaning Adapters J-45076-46 and J-45076-55 Shown (Equivalent Adapters Acceptable)
