Service Bulletin

PRELIMINARY INFORMATION

Subject: Unwanted Window Reversal During An Express Up Function

Models: 2015 Cadillac ATS Coupe

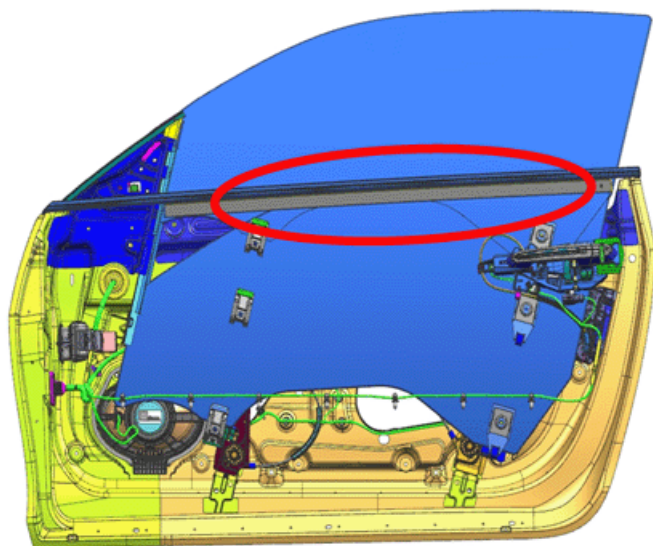
1. Check the inner belt molding to make sure it was not installed too far forward causing the lip to fold over adding resistance to the window operation.

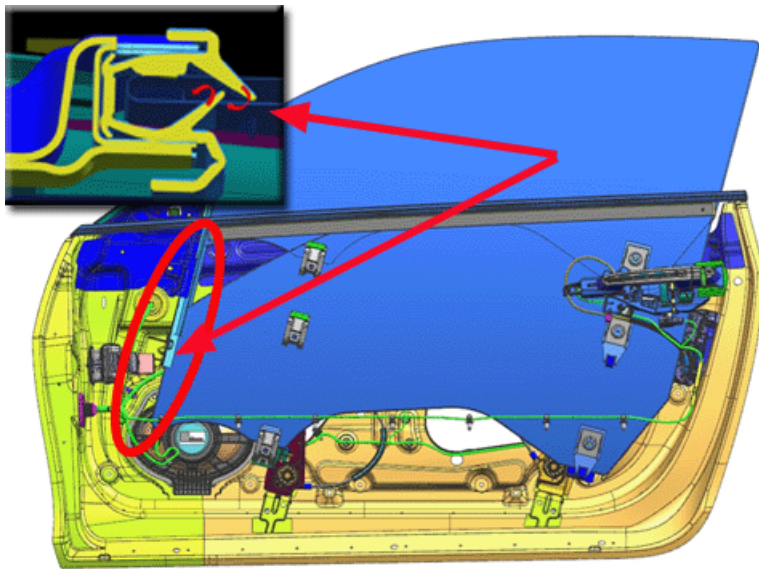
2. Check the forward run channel seals to make sure they are not folded under the forward edge of glass. You cannot see this unless you look down through the belt line seals
