# Service Bulletin

**Subject:** SES Lamp With Camshaft Position Codes

**Models:** 2015-2016 Cadillac Escalade  
2014-2016 Chevrolet Silverado 1500  
2015-2016 Chevrolet Suburban, Tahoe  
2014-2016 GMC Sierra 1500  
2015-2016 GMC Yukon Yukon XL  
Built with RPO's 4.3L 5.3L 6.2L L83 L86 LV3

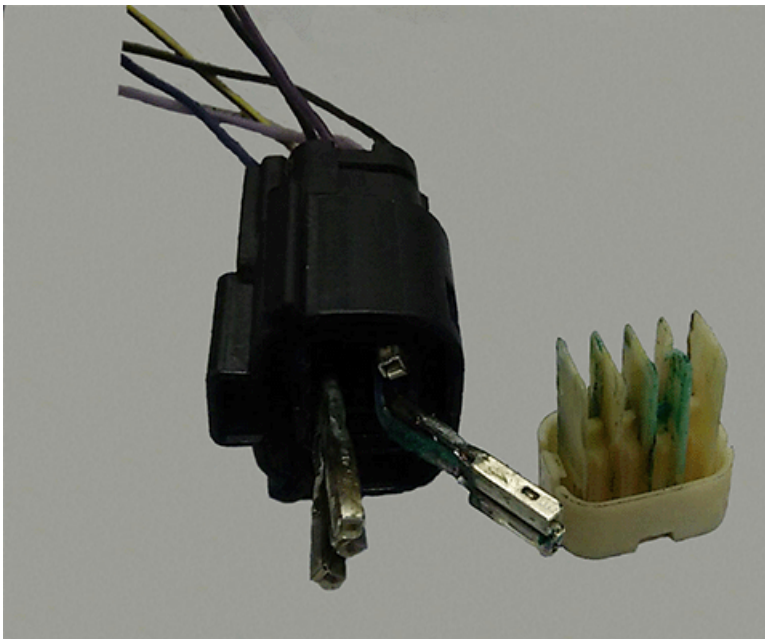
A vehicle may be setting DTC's P0340 and P0341 at times

If normal SI Diagnostics does not isolate the concern, inspect for corrosion in connector X154 located on the front cover next to the vacuum pump.

See the illustration below

If this condition is encountered repair as needed.
