Service Bulletin

PRELIMINARY INFORMATION

Subject: Upper Steering Column Pop Click Tick Snap Itch Noise While Turning The Steering Wheel

Models: 2015 Cadillac Escalade Models
2015 Chevrolet Suburban, Tahoe
2015 GMC Yukon Models
With Power Tilt and Telescoping Steering Column (RPO N38)

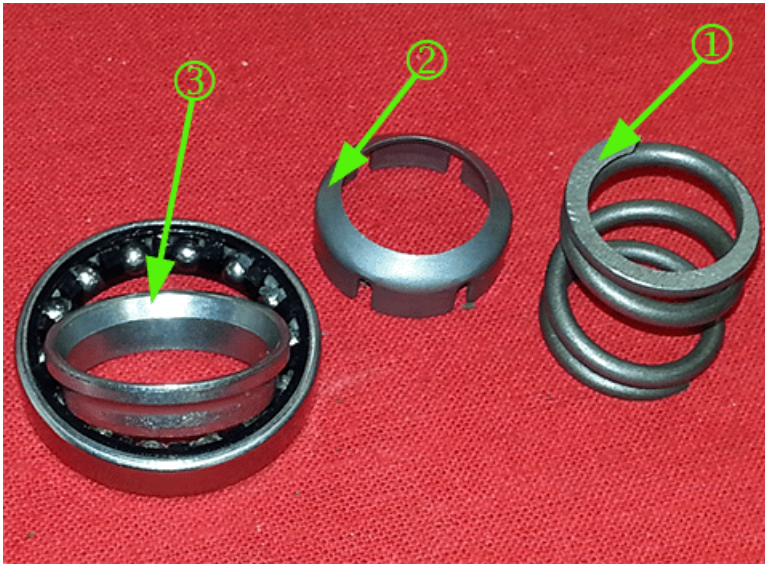
This noise could be caused by the upper column bearing race being slightly out of alignment.

1.4 Using a magnet, remove the upper bearing inner race (3) from the column. Do NOT remove the upper bearing.

2. Install the new steering column upper bearing inner race (3), spring seat (2), and spring (1) to the column:

2.1 Install the new upper bearing inner race (3). The new inner race comes with a new upper bearing, discard the new bearing as it will not be used.
